# NGQAMAKHWE WATER SUPPLY SCHEME - PHASE 3

## Aquatic Biodiversity Assessment

DRAFT REPORT

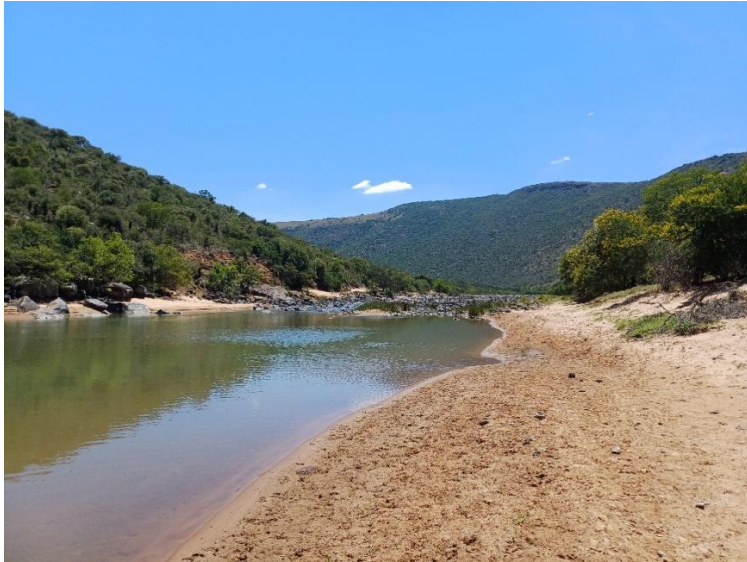
**Table 8-2 Lowlands river 1 details (no direct crossing)**

Ngqamakhwe LLR 1		Crossing No:	N/A	Quaternary Catchment	S50J	Map Reference	Figure 8-2
Habitat type	Lowlands River			Latitude:	-32.190077	Longitude:	27.803531
Photograph

IHI/PES	Condition Score		Key current impacts				
	B/	C	Minor bed and channel modification due to erosion in the stream system as well as moderate bank erosion. Some invasive alien species present.				
EIS Score	Moderate EIS. The score is derived from the ecological importance of the Tsomo River.						
Risks	Low risks associated with the proposed development given that the pipeline alignments will not cross this stream system at all. A low risk exists because the pipeline is located in the catchment of the stream system.

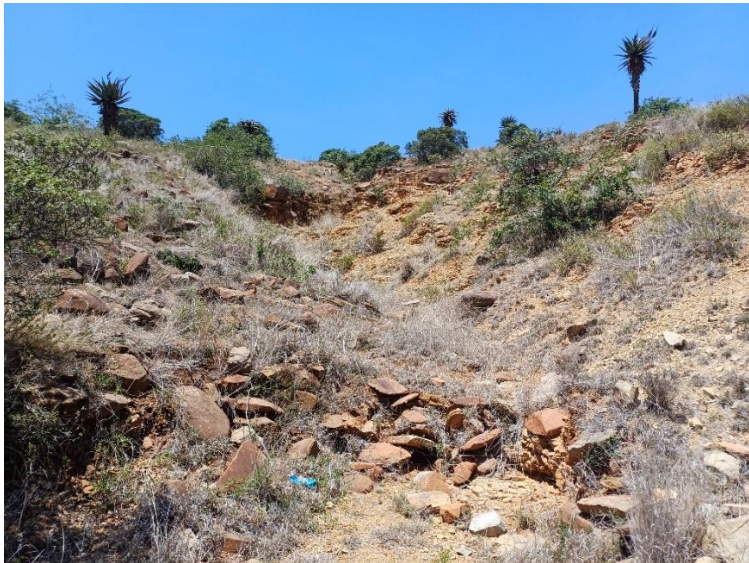
**Table 8-3 Mountain stream 1 details (no direct crossing)**

Ngqamakhwe MS 1	Crossing No:	N/A	Quaternary Catchment	S50J	Map Reference	Figure 8-2
Habitat type	Mountain Stream		Latitude:	-32.1915225	Longitude:	27.8068017
Photograph

IHI/PES	Condition Score	Key current impacts				
	A	Minor channel and bed modification in the stream system. Introduction of alien vegetation in the stream system as well as the presence of litter in the riparian zone.				
EIS Score	Moderate EIS. The score is derived from the ecological importance of the stream given it is a tributary of the Tsomo River.					
Risks	Low risks associated with the proposed development given that the pipeline alignments will not cross this stream system at all. A low risk exists because the pipeline is located in the catchment of the stream system and within close proximity to the stream.

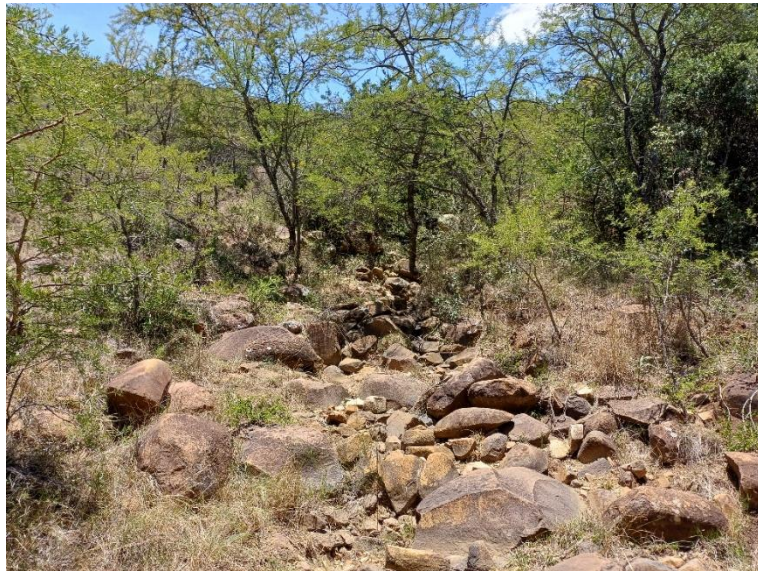
**Table 8-4 Mountain stream 2 details (no direct crossing)**

Ngqamakhwe MS 2	Crossing No:	N/A	Quaternary Catchment	S50J	Map Reference	Figure 8-2
Habitat type	Mountain Stream		Latitude:	-32.198997	Longitude:	27.814003
Photograph

IHI/PES	Condition Score	Key current impacts				
	A	Minor bank and channel erosion.				
EIS Score	Moderate EIS. The score is derived from the ecological importance of the stream given it is a tributary of the Ngculu River.					
Risks	Low risks associated with the proposed development given that the pipeline alignments will not cross this stream system at all. A low risk exists because the pipeline is located in the catchment of the stream system.

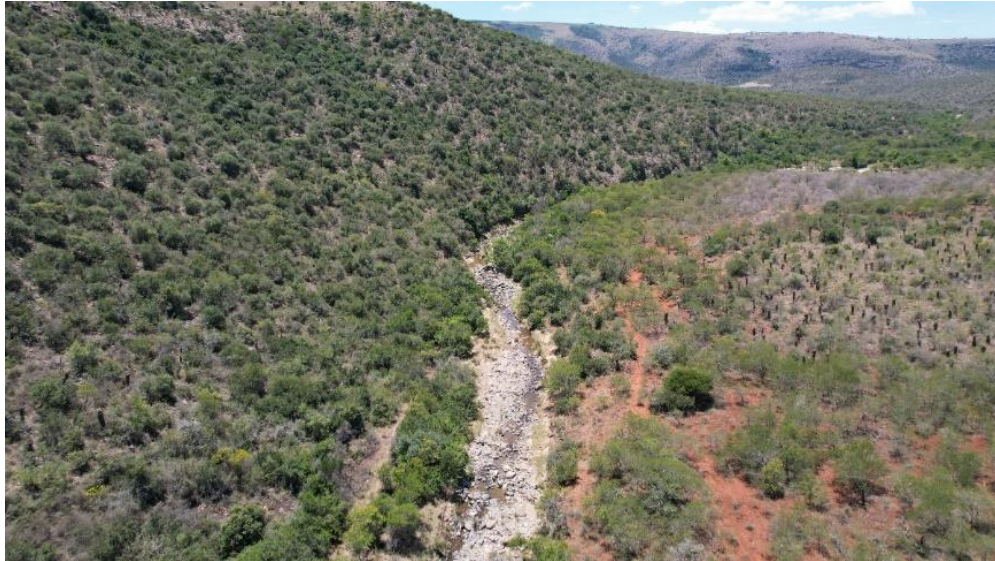
**Table 8-5 Upper foothills 1 details (no direct crossing)**

Ngqamakhwe UFH 1	Crossing No:	N/A	Quaternary Catchment	S50J	Map Reference	Figure 8-2
Habitat type	Upper Foothills River		Latitude:	-32.200351	Longitude:	27.819532
Photograph

IHI/PES	Condition Score		Key current impacts			
	B/	C	Moderate bank erosion and alteration and the encroachment of invasive alien plants.			
EIS Score	Moderate EIS. The score is derived from the ecological importance of the Ngculu River					
Risks	Low risks associated with the proposed development given that the pipeline alignments will not cross this stream system at all. A low risk exists because the pipeline is located in the catchment of the stream system.

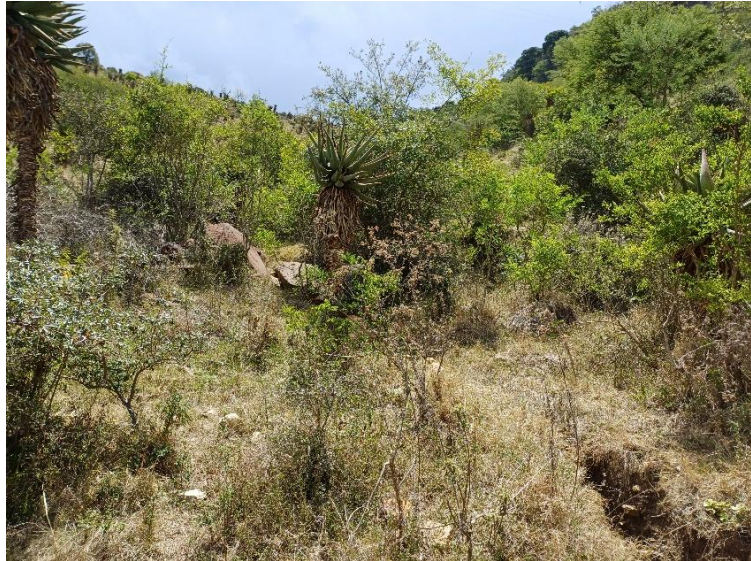
**Table 8-6 Mountain headwater stream 1 details (no direct crossing)**

Ngqamakhwe MHS 1	Crossing No:	N/A	Quaternary Catchment	S50J	Map Reference	Figure 8-3
Habitat type	Mountain Headwater Stream		Latitude:	-32.1875099	Longitude:	27.8272388
Photograph

IHI/PES	Condition Score	Key current impacts				
	A	Minor bank modification within the stream system.				
EIS Score	Moderate EIS. The score is derived from the ecological importance of the stream given it is a tributary of the Ngculu River.					
Risks	Low risks associated with the proposed development given that the pipeline alignments will not cross this stream system at all. A low risk exists because the pipeline is located in the catchment of the stream system.

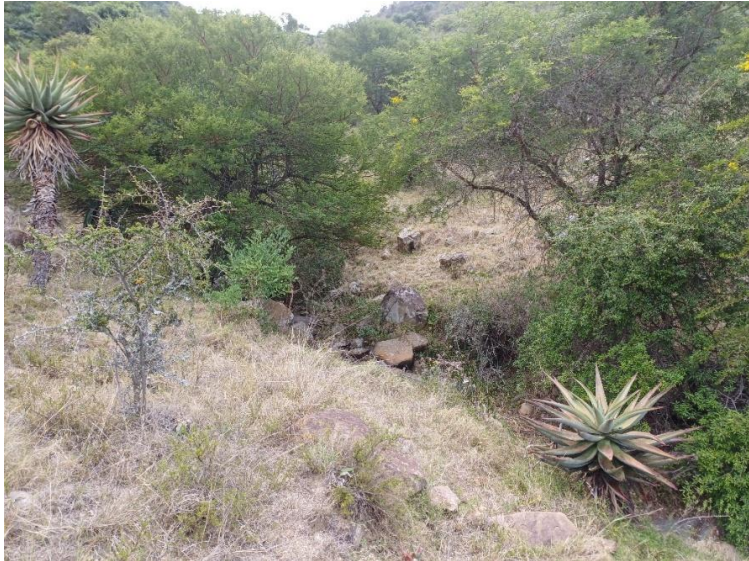
**Table 8-7 Mountain headwater stream 2 details (crossing S50J-2)**

Ngqamakhwe MHS 2	Crossing No:	S50J-2	Quaternary Catchment	S50J	Map Reference	Figure 8-3
Habitat type	Mountain Headwater Stream		Latitude:	-32.1875433	Longitude:	27.8272674
Photograph

IHI/PES	Condition Score	Key current impacts				
	A	Minor instream invasive alien plants present.				
EIS Score	Moderate EIS. The score is derived from the ecological importance of the stream given it is a tributary of the Ngculu River.					
Risks	Low to moderate risks associated with the proposed development given that the pipeline alignments cross this stream at a single point along its length.

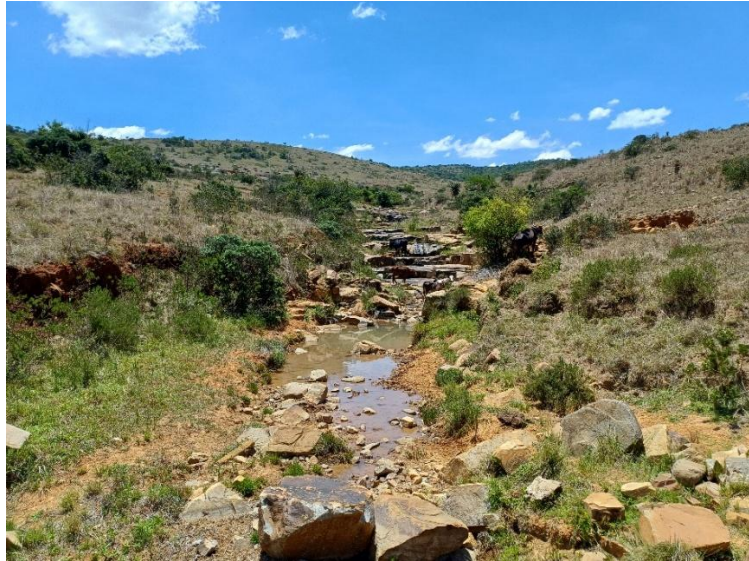
**Table 8-8 Mountain stream 3 details (crossing S50J-1)**

Ngqamakhwe MS 3	Crossing No:	S50J-1	Quaternary Catchment	S50J	Map Reference	Figure 8-3
Habitat type	Mountain Stream		Latitude:	-32.185866	Longitude:	27.821340
Photograph

IHI/PES	Condition Score	Key current impacts				
	B	Minor channel and bed modification due to erosion and a road crossing. Bank erosion present due to uncontrolled stormwater runoff approaching the road crossing.				
EIS Score	Moderate EIS. The score is derived from the ecological importance of the stream given it is a tributary of the Ngculu River.					
Risks	Low to moderate risks associated with the proposed development given that the pipeline alignments cross this stream at a single point. This crossing point is located along an existing road.

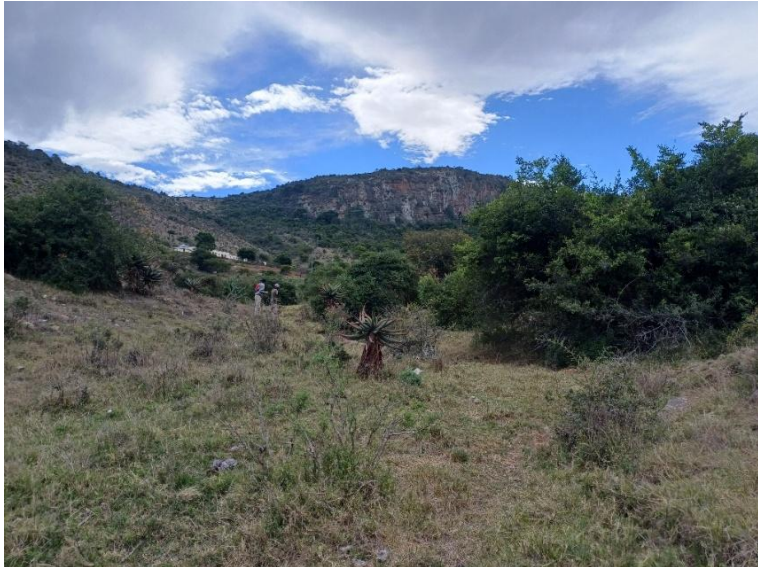
**Table 8-9 Mountain stream 5 details (crossing S50J-3)**

Ngqamakhwe MS 5	Crossing No:	S50J-3	Quaternary Catchment	S50J	Map Reference	Figure 8-3
Habitat type	Mountain Stream		Latitude:	-32.1894833	Longitude:	27.8305231
Photograph

IHI/PES	Condition Score	Key current impacts				
	B	Minor flow, bed and channel modification in the system.				
EIS Score	Moderate EIS. The score is derived from the ecological importance of the stream given it is a tributary of the Ngculu River.					
Risks	Low to moderate risks associated with the proposed development given that the pipeline alignments cross this stream at a single point along its length in an area that is already disturbed due to footpaths.

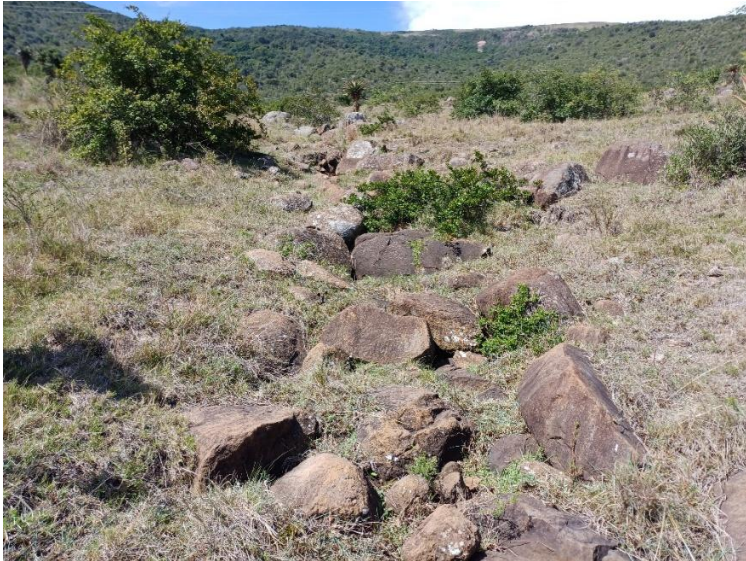
**Table 8-10 Mountain stream 6 details (crossing S50J-4)**

Ngqamakhwe MS 6	Crossing No:	S50J-4	Quaternary Catchment	S50J	Map Reference	Figure 8-4
Habitat type	Mountain Stream		Latitude:	-32.1882384	Longitude:	27.8332473
Photograph

IHI/PES	Condition Score	Key current impacts				
	A	Minor litter found within the stream.				
EIS Score	Moderate EIS. The score is derived from the ecological importance of the stream given it is a tributary of the Ngculu River.					
Risks	Low to moderate risks associated with the proposed development given that the pipeline alignments cross this stream at a single point along its length.

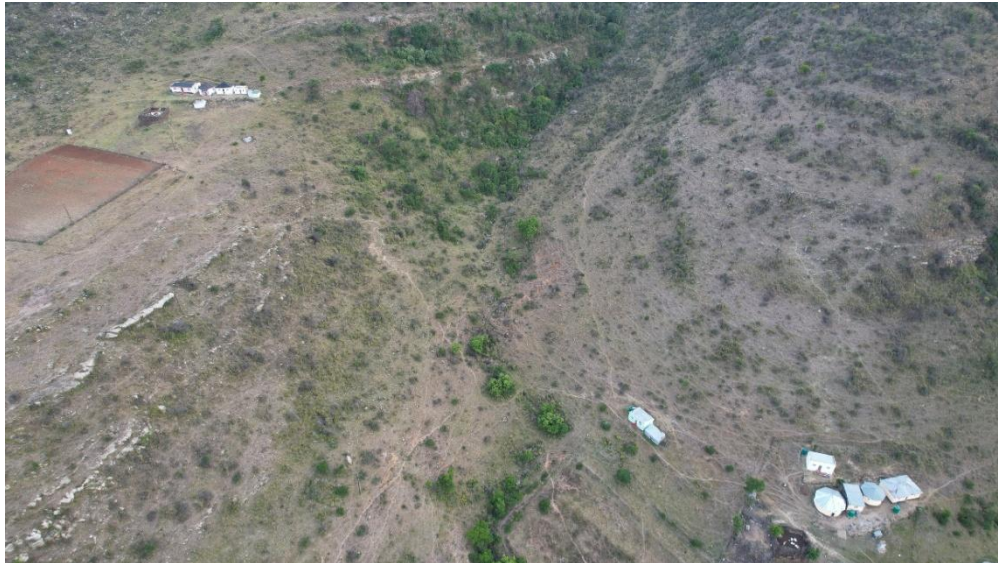
IHI/PES	Condition Score	Key current impacts				
	C	Minor bed and channel modification as well as a major presence of invasive alien species within the stream system.				
EIS Score	Moderate EIS. The score is derived from the ecological importance of the stream given it is a tributary of the Ngculu River.					
Risks	Low risks associated with the proposed development given that the pipeline alignments will not cross this stream system at all. A low risk exists because the pipeline is located in the catchment of the stream system.

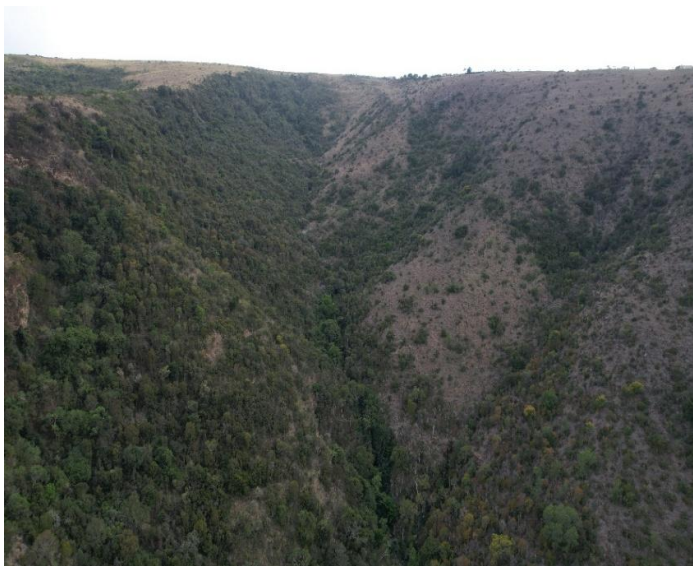
**Table 8-12 Mountain stream 9 details (no direct crossing)**

Ngqamakhwe MS 9	Crossing No:	N/A	Quaternary Catchment	S50J	Map Reference	Figure 8-4
Habitat type	Mountain Stream		Latitude:	-32.1905455	Longitude:	27.8434196
Photograph

IHI/PES	Condition Score		Key current impacts			
	A/	B	Minor bed and channel modification in the stream system.			
EIS Score	Moderate EIS. The score is derived from the ecological importance of the stream given it is a tributary of the Ngculu River.					
Risks	Low risks associated with the proposed development given that the pipeline alignments will not cross this stream system at all. A low risk exists because the pipeline is located in the catchment of the stream system.

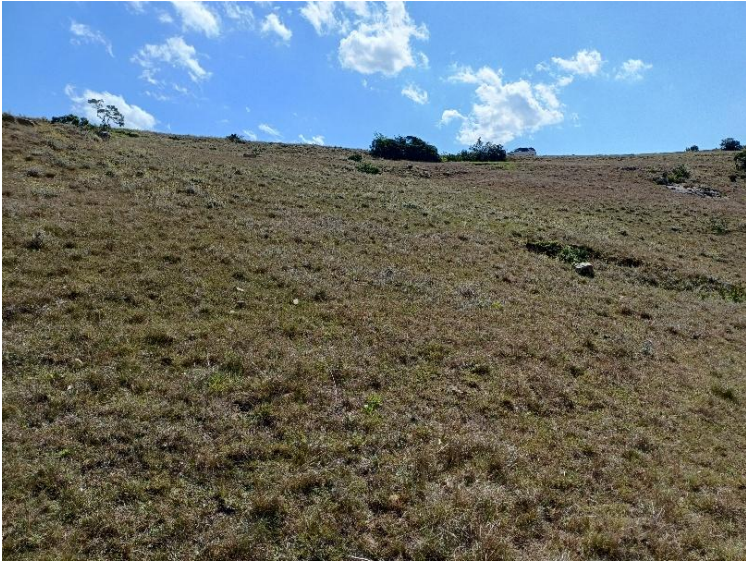
**Table 8-13 Seep 1 details (no direct crossing)**

Ngqamakhwe SEEP 1	Crossing No:	N/A	Quaternary Catchment	S50J	Map Reference	Figure 8-5
Habitat type	Hillslope Seep Wetland		Latitude:	-32.1801232	Longitude:	27.8455450
Photograph

IHI/PES	Condition Score	Key current impacts				
	C	Heavy grazing by livestock which has transformed the natural vegetation structure and composition.				
EIS Score	Moderate EIS. The score is derived from the biodiversity maintenance ecological importance of the wetland due to the relatively good ecological condition of C and the fact that it is ecologically connected to other wetlands and freshwater ecosystems of importance.					
Risks	Minor risks are posed to this wetland given that there are no direct crossings that are proposed for this wetland. Minor risks include increased runoff from a burst pipe in the catchment of the wetland or from sedimentation during the construction phase.

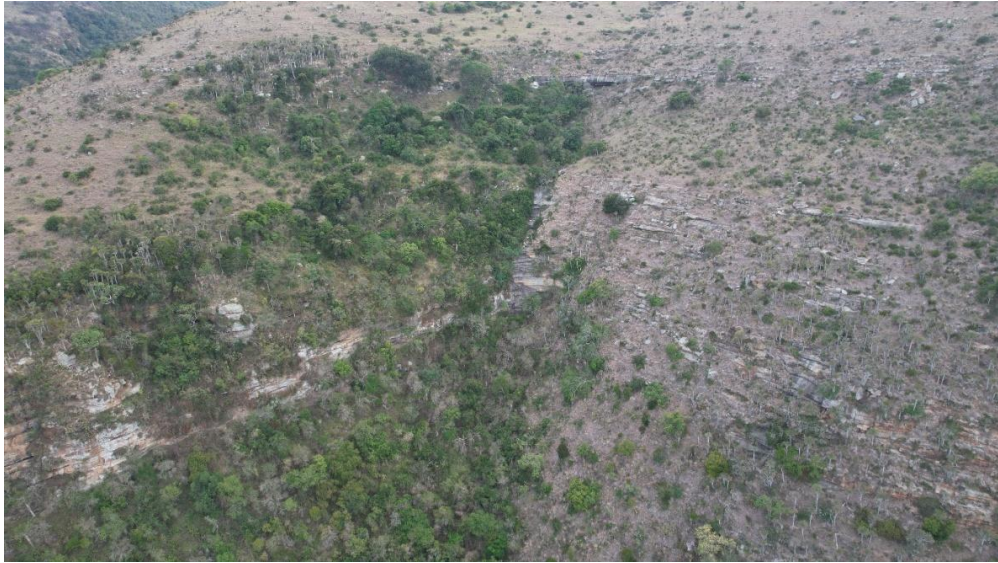
IHI/PES	Condition Score	Key current impacts				
	A	Minor impacts associated with the stream due to invasive alien plan encroachment.				
EIS Score	Moderate EIS. The score is derived from the ecological importance of the stream given it is a tributary of the Ngculu River.					
Risks	Low risks associated with the proposed development given that the pipeline alignments will not cross this stream system at all. A low risk exists because the pipeline is located in the catchment of the stream system.

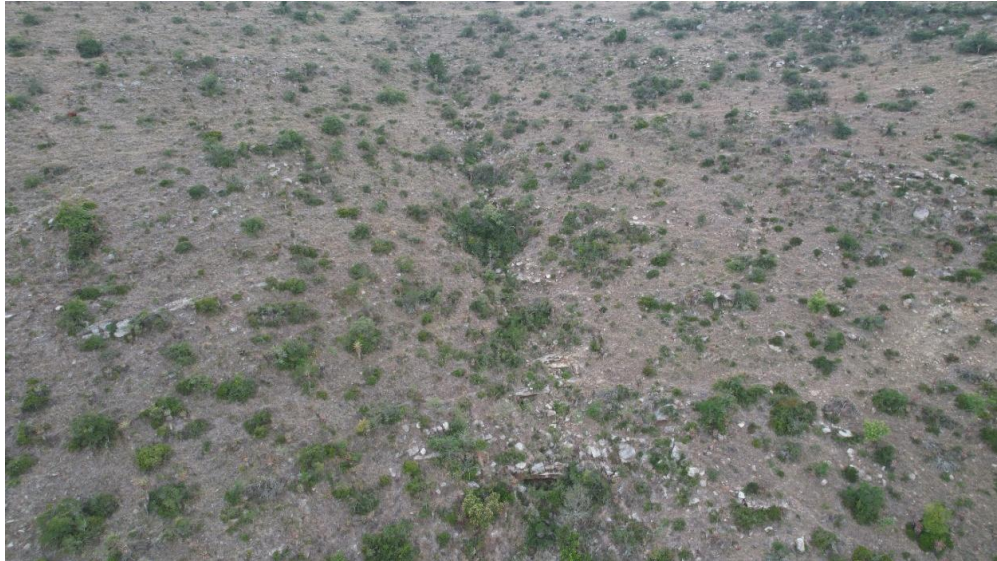
**Table 8-15 Mountain stream 4 details (no direct crossing)**

Ngqamakhwe MS 4	Crossing No:	N/A	Quaternary Catchment	S50J	Map Reference	Figure 8-6
Habitat type	Mountain Stream		Latitude:	-32.1908387	Longitude:	27.8457577
Photograph

IHI/PES	Condition Score		Key current impacts			
	A/	B	Minor bed and channel modification in the stream system.			
EIS Score	Moderate EIS. The score is derived from the ecological importance of the stream given it is a tributary of the Ngculu River.					
Risks	Low risks associated with the proposed development given that the pipeline alignments will not cross this stream system at all. A low risk exists because the pipeline is located in the catchment of the stream system.

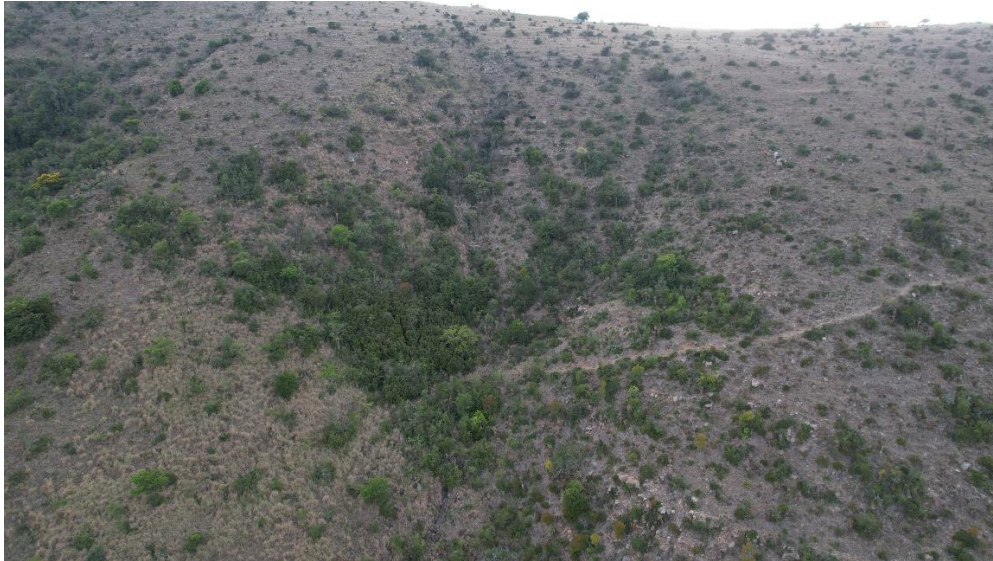
**Table 8-16 Mountain stream 21 details (no direct crossing)**

Ngqamakhwe MS 21	Crossing No:	N/A	Quaternary Catchment	S50J	Map Reference	Figure 8-6
Habitat type	Mountain Stream		Latitude:	-32.1905455	Longitude:	27.8434196
Photograph

IHI/PES	Condition Score		Key current impacts			
	A/	B	Minor bed and channel modification in the stream system.			
EIS Score	Moderate EIS. The score is derived from the ecological importance of the stream given it is a tributary of the Ngculu River.					
Risks	Low risks associated with the proposed development given that the pipeline alignments will not cross this stream system at all. A low risk exists because the pipeline is located in the catchment of the stream system.

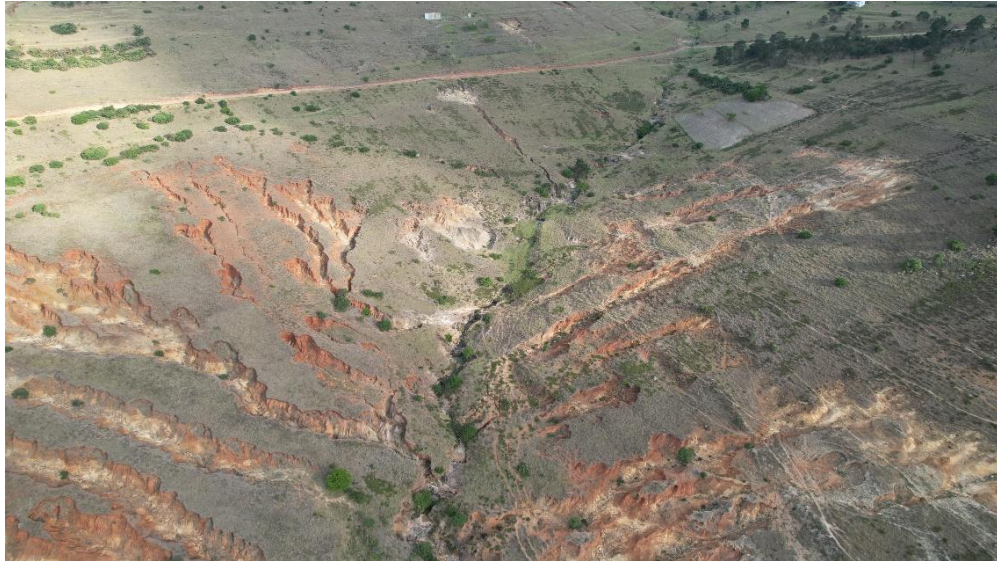
**Table 8-17 Transitional river 1 details (no direct crossing)**

Ngqamakhwe TR 1	Crossing No:	N/A	Quaternary Catchment	S50J	Map Reference	Figure 8-6
Habitat type	Transitional River		Latitude:	-32.192599	Longitude:	27.854518
Photograph

IHI/PES	Condition Score	Key current impacts				
	D	Major bed and channel modification within the stream system as well as major erosion and channel modification within the riparian area.				
EIS Score	Moderate EIS. The score is derived from the ecological importance of the stream given it is a tributary of the Ngculu River.					
Risks	Low risks associated with the proposed development given that the pipeline alignments will not cross this stream system at all. A low risk exists because the pipeline is located in the catchment of the stream system.

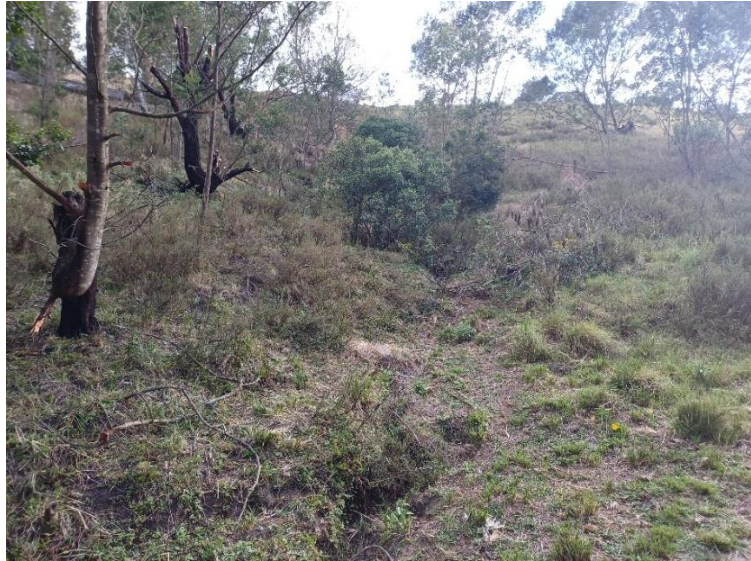
**Table 8-18 Mountain headwater stream 4 details (crossing S50J-6)**

Ngqamakhwe MHS 4	Crossing No:	S50J-6	Quaternary Catchment	S50J	Map Reference	Figure 8-7
Habitat type	Mountain Headwater Stream		Latitude:	-32.1800525	Longitude:	27.8643596
Photograph

IHI/PES	Condition Score	Key current impacts				
	C	Extensive instream and riparian invasive alien plants present. Bed and bank modification also present.				
EIS Score	Moderate EIS. The score is derived from the ecological importance of the stream given it is a tributary of the Ngculu River.					
Risks	Low to moderate risks associated with the proposed development given that the pipeline alignments cross this stream at an area of existing disturbance (i.e. road crossing) but the stream is relatively steep and any unmitigated disturbance will likely cause extensive erosion within the stream and surrounding area.

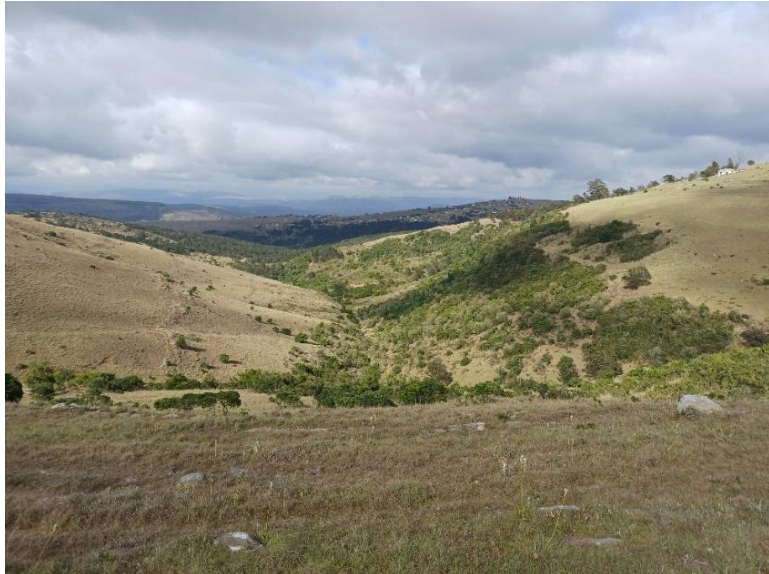
**Table 8-19 Mountain headwater stream 5 details (no direct crossing)**

Ngqamakhwe MHS 5	Crossing No:	N/A	Quaternary Catchment	S50J	Map Reference	Figure 8-7
Habitat type	Mountain Headwater Stream	Latitude:		-32.180648	Longitude:	27.874980
Photograph

IHI/PES	Condition Score	Key current impacts				
	A	Minor impacts associated with the stream.				
EIS Score	Moderate EIS. The score is derived from the ecological importance of the stream given it is a tributary of the Ngculu River.					
Risks	Low risks associated with the proposed development given that the pipeline alignments will not cross this stream system at all. A low risk exists because the pipeline is located in the catchment of the stream system.

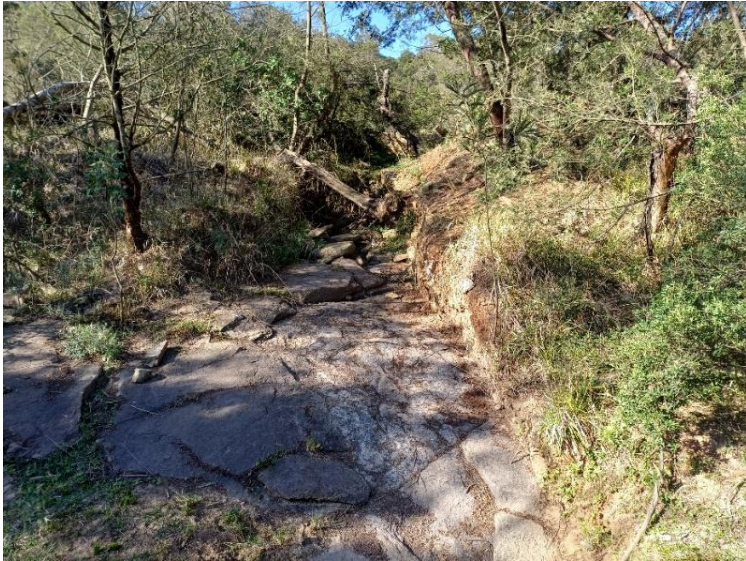
**Table 8-20 Mountain stream 7 details (crossing S50J-5)**

Ngqamakhwe MS 7	Crossing No:	S60J-5	Quaternary Catchment	S60J	Map Reference	Figure 8-7
Habitat type	Mountain Stream		Latitude:	-32.1831284	Longitude:	27.8613527
Photograph

IHI/PES	Condition Score	Key current impacts				
	C	Minor channel and bed modification due to erosion and a road crossing. Minor bank erosion present due to uncontrolled stormwater runoff approaching the road crossing. Severe invasive alien infestation in the stream system and within the riparian area.				
EIS Score	Moderate EIS. The score is derived from the ecological importance of the stream given it is a tributary of the Ngculu River.					
Risks	Low to moderate risks associated with the proposed development given that the pipeline alignments cross this stream at a single point. This crossing point is located along an existing road, but unmitigated may cause further erosion of the stream banks.

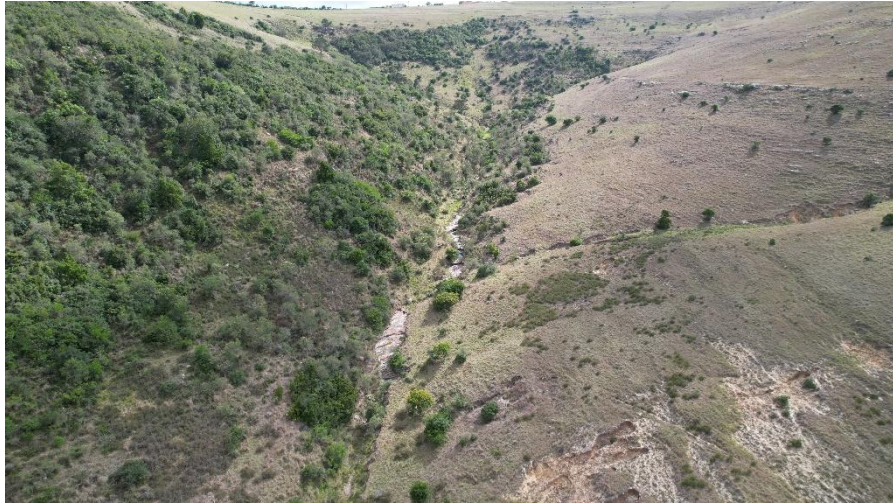
**Table 8-21 Mountain stream 19 details (no direct crossing)**

Ngqamakhwe MS 19	Crossing No:	N/A	Quaternary Catchment	S50J	Map Reference	Figure 8-7
Habitat type	Mountain Stream		Latitude:	-32.182903	Longitude:	27.870251
Photograph

IHI/PES	Condition Score	Key current impacts				
	C	Minor channel and bed modification in the stream system. Introduction of alien vegetation in the stream and on the banks further down the stream system. There is also bank modification present along the stream.				
EIS Score	Moderate EIS. The score is derived from the ecological importance of the stream given it is a tributary of the Ngculu River.					
Risks	Low risks associated with the proposed development given that the pipeline alignments will not cross this stream system at all. A low risk exists because the pipeline is located in the catchment of the stream system and within close proximity to the stream.

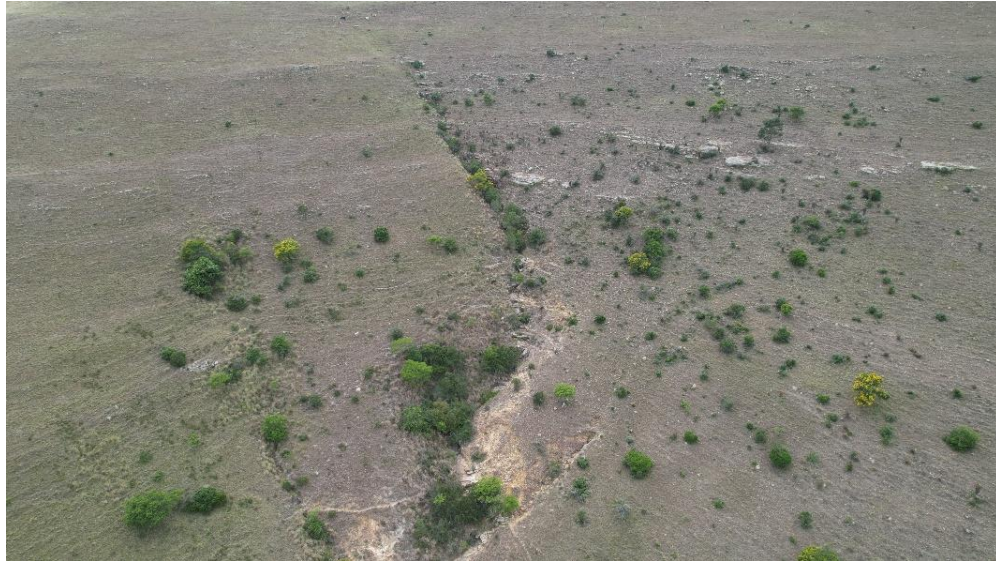
**Table 8-22 Mountain stream 20 details (no direct crossing)**

Ngqamakhwe MS 20	Crossing No:	N/A	Quaternary Catchment	S50J	Map Reference	Figure 8-7
Habitat type	Mountain Stream		Latitude:	-32.1848938	Longitude:	27.8695903
Photograph

IHI/PES	Condition Score	Key current impacts				
	C	Minor channel and bed modification in the stream system and bank modification and erosion are present within the riverine unit, which is affecting the integrity of the riparian habitat.				
EIS Score	Moderate EIS. The score is derived from the ecological importance of the stream given it is a tributary of the Ngculu River.					
Risks	Low risks associated with the proposed development given that the pipeline alignments will not cross this stream system at all. A low risk exists because the pipeline is located in the catchment of the stream system and within close proximity to the stream.

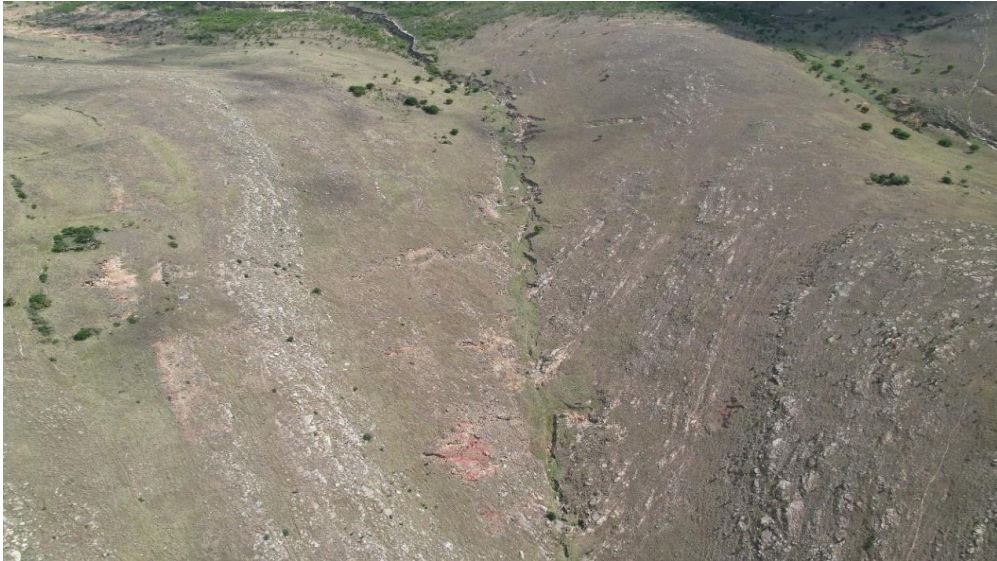
**Table 8-23 Mountain headwater stream 6 (no direct crossing)**

Ngqamakhwe MHS 6	Crossing No:	N/A	Quaternary Catchment	S50J	Map Reference	Figure 8-8
Habitat type	Mountain Headwater Stream		Latitude:	-32.174879	Longitude:	27.876263
Photograph

IHI/PES	Condition Score	Key current impacts				
	A	Minor impacts associated with the stream.				
EIS Score	Moderate EIS. The score is derived from the ecological importance of the stream given it is a tributary of the Tsomo River.					
Risks	Low risks associated with the proposed development given that the pipeline alignments will not cross this stream system at all. A low risk exists because the pipeline is located in the catchment of the stream system.

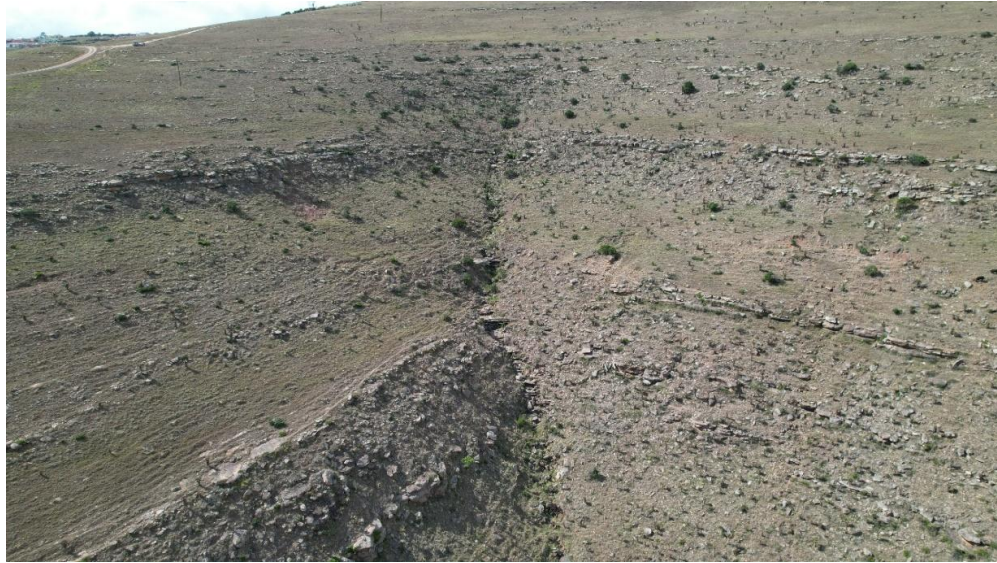
IHI/PES	Condition Score	Key current impacts				
	A	Minor impacts associated with the stream.				
EIS Score	Moderate EIS. The score is derived from the ecological importance of the stream given it is a tributary of the Tsomo River.					
Risks	Low risks associated with the proposed development given that the pipeline alignments will not cross this stream system at all. A low risk exists because the pipeline is located in the catchment of the stream system.

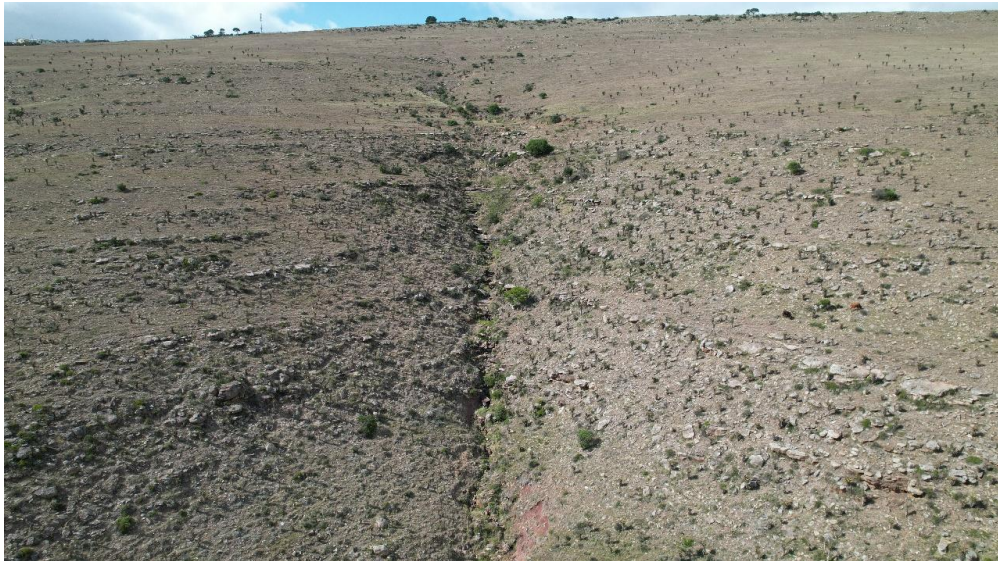
**Table 8-25 Mountain headwater stream 10 (no direct crossing)**

Ngqamakhwe MHS 10	Crossing No:	N/A	Quaternary Catchment	S50J	Map Reference	Figure 8-8
Habitat type	Mountain Headwater Stream	Latitude:		-32.173530	Longitude:	27.867292
Photograph

IHI/PES	Condition Score	Key current impacts				
	A	Minor impacts associated with the stream.				
EIS Score	Moderate EIS. The score is derived from the ecological importance of the stream given it is a tributary of the Tsomo River.					
Risks	Low risks associated with the proposed development given that the pipeline alignments will not cross this stream system at all. A low risk exists because the pipeline is located in the catchment of the stream system.

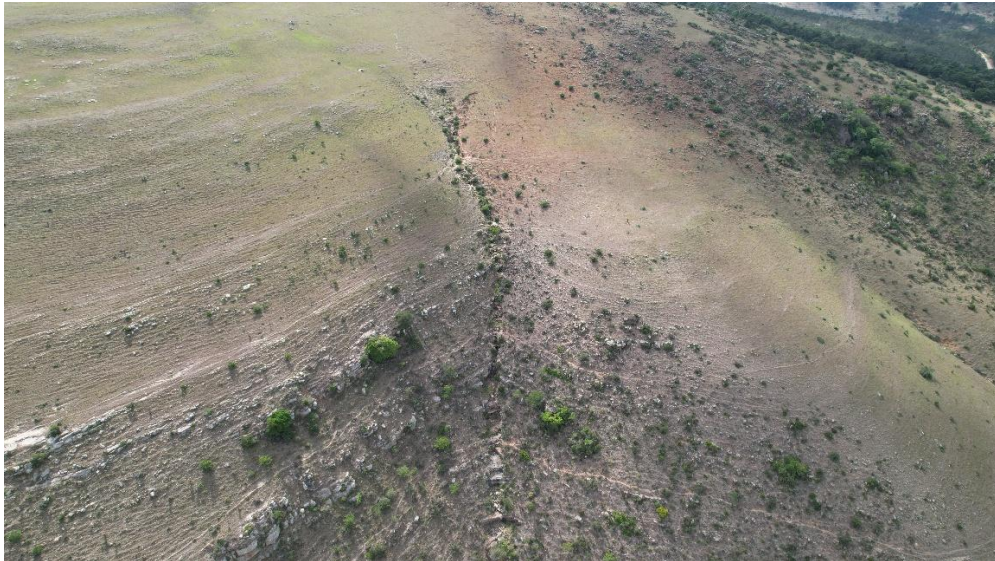
**Table 8-26 Mountain headwater stream 11 (no direct crossing)**

Ngqamakhwe MHS 11	Crossing No:	N/A	Quaternary Catchment	S50J	Map Reference	Figure 8-8
Habitat type	Mountain Headwater Stream	Latitude:		-32.1767760	Longitude:	27.8607726
Photograph

IHI/PES	Condition Score	Key current impacts				
	A	Minor impacts associated with the stream.				
EIS Score	Moderate EIS. The score is derived from the ecological importance of the stream given it is a tributary of the Tsomo River.					
Risks	Low risks associated with the proposed development given that the pipeline alignments will not cross this stream system at all. A low risk exists because the pipeline is located in the catchment of the stream system.

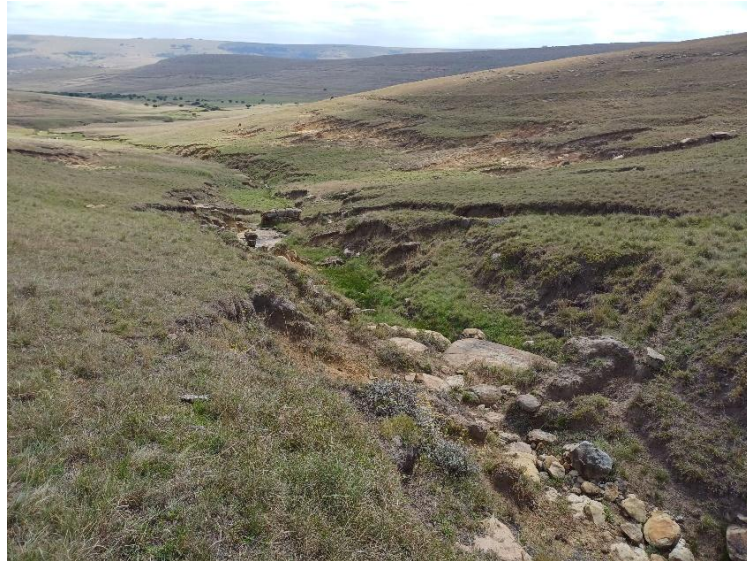
**Table 8-27 Mountain headwater stream 13 details (no direct crossing)**

Ngqamakhwe MHS 13	Crossing No:	N/A	Quaternary Catchment	S50J	Map Reference	Figure 8-9
Habitat type	Mountain Headwater Stream		Latitude:	-32.185016	Longitude:	27.888311
Photograph

IHI/PES	Condition Score		Key current impacts			
	C/	D	A high level of bed and channel modification within the stream system as well as a large amount of bank erosion and channel modification in the riparian areas.			
EIS Score	Moderate EIS. The score is derived from the ecological importance of the stream given it is a tributary of the Tsomo River.					
Risks	Low risks associated with the proposed development given that the pipeline alignments will not cross this stream system at all. A low risk exists because the pipeline is located in the catchment of the stream system.

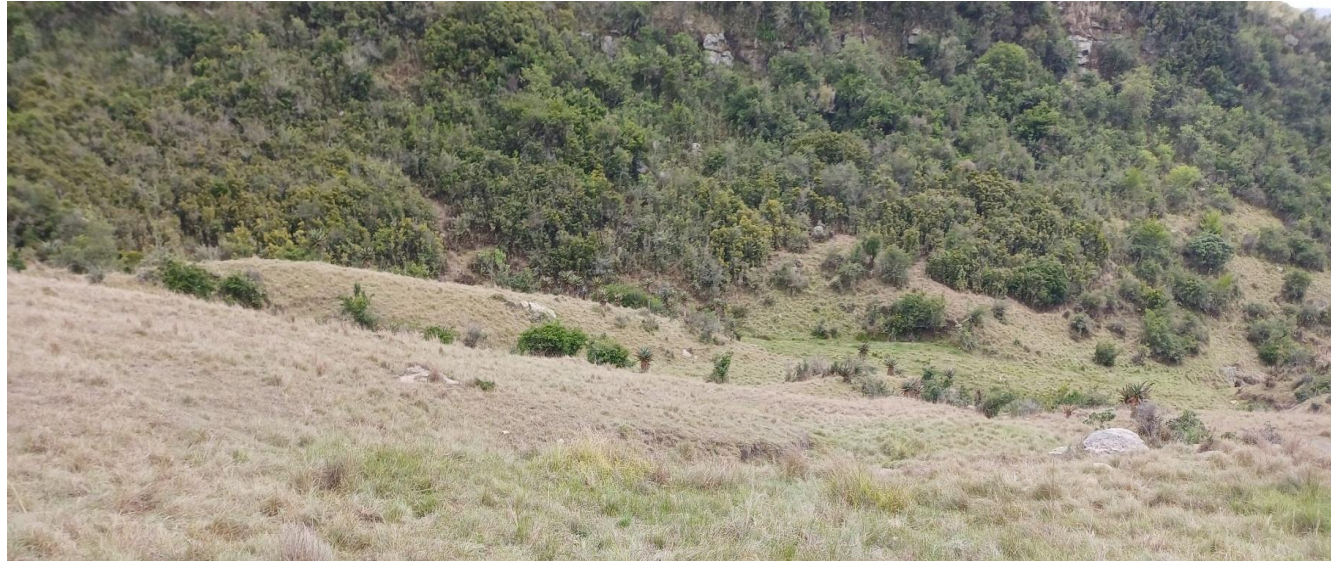
IHI/PES	Condition Score	Key current impacts				
	A	Minor impacts associated with the stream.				
EIS Score	Moderate EIS. The score is derived from the ecological importance of the stream given it is a tributary of the Tsomo River.					
Risks	Low risks associated with the proposed development given that the pipeline alignments will not cross this stream system at all. A low risk exists because the pipeline is located in the catchment of the stream system.

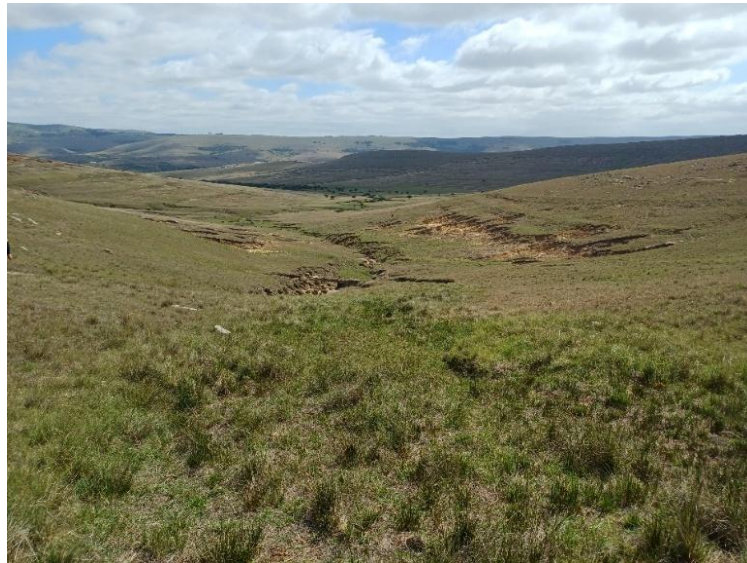
**Table 8-29 Seep 2 details (no direct crossing)**

Ngqamakhwe SEEP 2	Crossing No:	N/A	Quaternary Catchment	S50J	Map Reference	Figure 8-9
Habitat type	Hillslope Seep Wetland		Latitude:	-32.1858296	Longitude:	27.8876648
Photograph

IHI/PES	Condition Score	Key current impacts				
	C	Moderate grazing and trampling by livestock, minor erosion present within the wetland.				
EIS Score	Moderate EIS. The score is derived from the biodiversity maintenance ecological importance of the wetland due to the relatively good ecological condition of C, the fact that it is ecologically connected to other wetlands and freshwater ecosystems of importance and that it provides important grazing land for livestock.					
Risks	Minor risks are posed to this wetland given that there are no direct crossings that are proposed for this wetland. Minor risks include increased runoff from a burst pipe in the catchment of the wetland or from sedimentation during the construction phase.

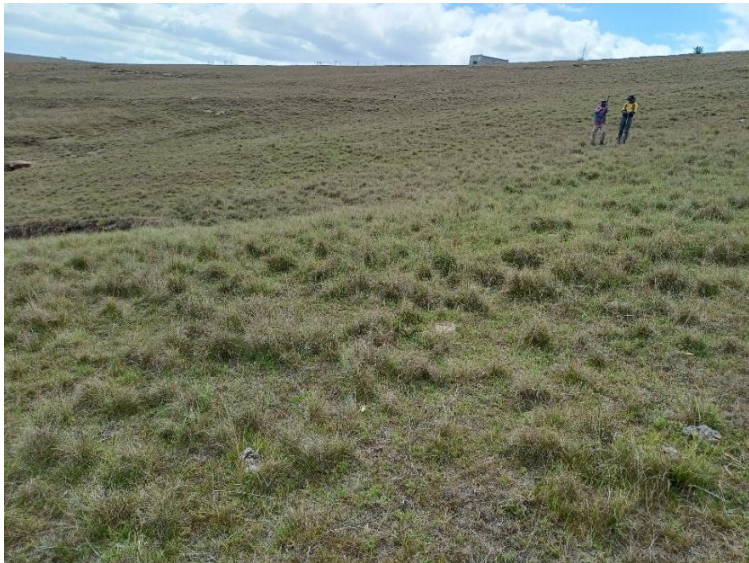
**Table 8-30 Seep 3 details (no direct crossing)**

Ngqamakhwe SEEP 3		Crossing No:	N/A	Quaternary Catchment	S50J	Map Reference	Figure 8-9
Habitat type	Hillslope Seep Wetland			Latitude:	-32.1853614	Longitude:	27.8886464
Photograph

IHI/PES	Condition Score	Key current impacts					
	C	Heavy grazing and trampling by livestock, minor erosion present within the wetland.					
EIS Score	Moderate EIS. The score is derived from the biodiversity maintenance ecological importance of the wetland due to the relatively good ecological condition of C and the fact that it is ecologically connected to other wetlands and freshwater ecosystems of importance.						
Risks	Minor risks are posed to this wetland given that there are no direct crossings that are proposed for this wetland. Minor risks include increased runoff from a burst pipe in the catchment of the wetland or from sedimentation during the construction phase.

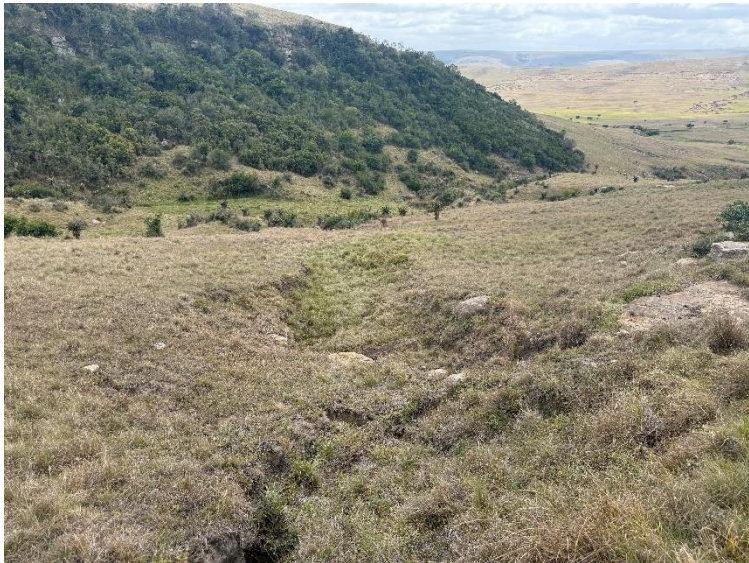
**Table 8-31 Seep 4 details (no direct crossing)**

Ngqamakhwe SEEP 4	Crossing No:	N/A	Quaternary Catchment	S50J	Map Reference	Figure 8-9
Habitat type	Hillslope Seep Wetland		Latitude:	-32.1814904	Longitude:	27.8865323
Photograph

IHI/PES	Condition Score	Key current impacts				
	C	Moderate grazing and trampling by livestock.				
EIS Score	Moderate EIS. The score is derived from the biodiversity maintenance ecological importance of the wetland due to the relatively good ecological condition of C and the fact that it is ecologically connected to other wetlands and freshwater ecosystems of importance.					
Risks	Minor risks are posed to this wetland given that there are no direct crossings that are proposed for this wetland. Minor risks include increased runoff from a burst pipe in the catchment of the wetland or from sedimentation during the construction phase.

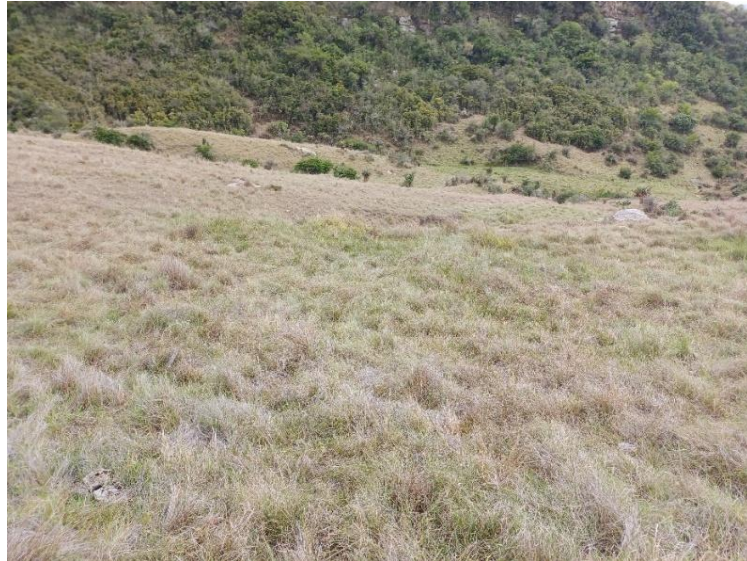
**Table 8-32 Seep 5 details (no direct crossing)**

Ngqamakhwe SEEP 5	Crossing No:	N/A	Quaternary Catchment	S50J	Map Reference	Figure 8-9
Habitat type	Hillslope Seep Wetland		Latitude:	-32.1816821	Longitude:	27.8860048
Photograph

IHI/PES	Condition Score	Key current impacts				
	C	Moderate grazing and trampling by livestock, minor erosion present within the wetland.				
EIS Score	Moderate EIS. The score is derived from the biodiversity maintenance ecological importance of the wetland due to the relatively good ecological condition of C and the fact that it is ecologically connected to other wetlands and freshwater ecosystems of importance.					
Risks	Minor risks are posed to this wetland given that there are no direct crossings that are proposed for this wetland. Minor risks include increased runoff from a burst pipe in the catchment of the wetland or from sedimentation during the construction phase.

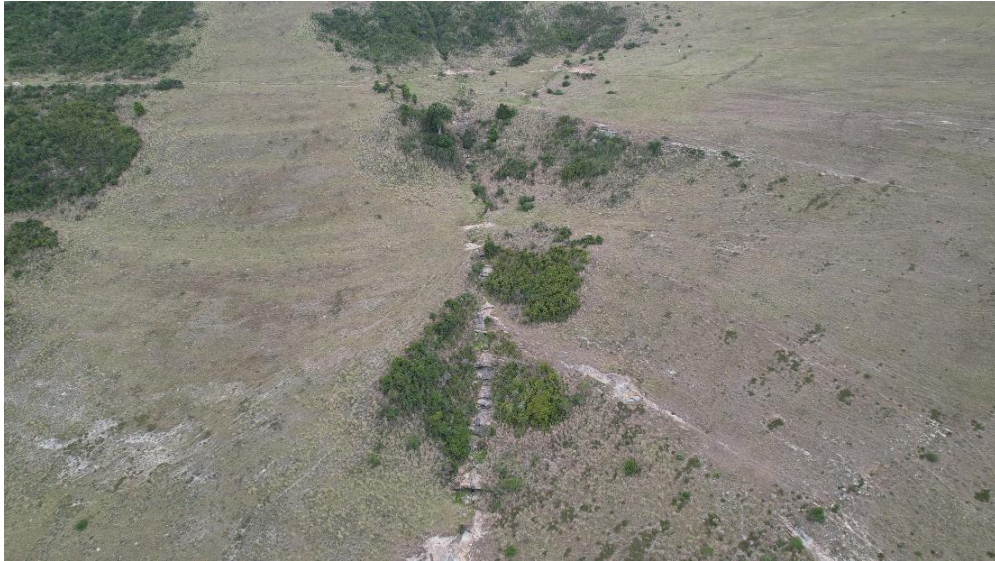
**Table 8-33 Mountain headwater stream 8 (no direct crossing)**

Ngqamakhwe MHS 8	Crossing No:	N/A	Quaternary Catchment	S50J	Map Reference	Figure 8-10
Habitat type	Mountain Headwater Stream	Latitude:		-32.187792	Longitude:	27.878727
Photograph

IHI/PES	Condition Score	Key current impacts				
	A	Minor impacts associated with the stream.				
EIS Score	Moderate EIS. The score is derived from the ecological importance of the stream given it is a tributary of the Ngculu River.					
Risks	Low risks associated with the proposed development given that the pipeline alignments will not cross this stream system at all. A low risk exists because the pipeline is located in the catchment of the stream system.
