# NGQAMAKHWE WATER SUPPLY SCHEME - PHASE 3

## Aquatic Biodiversity Assessment

DRAFT REPORT

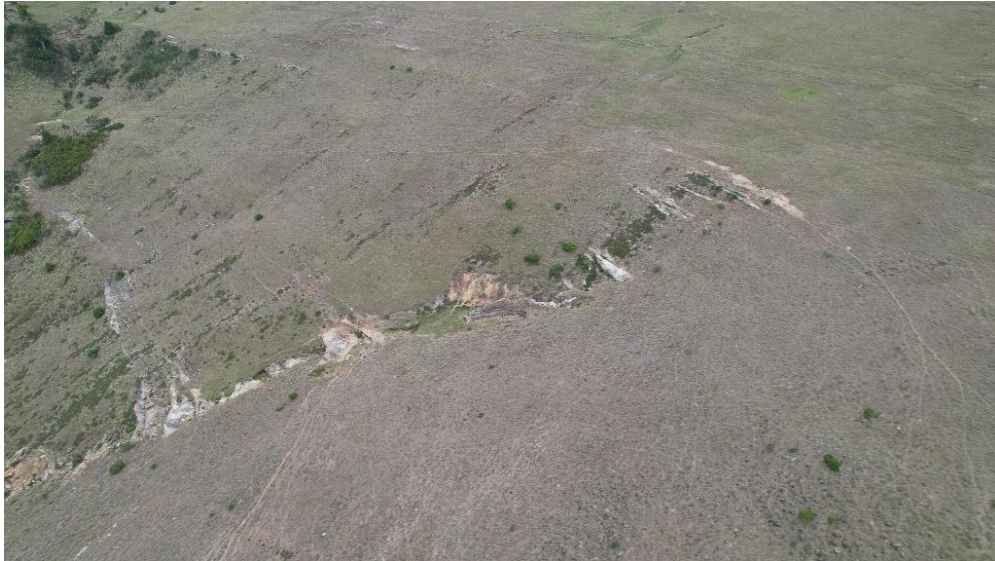
**Table 8-34 Mountain headwater stream 12 (no direct crossing)**

Ngqamakhwe MHS 12	Crossing No:	N/A	Quaternary Catchment	S50J	Map Reference	Figure 8-10
Habitat type	Mountain Headwater Stream		Latitude:	-32.1909895	Longitude:	27.8801370
Photograph

IHI/PES	Condition Score	Key current impacts				
	C	Moderate bank erosion and channel modification within the stream system.				
EIS Score	Moderate EIS. The score is derived from the ecological importance of the stream given it is a tributary of the Ngculu River.					
Risks	Low risks associated with the proposed development given that the pipeline alignments will not cross this stream system at all. A low risk exists because the pipeline is located in the catchment of the stream system.

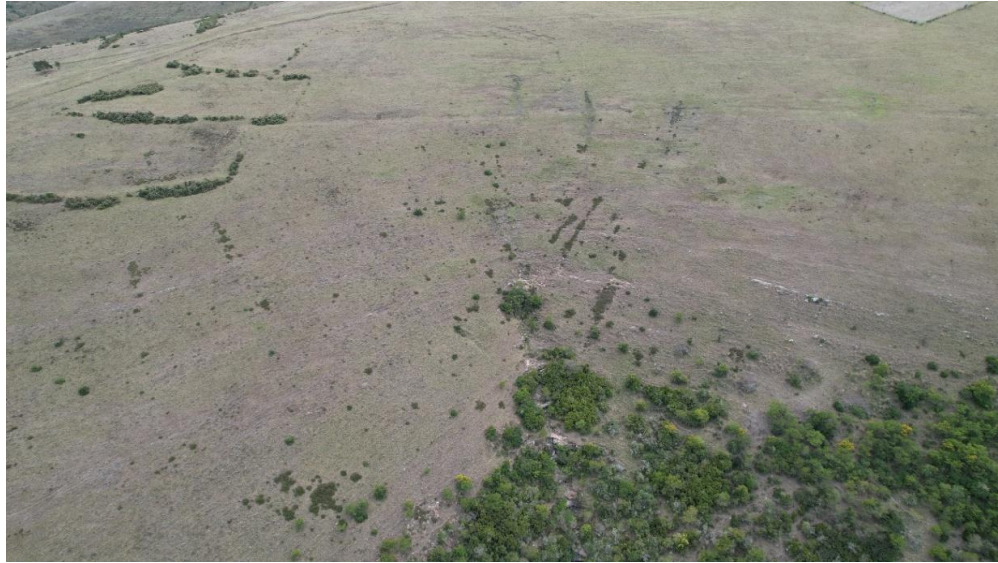
IHI/PES	Condition Score		Key current impacts			
	A/	B	Minor bed modification within the stream system.			
EIS Score	Moderate EIS. The score is derived from the ecological importance of the stream given it is a tributary of the Ngculu River.					
Risks	Low risks associated with the proposed development given that the pipeline alignments will not cross this stream system at all. A low risk exists because the pipeline is located in the catchment of the stream system.

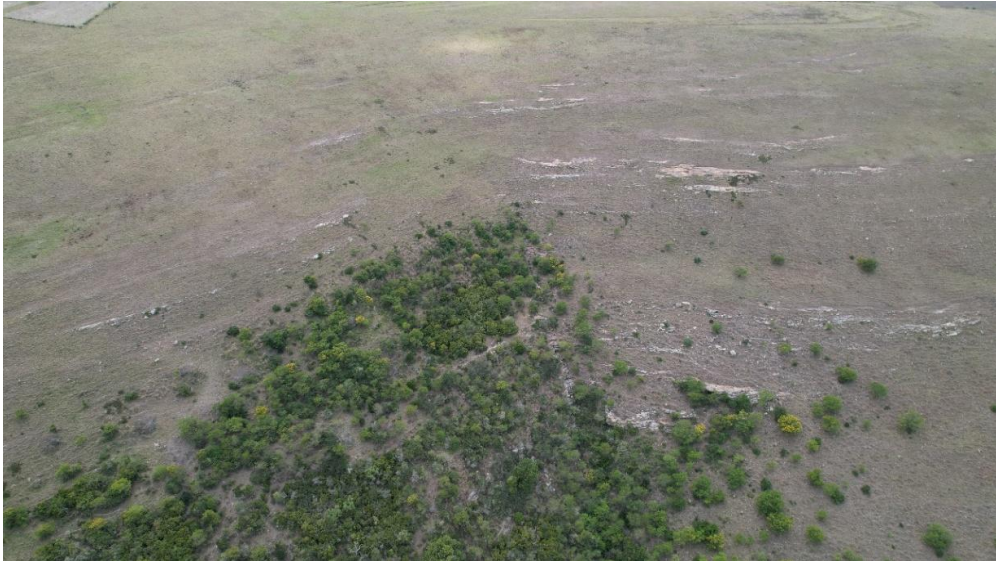
**Table 8-36 Mountain headwater stream 16 (no direct crossing)**

Ngqamakhwe MHS 16	Crossing No:	N/A	Quaternary Catchment	S50J	Map Reference	Figure 8-10
Habitat type	Mountain Headwater Stream		Latitude:	-32.2021393	Longitude:	27.8816689
Photograph

IHI/PES	Condition Score		Key current impacts			
	A/	B	Minor bed modification within the stream system.			
EIS Score	Moderate EIS. The score is derived from the ecological importance of the stream given it is a tributary of the Ngculu River.					
Risks	Low risks associated with the proposed development given that the pipeline alignments will not cross this stream system at all. A low risk exists because the pipeline is located in the catchment of the stream system.

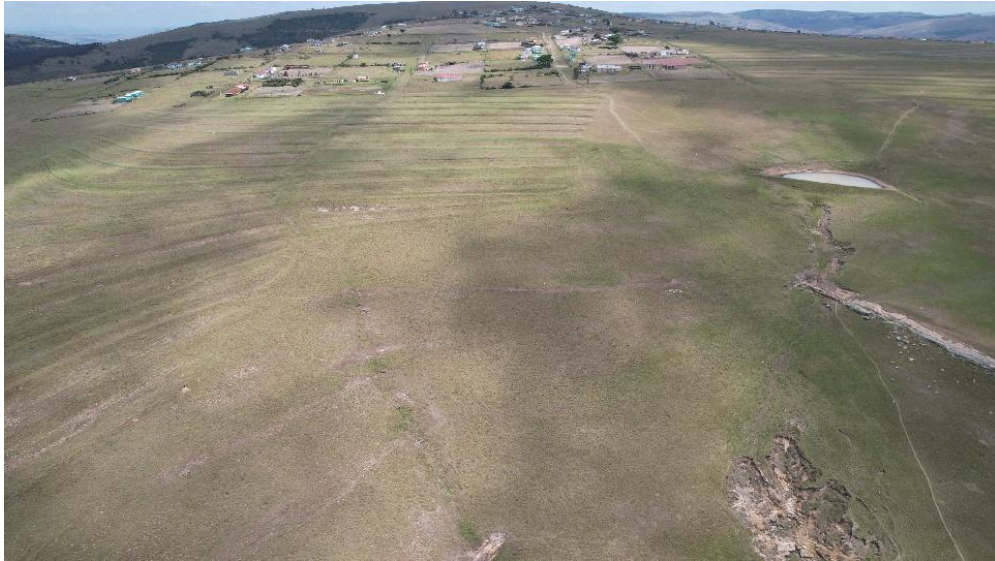
**Table 8-37 Seep 6 (no direct crossing)**

Ngqamakhwe SEEP 6	Crossing No:	N/A	Quaternary Catchment	S50J	Map Reference	Figure 8-9
Habitat type	Hillslope Seep Wetland		Latitude:	-32.200418	Longitude:	27.888421
Photograph

IHI/PES	Condition Score	Key current impacts				
	C	Moderate grazing and trampling by livestock, minor erosion present within the wetland as well as infilling in the form of a dam.				
EIS Score	Moderate EIS. The score is derived from the biodiversity maintenance ecological importance of the wetland due to the relatively good ecological condition of C and the fact that it is ecologically connected to other wetlands and freshwater ecosystems of importance.					
Risks	Minor risks are posed to this wetland given that there are no direct crossings that are proposed for this wetland. Minor risks include increased runoff from a burst pipe in the catchment of the wetland or from sedimentation during the construction phase.

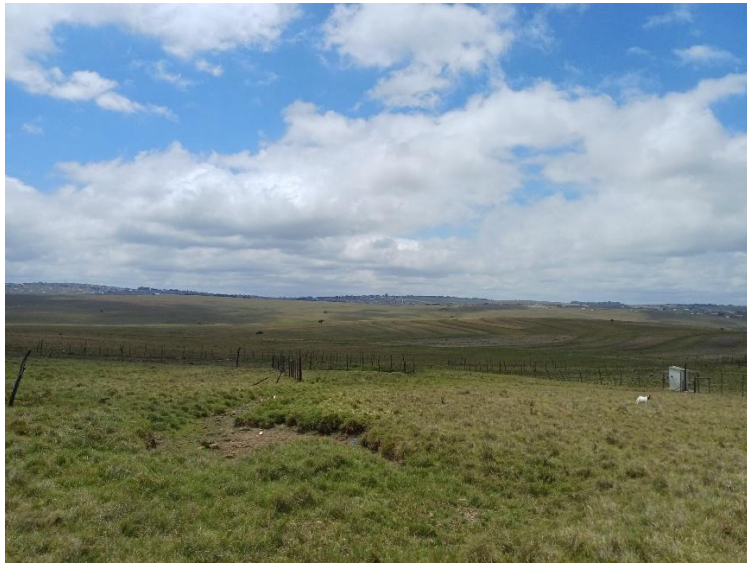
**Table 8-38 Seep 7 (no direct crossing)**

Ngqamakhwe SEEP 7	Crossing No:	N/A	Quaternary Catchment	S50J	Map Reference	Figure 8-10
Habitat type	Hillslope Seep Wetland		Latitude:	-32.193568	Longitude:	27.889716
Photograph

IHI/PES	Condition Score	Key current impacts				
	C	Heavy grazing and trampling by livestock, minor erosion present within the wetland as well has historical agriculture.				
EIS Score	Moderate EIS. The score is derived from the biodiversity maintenance ecological importance of the wetland due to the relatively good ecological condition of C and the fact that it is ecologically connected to other wetlands and freshwater ecosystems of importance.					
Risks	Minor risks are posed to this wetland given that there are no direct crossings that are proposed for this wetland. Minor risks include increased runoff from a burst pipe in the catchment of the wetland or from sedimentation during the construction phase.

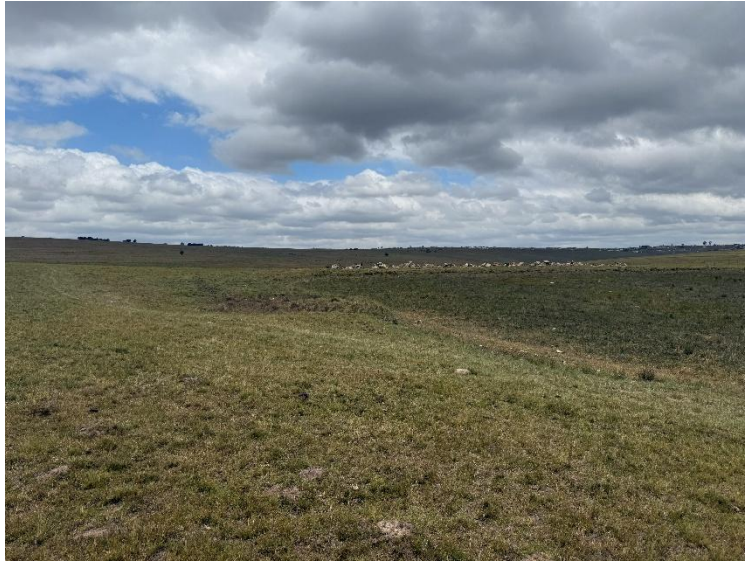
**Table 8-39 Seep 8 details (no direct crossing)**

Ngqamakhwe SEEP 8	Crossing No:	N/A	Quaternary Catchment	S50J	Map Reference	Figure 8-11
Habitat type	Hillslope Seep Wetland		Latitude:	-32.190062	Longitude:	27.898702
Photograph

IHI/PES	Condition Score	Key current impacts				
	C	Moderate grazing and trampling by livestock, minor erosion present within the wetland as well as evidence of historical agriculture.				
EIS Score	Moderate EIS. The score is derived from the biodiversity maintenance ecological importance of the wetland due to the relatively good ecological condition of C and the fact that it is ecologically connected to other wetlands and freshwater ecosystems of importance.					
Risks	Minor risks are posed to this wetland given that there are no direct crossings that are proposed for this wetland. Minor risks include increased runoff from a burst pipe in the catchment of the wetland or from sedimentation during the construction phase.

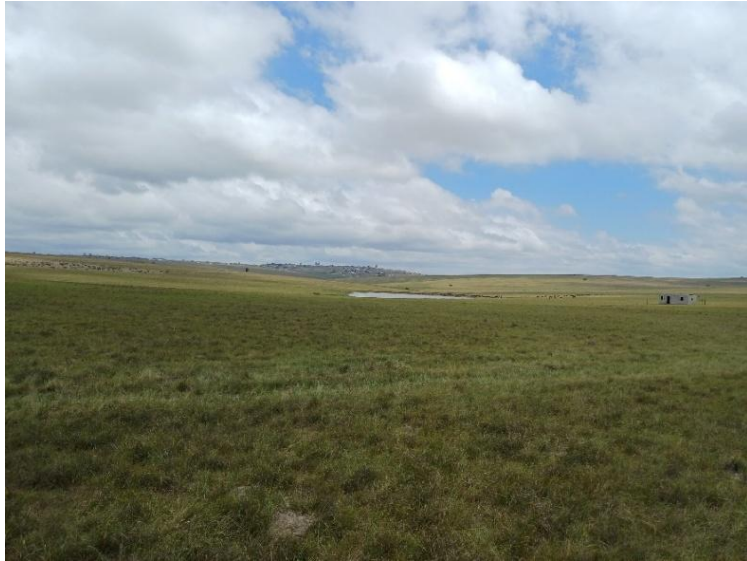
**Table 8-40 Seep 9 details (crossing S50J-7)**

Ngqamakhwe SEEP 9	Crossing No:	S50J-7	Quaternary Catchment	S50J	Map Reference	Figure 8-11
Habitat type	Hillslope Seep Wetland		Latitude:	-32.185898	Longitude:	27.904445
Photograph

IHI/PES	Condition Score	Key current impacts				
	C	Moderate grazing and trampling by livestock, minor erosion present within the wetland.				
EIS Score	Moderate EIS. The score is derived from the biodiversity maintenance ecological importance of the wetland due to the relatively good ecological condition of C and the fact that it is ecologically connected to other wetlands and freshwater ecosystems of importance.					
Risks	Moderate to low risks associated with the proposed pipeline alignment given that the pipeline will pass directly through the northern edge of the wetland, but it is located in an existing disturbance (i.e. the road, footpaths and dwellings). Provided that careful construction measures are followed, the risk should be low. Additionally, the wetland is located on a gentle slope, so the risk of erosion is reduced.

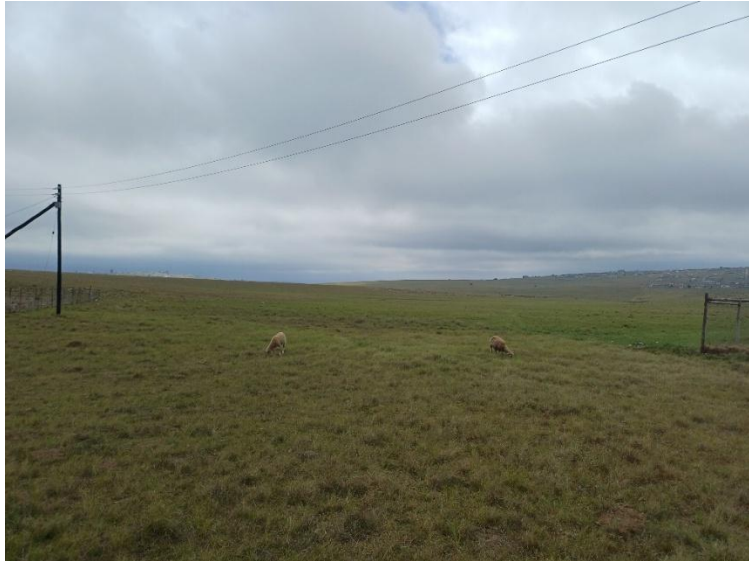
**Table 8-41 Seep 10 details (no direct crossing)**

Ngqamakhwe SEEP 10	Crossing No:	N/A	Quaternary Catchment	S50J	Map Reference	Figure 8-11
Habitat type	Hillslope Seep Wetland		Latitude:	-32.188449	Longitude:	27.912518
Photograph

IHI/PES	Condition Score	Key current impacts				
	C	Moderate grazing and trampling by livestock, minor erosion present within the wetland.				
EIS Score	Moderate EIS. The score is derived from the biodiversity maintenance ecological importance of the wetland due to the relatively good ecological condition of C and the fact that it is ecologically connected to other wetlands and freshwater ecosystems of importance.					
Risks	Minor risks are posed to this wetland given that there are no direct crossings that are proposed for this wetland. Minor risks include increased runoff from a burst pipe in the catchment of the wetland or from sedimentation during the construction phase.

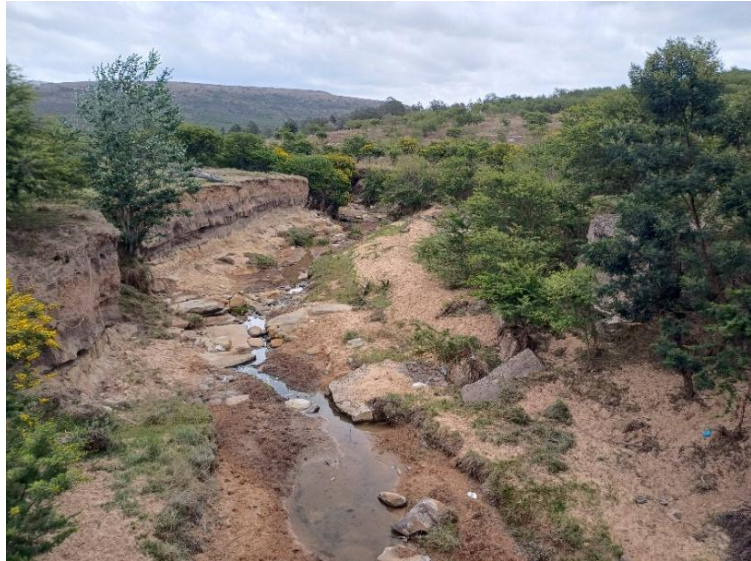
**Table 8-42 Lowlands river 2 details (no direct crossing)**

Ngqamakhwe LLR 2	Crossing No:	N/A	Quaternary Catchment	S50J	Map Reference	Figure 8-12
Habitat type	Lowlands River		Latitude:	-32.1587001	Longitude:	27.8983277
Photograph

IHI/PES	Condition Score	Key current impacts				
	E	Major bed and channel modification as well as invasive alien plants present within the stream system. Moderate vegetation removal and major bank erosion and channel modification within the riparian area. Invasive alien species also present in the riparian area.				
EIS Score	Moderate EIS. The score is derived from the ecological importance of the stream given it is a tributary of the Tsomo River.					
Risks	Low risks associated with the proposed development given that the pipeline alignments will not cross this stream system at all. A low risk exists because the pipeline is located in the catchment of the stream system.

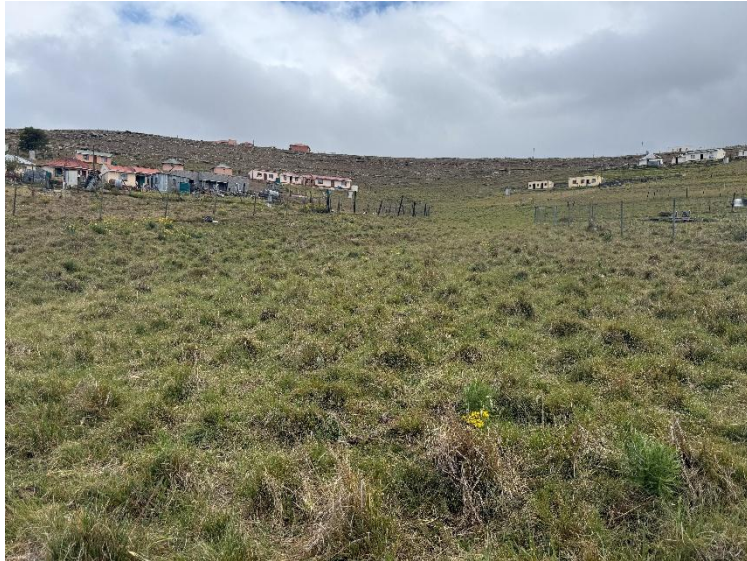
**Table 8-43 Unchannelled valley-bottom wetland 1 details (no direct crossing)**

Ngqamakhwe UVB 1	Crossing No:	N/A	Quaternary Catchment	S50J	Map Reference	Figure 8-12
Habitat type	Unchannelled Valley-Bottom Wetland		Latitude:	-32.177464	Longitude:	27.905469
Photograph

IHI/PES	Condition Score	Key current impacts				
	C	Moderate grazing and trampling by livestock, moderate erosion present and dwellings encroaching within the wetland.				
EIS Score	Moderate EIS. This score is derived from its ecological sensitivity and the fact that unchannelled valley-bottom wetlands are sensitive to changes in floods and extremely sensitive to the changes in low flows during the dry season.					
Risks	Minor risks are posed to this wetland given that there are no direct crossings that are proposed for this wetland. Minor risks include increased runoff from a burst pipe in the catchment of the wetland or from sedimentation during the construction phase.

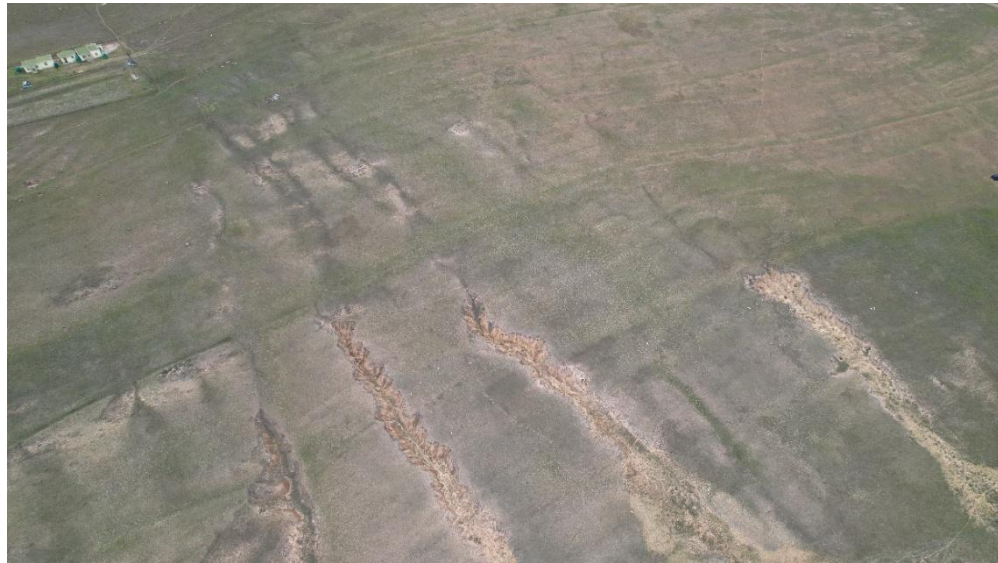
IHI/PES	Condition Score	Key current impacts				
	C	Moderate grazing and trampling by livestock, quite extensive erosion present within the wetland.				
EIS Score	Moderate EIS. The score is derived from the biodiversity maintenance ecological importance of the wetland due to the relatively good ecological condition of C and the fact that it is ecologically connected to other wetlands and freshwater ecosystems of importance.					
Risks	Minor risks are posed to this wetland given that there are no direct crossings that are proposed for this wetland. Minor risks include increased runoff from a burst pipe in the catchment of the wetland or from sedimentation during the construction phase.

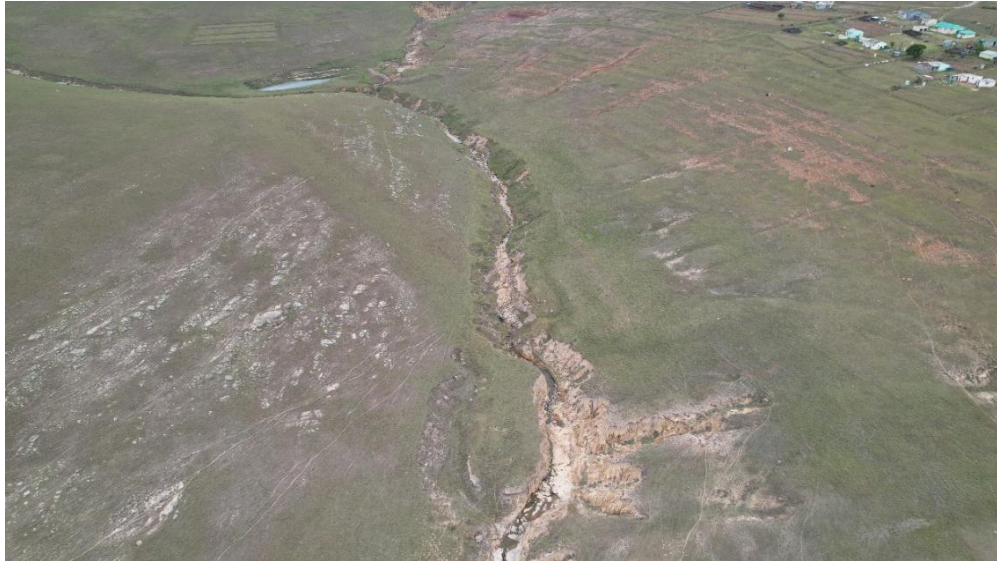
**Table 8-45 Transitional river 6 details (no direct crossing)**

Ngqamakhwe TR 6	Crossing No:	N/A	Quaternary Catchment	S50J	Map Reference	Figure 8-13
Habitat type	Transitional River		Latitude:	-32.174844	Longitude:	27.931418
Photograph

IHI/PES	Condition Score		Key current impacts			
	C/	D	Major bed and channel modification within the stream system as well as major erosion and channel modification within the riparian area.			
EIS Score	Moderate EIS. The score is derived from the ecological importance of the stream given it is a tributary of the Tsomo River.					
Risks	Low risks associated with the proposed development given that the pipeline alignments will not cross this stream system at all. A low risk exists because the pipeline is located in the catchment of the stream system.

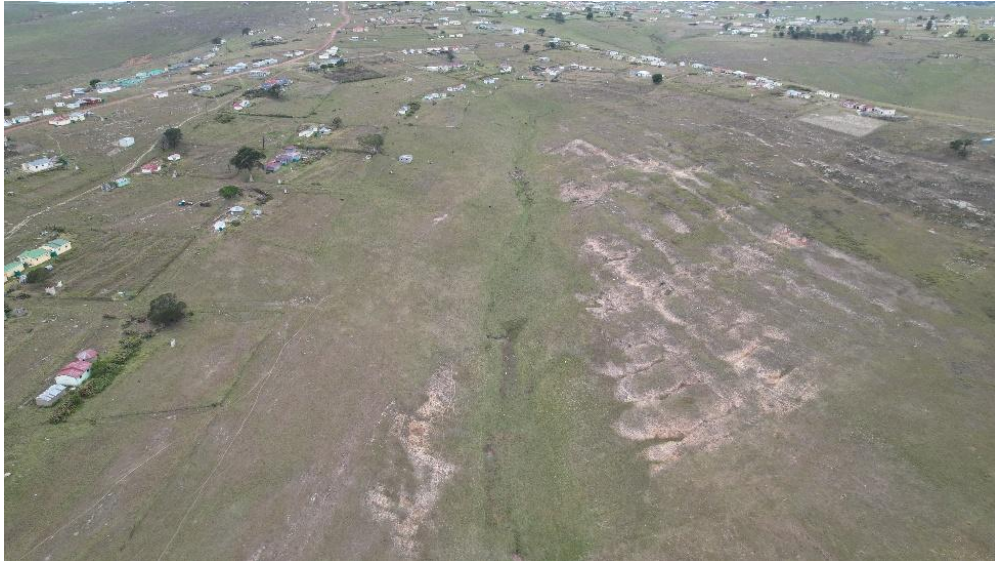
**Table 8-46 Unchannelled valley-bottom 3 details (no direct crossing)**

Ngqamakhwe UVB 3	Crossing No:	N/A	Quaternary Catchment	S50J	Map Reference	Figure 8-13
Habitat type	Unchannelled Valley-Bottom Wetland		Latitude:	-32.181120	Longitude:	27.926473
Photograph

IHI/PES	Condition Score	Key current impacts				
	C	Moderate grazing and trampling by livestock, moderate erosion present and dwellings encroaching within the wetland.				
EIS Score	Moderate EIS. This score is derived from its ecological sensitivity and the fact that unchannelled valley-bottom wetlands are sensitive to changes in floods and extremely sensitive to the changes in low flows during the dry season.					
Risks	Minor risks are posed to this wetland given that there are no direct crossings that are proposed for this wetland. Minor risks include increased runoff from a burst pipe in the catchment of the wetland or from sedimentation during the construction phase.

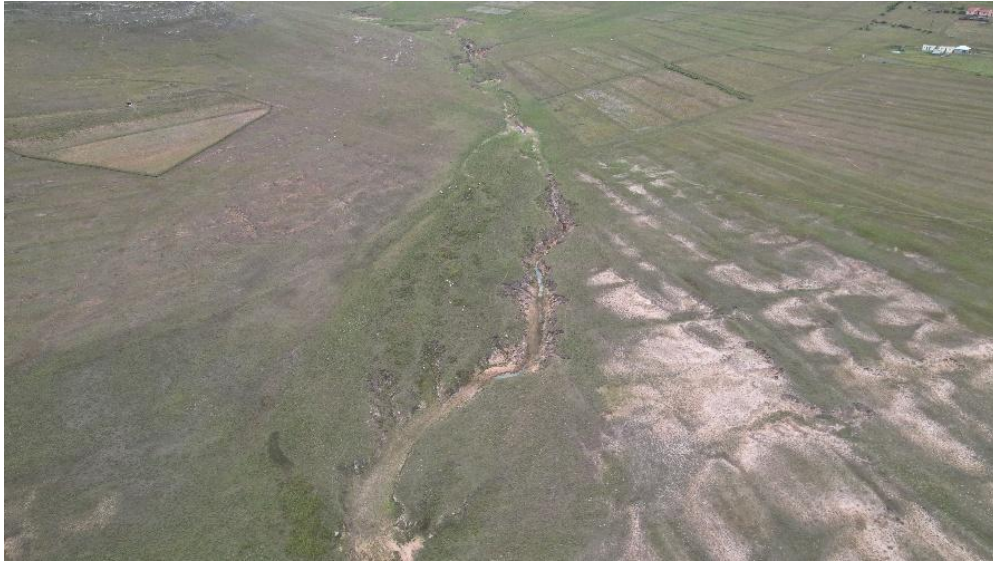
**Table 8-47 Channelled valley-bottom 1 details (no direct crossing)**

Ngqamakhwe CVB 1	Crossing No:	N/A	Quaternary Catchment	S50J	Map Reference	Figure 8-14
Habitat type	Channelled Valley-Bottom Wetland		Latitude:	-32.184366	Longitude:	27.919554
Photograph

IHI/PES	Condition Score	Key current impacts				
	C	Moderate grazing and trampling by livestock. Minor erosion present in the wetland but excessive erosion present on the banks surrounding it. This has been exacerbated by agricultural practices.				
EIS Score	High EIS. The score is derived from the biodiversity maintenance ecological importance of the wetland due to the relatively good ecological condition of C and the fact that it is ecologically connected to other wetlands and freshwater ecosystems of importance.					
Risks	Minor risks are posed to this wetland given that there are no direct crossings that are proposed for this wetland. Minor risks include increased runoff from a burst pipe in the catchment of the wetland or from sedimentation during the construction phase.

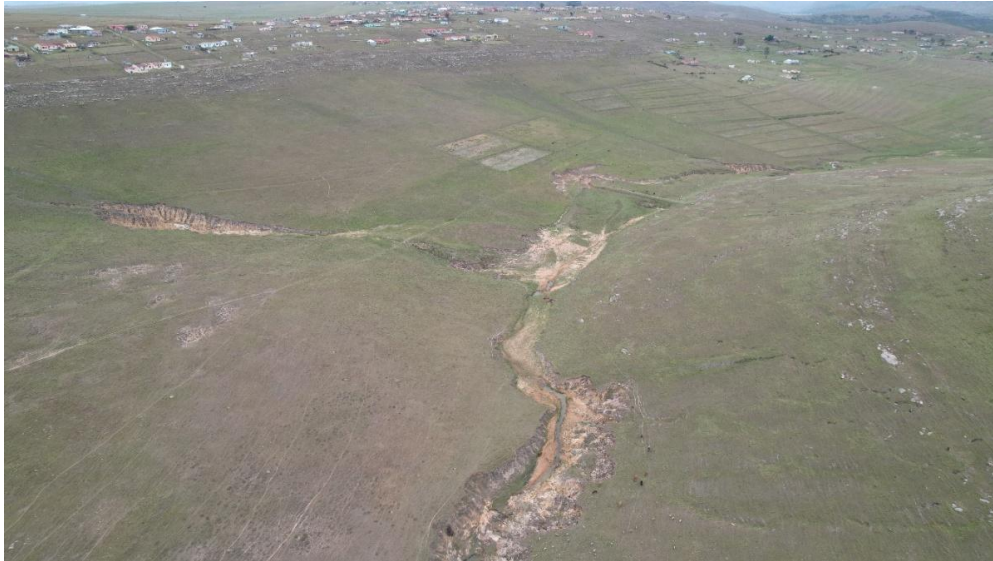
Ngqamakhwe MS 11	Crossing No:	N/A	Quaternary Catchment	S50J	Map Reference	Figure 8-14
Habitat type	Mountain Stream		Latitude:	-32.185257	Longitude:	27.925817
Photograph

IHI/PES	Condition Score	Key current impacts				
	C	Minor channel and bed modification in the stream system and bank modification present.				
EIS Score	Moderate EIS. The score is derived from the ecological importance of the stream given it is a tributary of the Ngculu River.					
Risks	Low risks associated with the proposed development given that the pipeline alignments will not cross this stream system at all. A low risk exists because the pipeline is located in the catchment of the stream system and within close proximity to the stream.

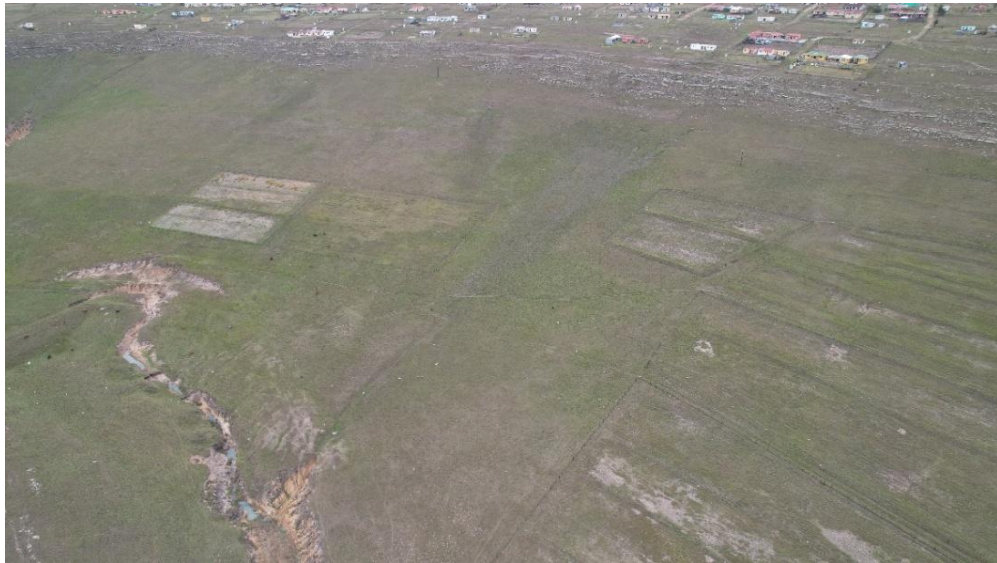
IHI/PES	Condition Score	Key current impacts				
	C	Heavy grazing and trampling by livestock, minor erosion present within the wetland.				
EIS Score	Moderate EIS. The score is derived from the biodiversity maintenance ecological importance of the wetland due to the relatively good ecological condition of C and the fact that it is ecologically connected to other wetlands and freshwater ecosystems of importance.					
Risks	Minor risks are posed to this wetland given that there are no direct crossings that are proposed for this wetland. Minor risks include increased runoff from a burst pipe in the catchment of the wetland or from sedimentation during the construction phase.

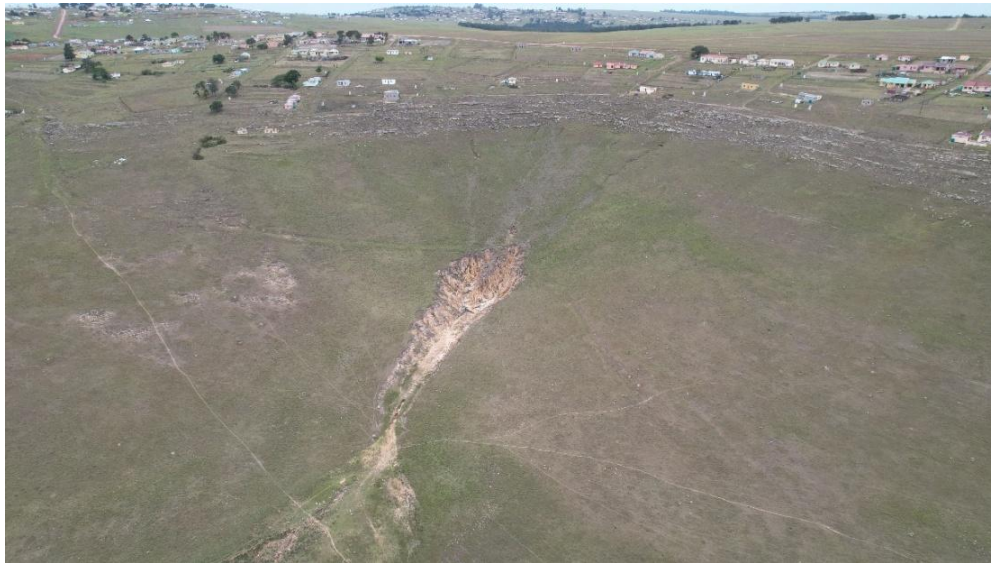
Ngqamakhwe SEEP 29	Crossing No:	N/A	Quaternary Catchment	S50J	Map Reference	Figure 8-14
Habitat type	Hillslope Seep Wetland	Latitude:		-32.187104	Longitude:	27.920995
Photograph

IHI/PES	Condition Score	Key current impacts				
	C	Moderate grazing and trampling by livestock, extensive erosion present within the wetland.				
EIS Score	Moderate EIS. The score is derived from the biodiversity maintenance ecological importance of the wetland due to the relatively good ecological condition of C and the fact that it is ecologically connected to other wetlands and freshwater ecosystems of importance.					
Risks	Minor risks are posed to this wetland given that there are no direct crossings that are proposed for this wetland. Minor risks include increased runoff from a burst pipe in the catchment of the wetland or from sedimentation during the construction phase.

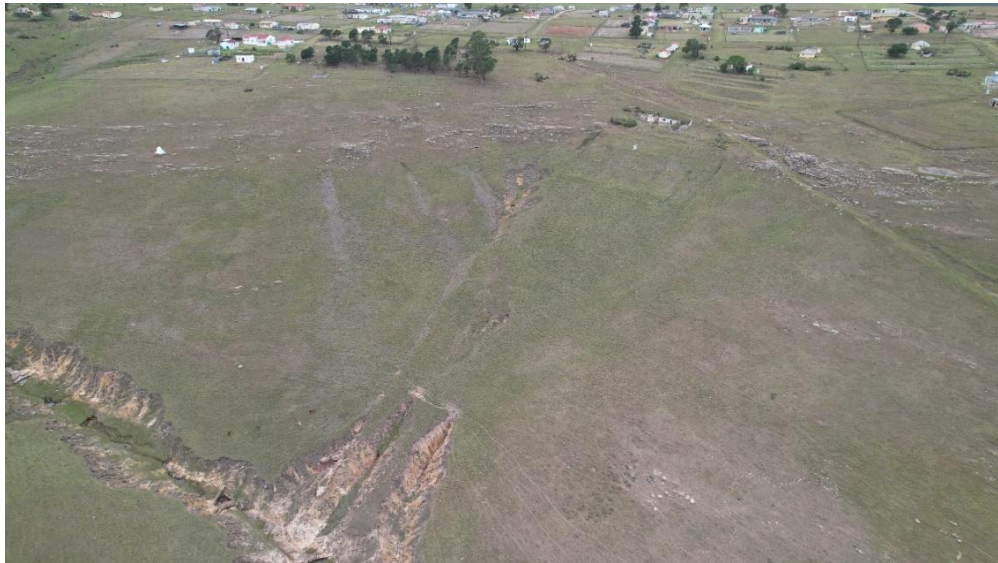
IHI/PES	Condition Score	Key current impacts				
	C	Moderate grazing and trampling by livestock, minor erosion present at the toe of the wetland.				
EIS Score	Moderate EIS. The score is derived from the biodiversity maintenance ecological importance of the wetland due to the relatively good ecological condition of C and the fact that it is ecologically connected to other wetlands and freshwater ecosystems of importance.					
Risks	Minor risks are posed to this wetland given that there are no direct crossings that are proposed for this wetland. Minor risks include increased runoff from a burst pipe in the catchment of the wetland or from sedimentation during the construction phase.

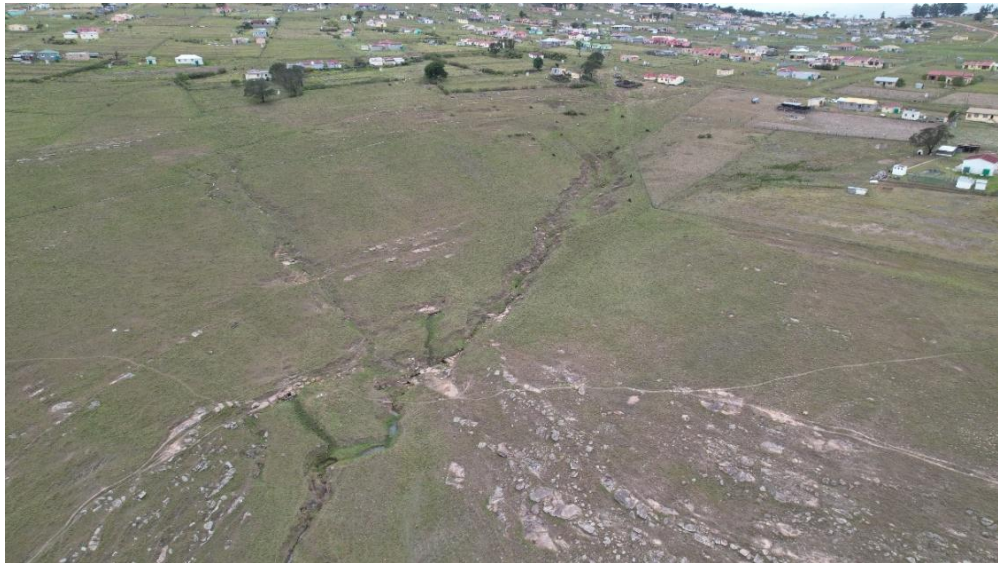
IHI/PES	Condition Score	Key current impacts				
	C	Moderate grazing and trampling by livestock, minor erosion present within the wetland.				
EIS Score	Moderate EIS. The score is derived from the biodiversity maintenance ecological importance of the wetland due to the relatively good ecological condition of C and the fact that it is ecologically connected to other wetlands and freshwater ecosystems of importance.					
Risks	Minor risks are posed to this wetland given that there are no direct crossings that are proposed for this wetland. Minor risks include increased runoff from a burst pipe in the catchment of the wetland or from sedimentation during the construction phase.

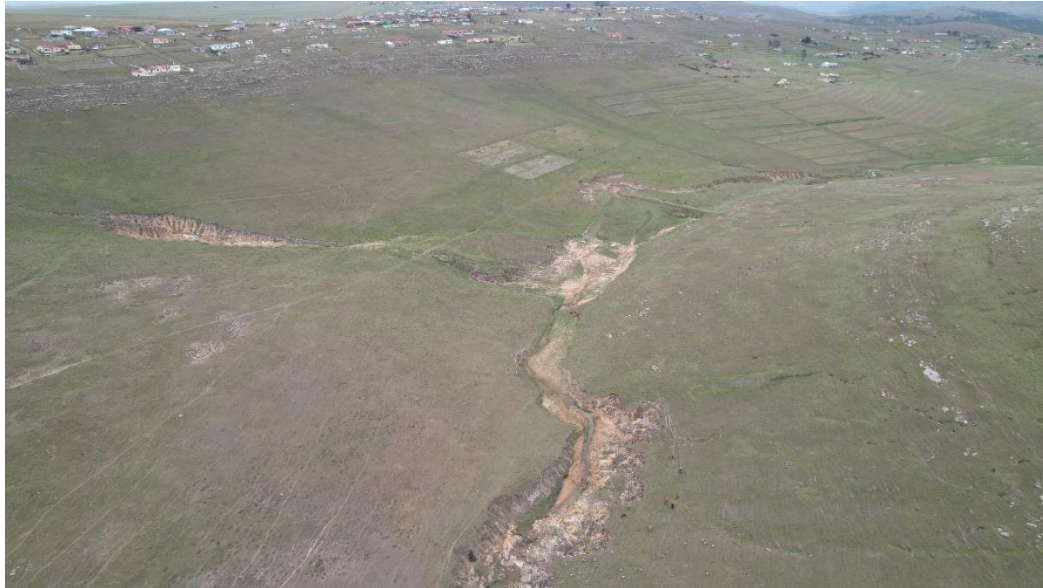
IHI/PES	Condition Score	Key current impacts				
	C	Minor channel and bed modification in the stream system and bank modification present.				
EIS Score	Moderate EIS. The score is derived from the ecological importance of the stream given it is a tributary of the Ngculu River.					
Risks	Low risks associated with the proposed development given that the pipeline alignments will not cross this stream system at all. A low risk exists because the pipeline is located in the catchment of the stream system and within close proximity to the stream.

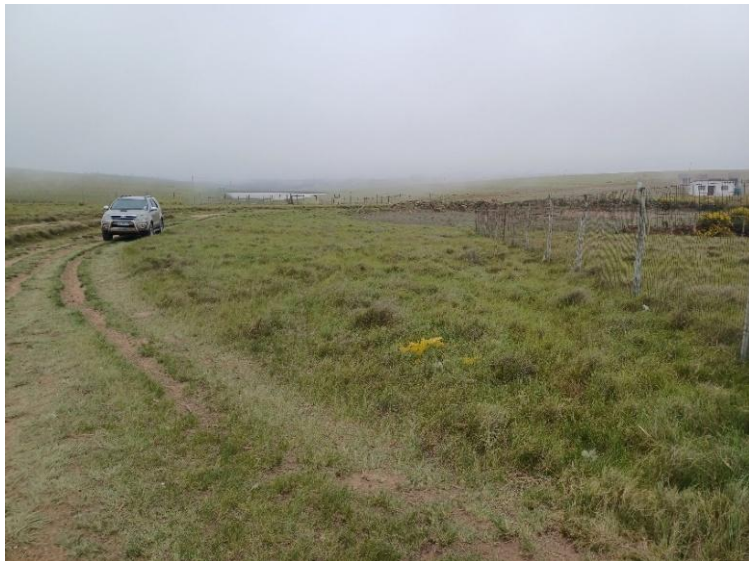
Ngqamakhwe SEEP 11	Crossing No:	N/A	Quaternary Catchment	S50J	Map Reference	Figure 8-15
Habitat type	Hillslope Seep Wetland		Latitude:	-32.191090	Longitude:	27.928936
Photograph

IHI/PES	Condition Score	Key current impacts				
	C	Moderate grazing and trampling by livestock, roads traversing the wetland, minor erosion present as well as subsistence agriculture within the wetland.				
EIS Score	Moderate EIS. The score is derived from the biodiversity maintenance ecological importance of the wetland due to the relatively good ecological condition of C and the fact that it is ecologically connected to other wetlands and freshwater ecosystems of importance.					
Risks	Minor risks are posed to this wetland given that there are no direct crossings that are proposed for this wetland. Minor risks include increased runoff from a burst pipe in the catchment of the wetland or from sedimentation during the construction phase.

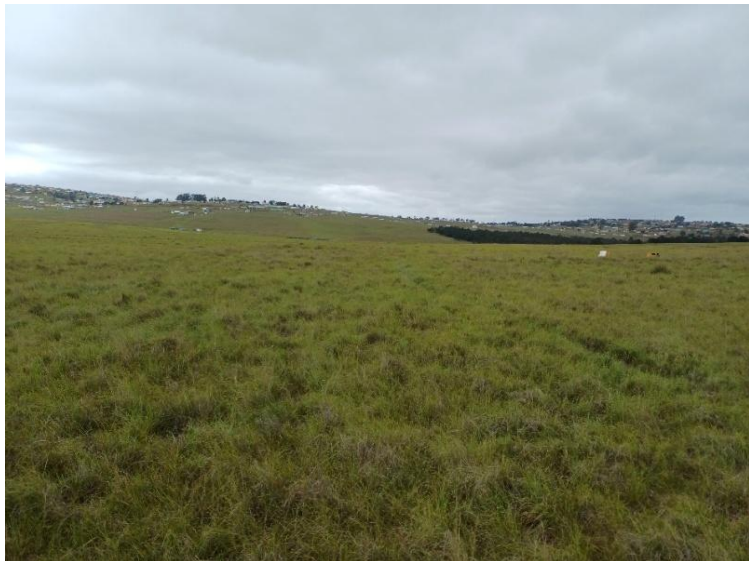
Ngqamakhwe SEEP 21	Crossing No:	N/A	Quaternary Catchment	S50J	Map Reference	Figure 8-15
Habitat type	Hillslope Seep Wetland		Latitude:	-32.193794	Longitude:	27.921183
Photograph

IHI/PES	Condition Score	Key current impacts				
	C	Moderate grazing and trampling by livestock, minor erosion present within the wetland as well as evidence of historical agriculture.				
EIS Score	Moderate EIS. The score is derived from the biodiversity maintenance ecological importance of the wetland due to the relatively good ecological condition of C and the fact that it is ecologically connected to other wetlands and freshwater ecosystems of importance.					
Risks	Minor risks are posed to this wetland given that there are no direct crossings that are proposed for this wetland. Minor risks include increased runoff from a burst pipe in the catchment of the wetland or from sedimentation during the construction phase.

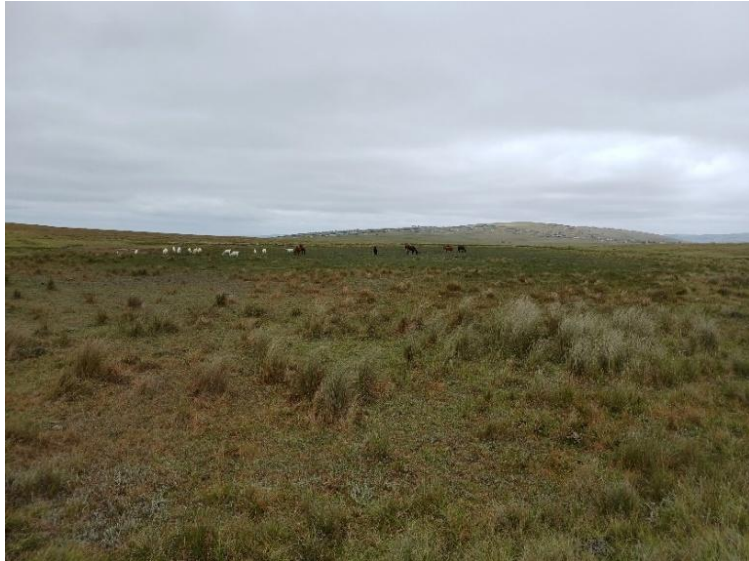
Ngqamakhwe DEPR 2	Crossing No:	N/A	Quaternary Catchment	S50J	Map Reference	Figure 8-16
Habitat type	Depression Wetland		Latitude:	-32.2039533	Longitude:	27.9087034
Photograph

IHI/PES	Condition Score	Key current impacts				
	B	Heavy grazing and trampling by livestock.				
EIS Score	High EIS. The score is derived from the biodiversity maintenance ecological importance of the wetland due to the good ecological condition of B and the fact that it supports a large amount of biodiversity.					
Risks	Minor risks are posed to this wetland given that there are no direct crossings that are proposed for this wetland. Minor risks include increased runoff from a burst pipe in the catchment of the wetland or from sedimentation during the construction phase.

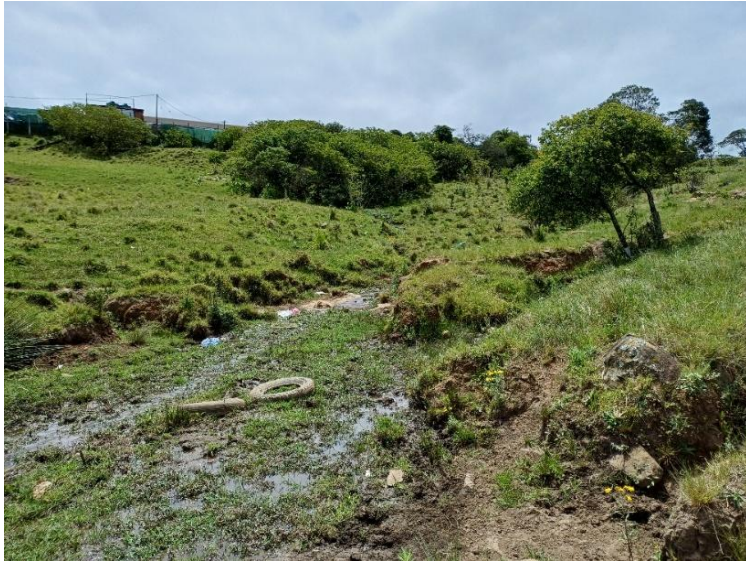
Ngqamakhwe MS 12	Crossing No:	N/A	Quaternary Catchment	S70D	Map Reference	Figure 8-16
Habitat type	Mountain Stream		Latitude:	-32.200644	Longitude:	27.939955
Photograph

IHI/PES	Condition Score		Key current impacts			
	B/	C	Minor channel and bed modification in the stream system. A dam is present as well as a dwelling below the dam within the stream system.			
EIS Score	Moderate EIS. The score is derived from the ecological importance of the stream given it is a tributary of the Ngqamakhwe River.					
Risks	Low risks associated with the proposed development given that the pipeline alignments will not cross this stream system at all. A low risk exists because the pipeline is located in the catchment of the stream system and within close proximity to the stream.

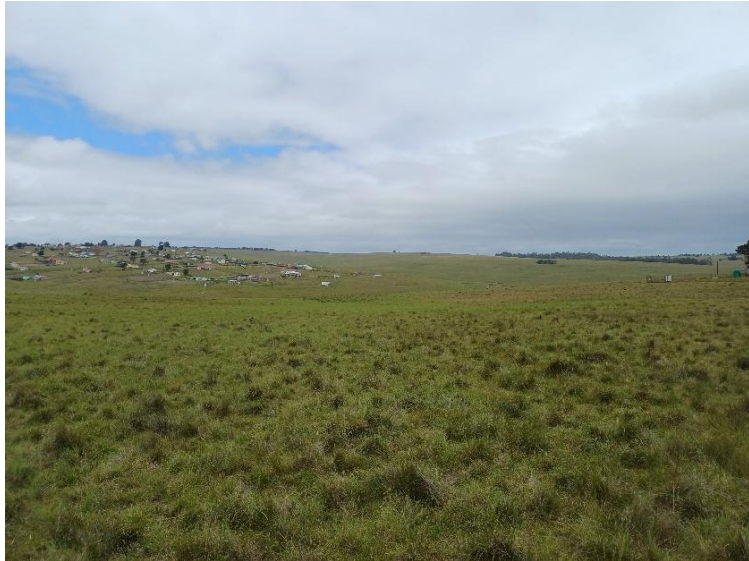
Ngqamakhwe SEEP 22	Crossing No:	N/A	Quaternary Catchment	S50J	Map Reference	Figure 8-16
Habitat type	Hillslope Seep Wetland		Latitude:	-32.2072288	Longitude:	27.9112683
Photograph

IHI/PES	Condition Score	Key current impacts				
	C	Moderate grazing and trampling by livestock and minor erosion present.				
EIS Score	Moderate EIS. The score is derived from the biodiversity maintenance ecological importance of the wetland due to the relatively good ecological condition of C and the fact that it is ecologically connected to other wetlands and freshwater ecosystems of importance.					
Risks	Minor risks are posed to this wetland given that there are no direct crossings that are proposed for this wetland. Minor risks include increased runoff from a burst pipe in the catchment of the wetland or from sedimentation during the construction phase.

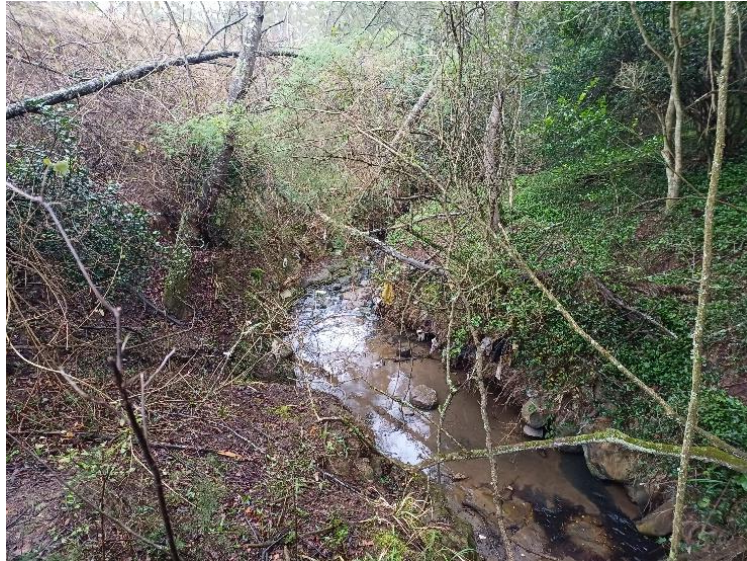
Ngqamakhwe TR 2	Crossing No:	N/A	Quaternary Catchment	S70D	Map Reference	Figure 8-16
Habitat type	Transitional River		Latitude:	-32.206871	Longitude:	27.940385
Photograph

IHI/PES	Condition Score	Key current impacts				
	E	Water abstraction present and major flow, channel and inundation modification within the stream system. Major invasive alien presence within the stream system and the riparian area. Litter observed within the stream system and surrounds.				
EIS Score	Moderate EIS. The score is derived from the ecological importance of the stream given it is a tributary of the Ngqamakhwe River.					
Risks	Low risks associated with the proposed development given that the pipeline alignments will not cross this stream system at all. A low risk exists because the pipeline is located in the catchment of the stream system.

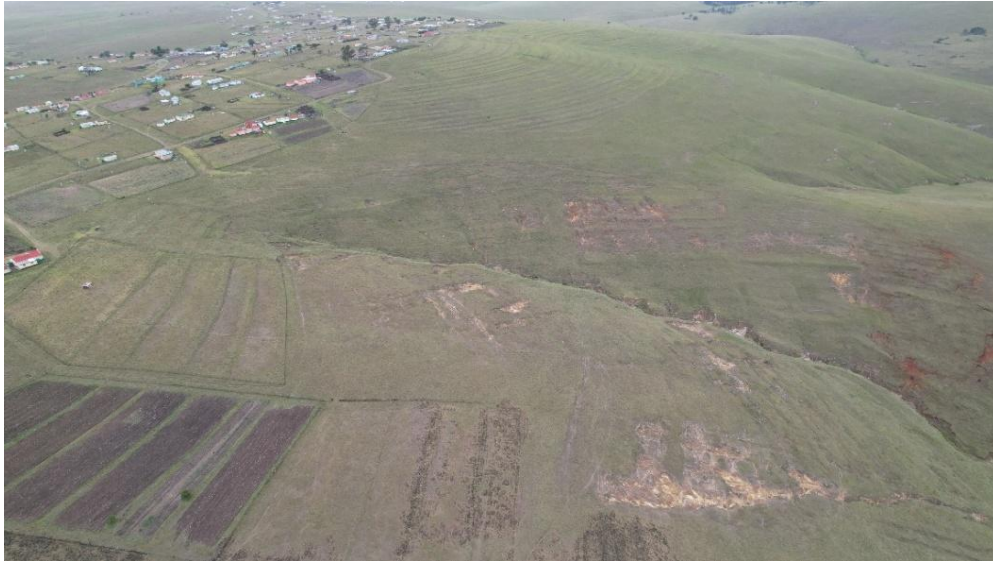
Ngqamakhwe MS 10	Crossing No:	N/A	Quaternary Catchment	S50J	Map Reference	Figure 8-17
Habitat type	Mountain Stream		Latitude:	-32.217811	Longitude:	27.886321
Photograph

IHI/PES	Condition Score	Key current impacts				
	C	Minor channel and bed modification in the stream system. Bank erosion and agricultural practices present.				
EIS Score	Moderate EIS. The score is derived from the ecological importance of the stream given it is a tributary of the Ngculu River.					
Risks	Low risks associated with the proposed development given that the pipeline alignments will not cross this stream system at all. A low risk exists because the pipeline is located in the catchment of the stream system and within close proximity to the stream.

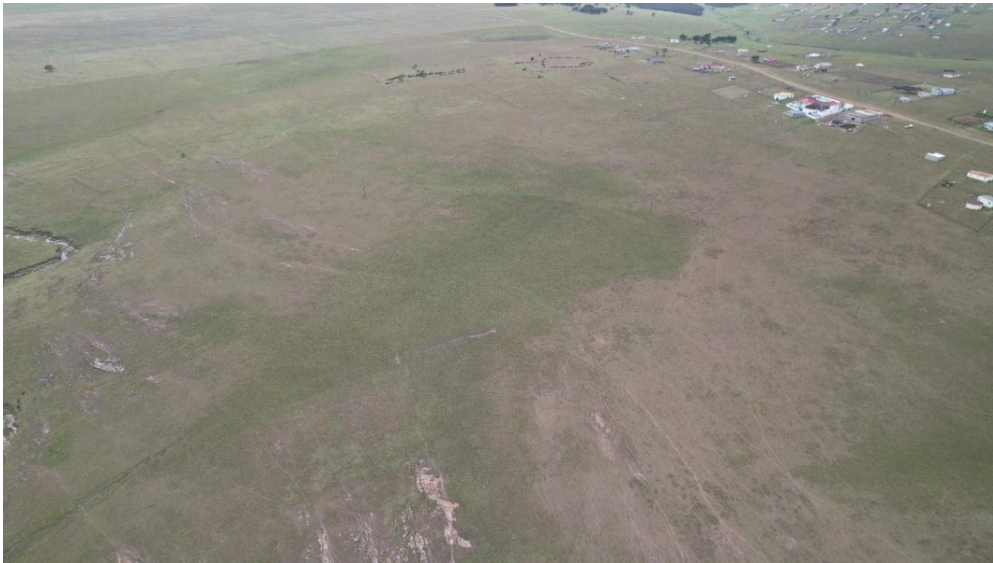
Ngqamakhwe SEEP 23	Crossing No:	N/A	Quaternary Catchment	S50J	Map Reference	Figure 8-17
Habitat type	Hillslope Seep Wetland	Latitude:		-32.206569	Longitude:	27.900266
Photograph

IHI/PES	Condition Score	Key current impacts				
	C	Moderate grazing and trampling by livestock, minor erosion present.				
EIS Score	Moderate EIS. The score is derived from the biodiversity maintenance ecological importance of the wetland due to the relatively good ecological condition of C and the fact that it is ecologically connected to other wetlands and freshwater ecosystems of importance.					
Risks	Minor risks are posed to this wetland given that there are no direct crossings that are proposed for this wetland. Minor risks include increased runoff from a burst pipe in the catchment of the wetland or from sedimentation during the construction phase.

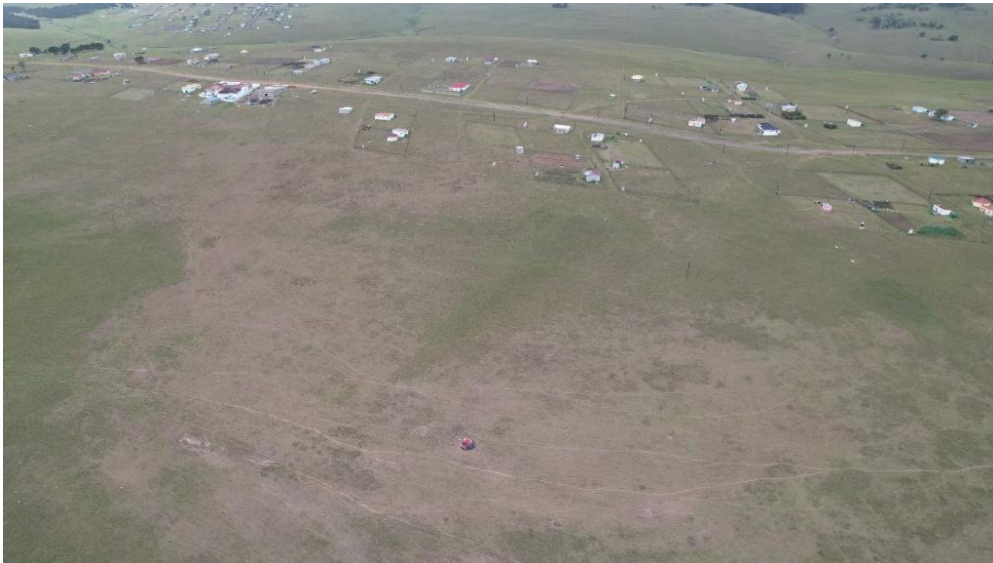
Ngqamakhwe SEEP 24	Crossing No:	N/A	Quaternary Catchment	S50J	Map Reference	Figure 8-17
Habitat type	Hillslope Seep Wetland		Latitude:	-32.208700	Longitude:	27.899616
Photograph

IHI/PES	Condition Score	Key current impacts				
	C	Moderate grazing and trampling by livestock, minor erosion present.				
EIS Score	Moderate EIS. The score is derived from the biodiversity maintenance ecological importance of the wetland due to the relatively good ecological condition of C and the fact that it is ecologically connected to other wetlands and freshwater ecosystems of importance.					
Risks	Minor risks are posed to this wetland given that there are no direct crossings that are proposed for this wetland. Minor risks include increased runoff from a burst pipe in the catchment of the wetland or from sedimentation during the construction phase.

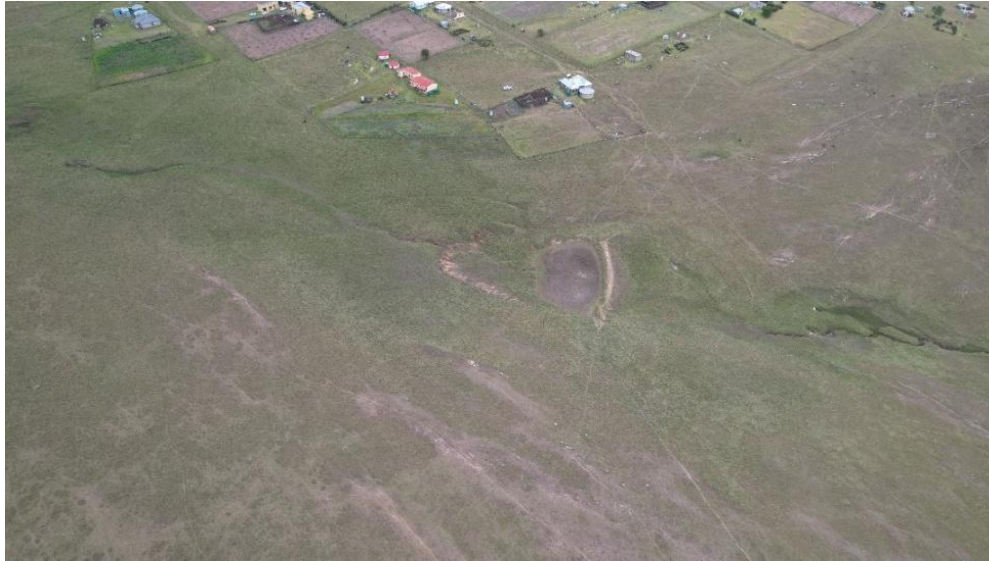
Ngqamakhwe SEEP 25	Crossing No:	N/A	Quaternary Catchment	S50J	Map Reference	Figure 8-17
Habitat type	Hillslope Seep Wetland		Latitude:	-32.209740	Longitude:	27.896093
Photograph

IHI/PES	Condition Score	Key current impacts				
	C	Moderate grazing and trampling by livestock, minor erosion present and a dam in the middle of the wetland.				
EIS Score	Moderate EIS. The score is derived from the biodiversity maintenance ecological importance of the wetland due to the relatively good ecological condition of C and the fact that it is ecologically connected to other wetlands and freshwater ecosystems of importance.					
Risks	Minor risks are posed to this wetland given that there are no direct crossings that are proposed for this wetland. Minor risks include increased runoff from a burst pipe in the catchment of the wetland or from sedimentation during the construction phase.
