# NGQAMAKHWE WATER SUPPLY SCHEME - PHASE 3

## Aquatic Biodiversity Assessment

DRAFT REPORT

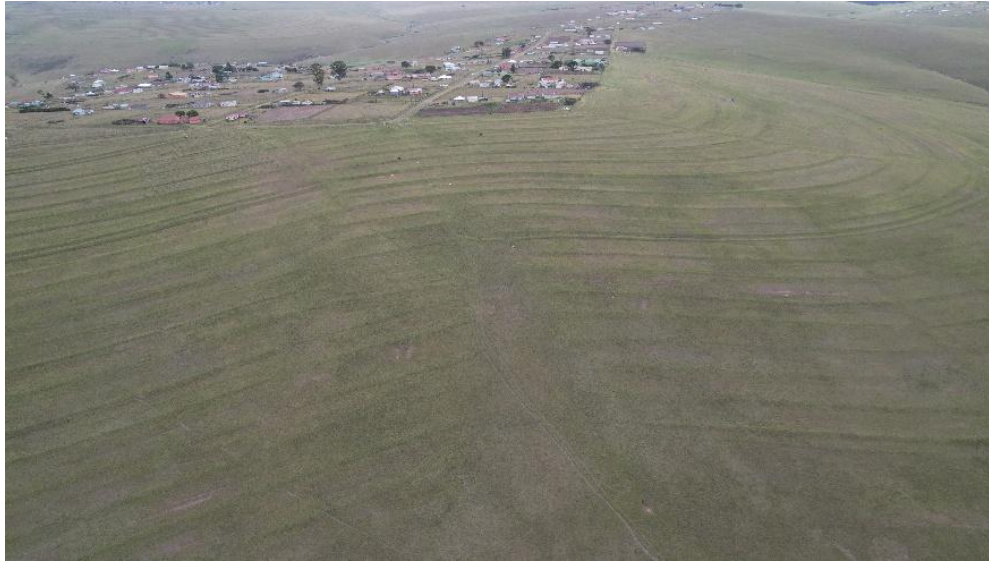
Ngqamakhwe SEEP 26	Crossing No:	N/A	Quaternary Catchment	S50J	Map Reference	Figure 8-17
Habitat type	Hillslope Seep Wetland		Latitude:	-32.220050	Longitude:	27.894642
Photograph

IHI/PES	Condition Score	Key current impacts				
	C	Moderate grazing and trampling by livestock, minor erosion present and evidence of historical agriculture.				
EIS Score	Moderate EIS. The score is derived from the biodiversity maintenance ecological importance of the wetland due to the relatively good ecological condition of C and the fact that it is ecologically connected to other wetlands and freshwater ecosystems of importance.					
Risks	Minor risks are posed to this wetland given that there are no direct crossings that are proposed for this wetland. Minor risks include increased runoff from a burst pipe in the catchment of the wetland or from sedimentation during the construction phase.

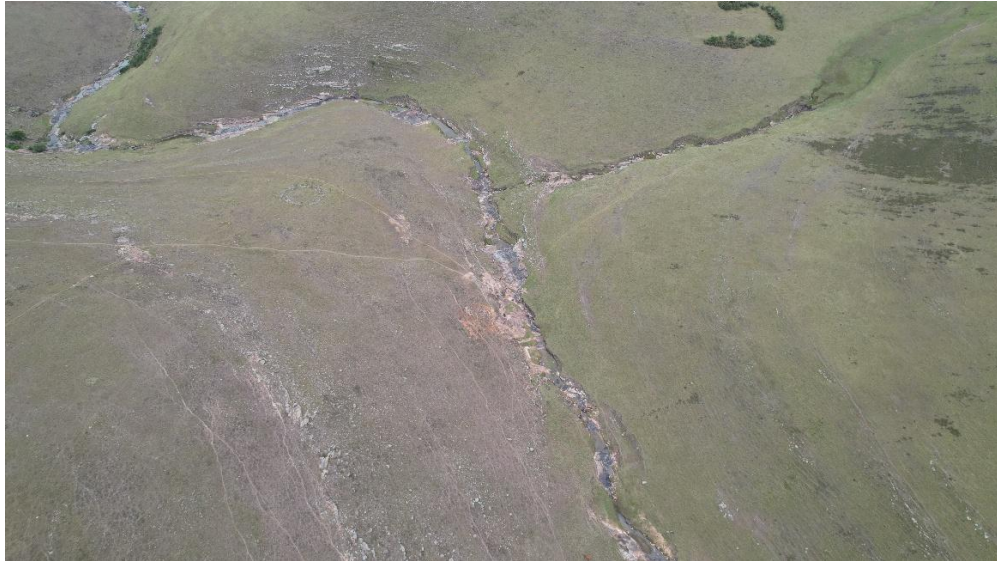
Ngqamakhwe TR 5	Crossing No:	N/A	Quaternary Catchment	S50J	Map Reference	Figure 8-17
Habitat type	Transitional River		Latitude:	-32.206214	Longitude:	27.890828
Photograph

IHI/PES	Condition Score	Key current impacts				
	C	Moderate bed and channel modification within the stream system as well as moderate bank erosion and channel modification within the riparian area.				
EIS Score	Moderate EIS. The score is derived from the ecological importance of the stream given it is a tributary of the Ngculu River.					
Risks	Low risks associated with the proposed development given that the pipeline alignments will not cross this stream system at all. A low risk exists because the pipeline is located in the catchment of the stream system.

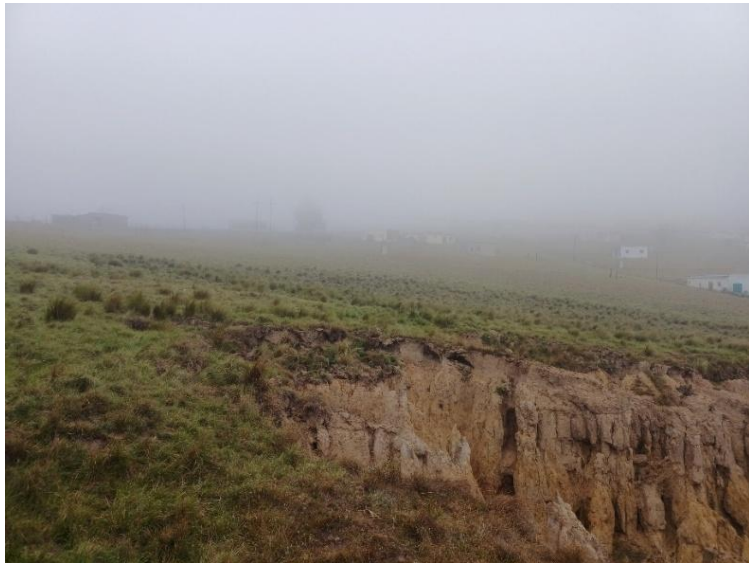
Ngqamakhwe SEEP 13	Crossing No:	N/A	Quaternary Catchment	S50J	Map Reference	Figure 8-18
Habitat type	Hillslope Seep Wetland		Latitude:	-32.1803127	Longitude:	27.9458675
Photograph

IHI/PES	Condition Score	Key current impacts				
	C	Moderate grazing and trampling by livestock, major erosion present at the toe of the wetland.				
EIS Score	Moderate EIS. The score is derived from the biodiversity maintenance ecological importance of the wetland due to the relatively good ecological condition of C and the fact that it is ecologically connected to other wetlands and freshwater ecosystems of importance.					
Risks	Minor risks are posed to this wetland given that there are no direct crossings that are proposed for this wetland. Minor risks include increased runoff from a burst pipe in the catchment of the wetland or from sedimentation during the construction phase.

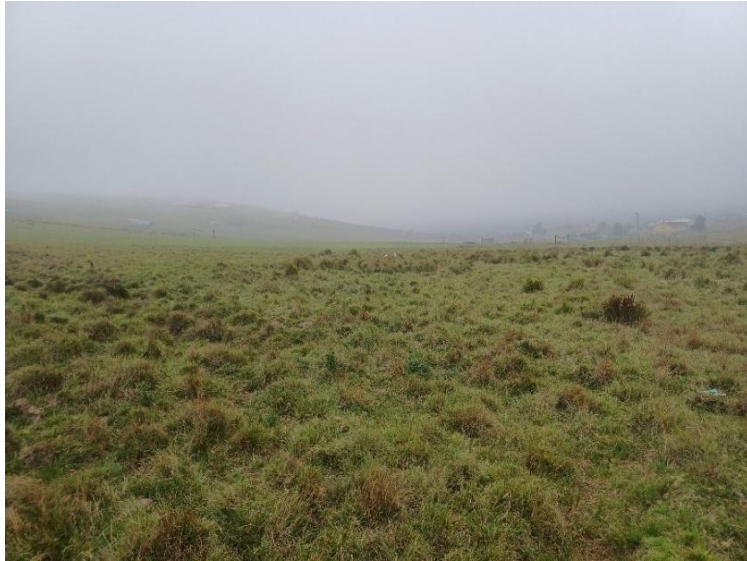
Ngqamakhwe SEEP 14	Crossing No:	N/A	Quaternary Catchment	S70D	Map Reference	Figure 8-18
Habitat type	Hillslope Seep Wetland		Latitude:	-32.181434	Longitude:	27.948981
Photograph

IHI/PES	Condition Score	Key current impacts				
	C	Moderate grazing and trampling by livestock, minor erosion and subsistence agriculture present.				
EIS Score	Moderate EIS. The score is derived from the biodiversity maintenance ecological importance of the wetland due to the relatively good ecological condition of C and the fact that it is ecologically connected to other wetlands and freshwater ecosystems of importance.					
Risks	Minor risks are posed to this wetland given that there are no direct crossings that are proposed for this wetland. Minor risks include increased runoff from a burst pipe in the catchment of the wetland or from sedimentation during the construction phase.

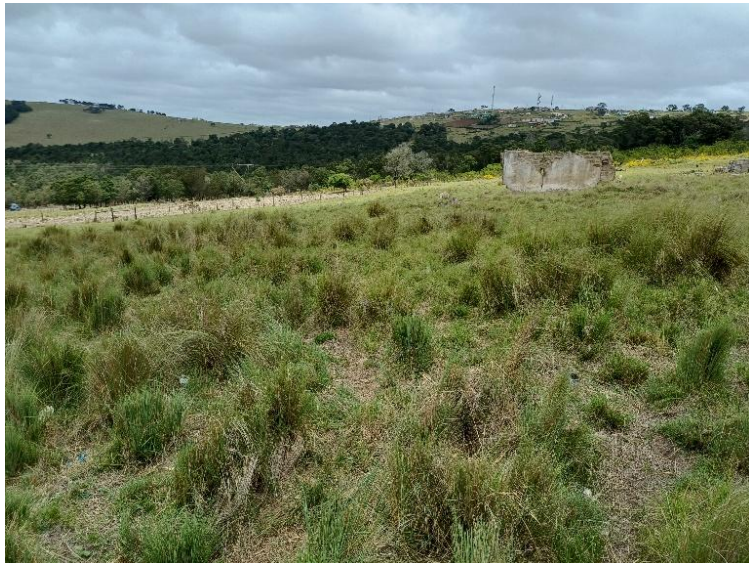
Ngqamakhwe SEEP 33	Crossing No:	N/A	Quaternary Catchment	S70D	Map Reference	Figure 8-18
Habitat type	Hillslope Seep Wetland		Latitude:	-32.185887	Longitude:	27.946546
Photograph

IHI/PES	Condition Score	Key current impacts				
	C	Moderate grazing and trampling by livestock, minor erosion present.				
EIS Score	Moderate EIS. The score is derived from the biodiversity maintenance ecological importance of the wetland due to the relatively good ecological condition of C and the fact that it is ecologically connected to other wetlands and freshwater ecosystems of importance.					
Risks	Minor risks are posed to this wetland given that there are no direct crossings that are proposed for this wetland. Minor risks include increased runoff from a burst pipe in the catchment of the wetland or from sedimentation during the construction phase.

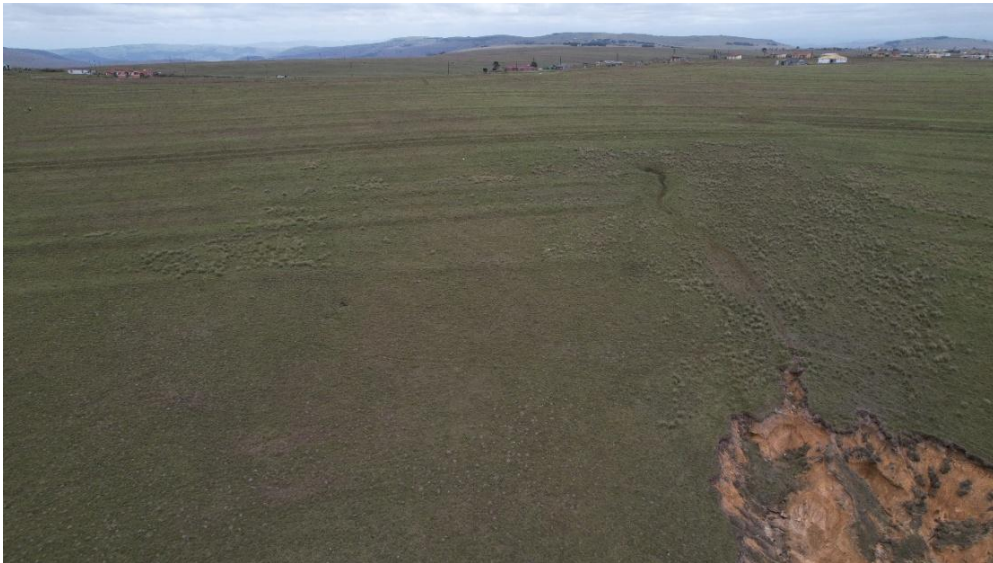
Ngqamakhwe SEEP 16	Crossing No:	N/A	Quaternary Catchment	S70D	Map Reference	Figure 8-19
Habitat type	Hillslope Seep Wetland	Latitude:		-32.1709517	Longitude:	27.9528104
Photograph

IHI/PES	Condition Score	Key current impacts				
	C	Moderate grazing and trampling by livestock, erosion present at the toe of the wetland.				
EIS Score	Moderate EIS. The score is derived from the biodiversity maintenance ecological importance of the wetland due to the relatively good ecological condition of C and the fact that it is ecologically connected to other wetlands and freshwater ecosystems of importance.					
Risks	Minor risks are posed to this wetland given that there are no direct crossings that are proposed for this wetland. Minor risks include increased runoff from a burst pipe in the catchment of the wetland or from sedimentation during the construction phase.

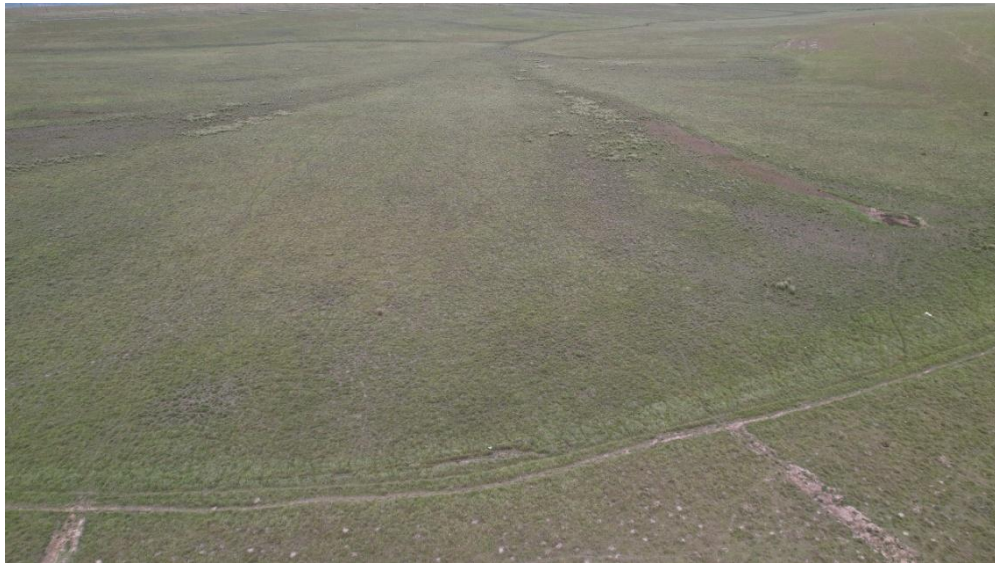
Ngqamakhwe SEEP 32	Crossing No:	N/A	Quaternary Catchment	S70D	Map Reference	Figure 8-19
Habitat type	Hillslope Seep Wetland	Latitude:		-32.1688564	Longitude:	27.9482414
Photograph

IHI/PES	Condition Score	Key current impacts				
	C	Heavy grazing and trampling by livestock, minor erosion present.				
EIS Score	Moderate EIS. The score is derived from the biodiversity maintenance ecological importance of the wetland due to the relatively good ecological condition of C and the fact that it is ecologically connected to other wetlands and freshwater ecosystems of importance.					
Risks	Minor risks are posed to this wetland given that there are no direct crossings that are proposed for this wetland. Minor risks include increased runoff from a burst pipe in the catchment of the wetland or from sedimentation during the construction phase.

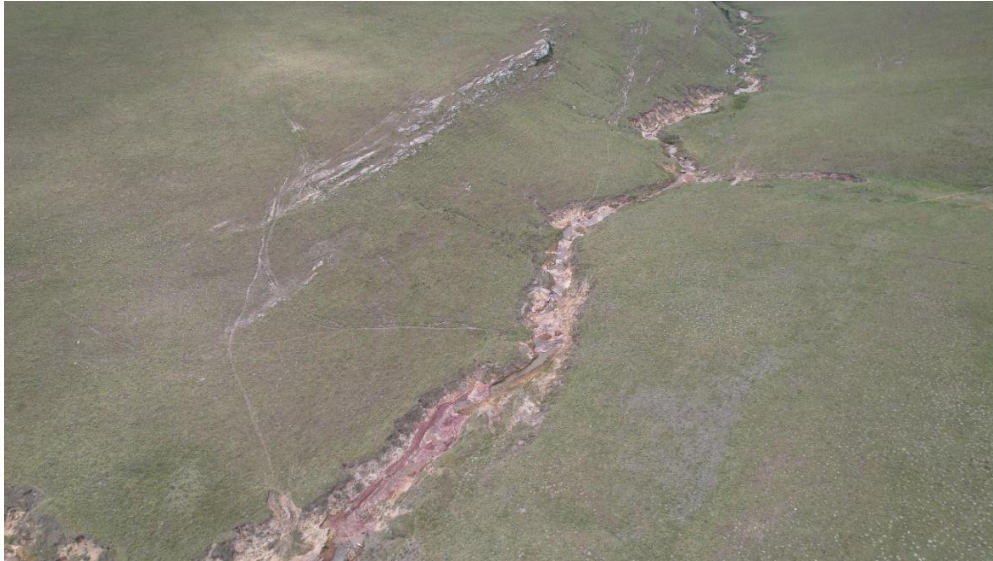
Ngqamakhwe TR 7	Crossing No:	N/A	Quaternary Catchment	S70D	Map Reference	Figure 8-19
Habitat type	Transitional River		Latitude:	-32.177680	Longitude:	27.961436
Photograph

IHI/PES	Condition Score	Key current impacts				
	B	Moderate bed and channel modification within the stream system.				
EIS Score	Moderate EIS. The score is derived from the ecological importance of the stream given it is a tributary of the Mtwaku River.					
Risks	Low risks associated with the proposed development given that the pipeline alignments will not cross this stream system at all. A low risk exists because the pipeline is located in the catchment of the stream system.

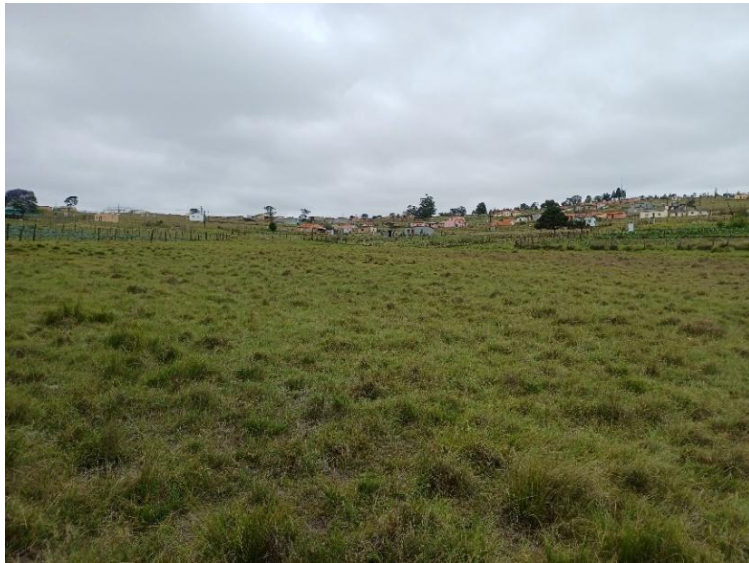
**Table 8-75 Seep 34 details (no direct crossing)**

Ngqamakhwe SEEP 34	Crossing No:	N/A	Quaternary Catchment	S70D	Map Reference	Figure 8-20
Habitat type	Hillslope Seep Wetland		Latitude:	-32.188241	Longitude:	27.976606
Photograph

IHI/PES	Condition Score	Key current impacts				
	C	Moderate grazing and trampling by livestock, there is a drain present and a dam in the wetland.				
EIS Score	Moderate EIS. The score is derived from the biodiversity maintenance ecological importance of the wetland due to the relatively good ecological condition of C and the fact that it is ecologically connected to other wetlands and freshwater ecosystems of importance.					
Risks	Minor risks are posed to this wetland given that there are no direct crossings that are proposed for this wetland. Minor risks include increased runoff from a burst pipe in the catchment of the wetland or from sedimentation during the construction phase.

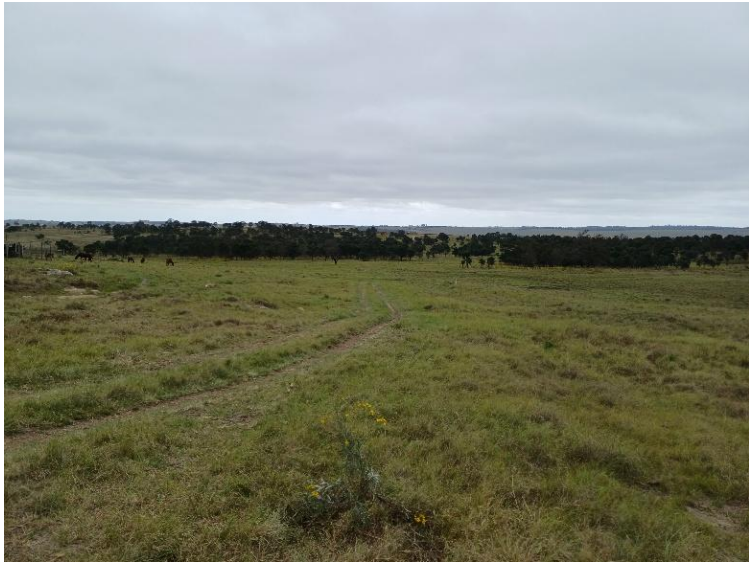
**Table 8-77 Seep 81 details (crossing S70D-8)**

Ngqamakhwe SEEP 81	Crossing No:	S70D-8	Quaternary Catchment	S70D	Map Reference	Figure 8-21
Habitat type	Hillslope Seep Wetland		Latitude:	-32.2042030	Longitude:	27.9817656
Photograph

IHI/PES	Condition Score	Key current impacts				
	C	Moderate grazing and trampling by livestock, invasive alien species present within the wetland and a gravel road traversing the wetland.				
EIS Score	Moderate EIS. The score is derived from the biodiversity maintenance ecological importance of the wetland due to the relatively good ecological condition of C and the fact that it is ecologically connected to other wetlands and freshwater ecosystems of importance.					
Risks	Moderate to low risks associated with the proposed pipeline alignment given that the pipeline will pass directly through the northern edge of the wetland. Provided that careful construction measures are followed, the risk should be low. Additionally, the wetland is located on a gentle slope, so the risk of erosion is reduced.

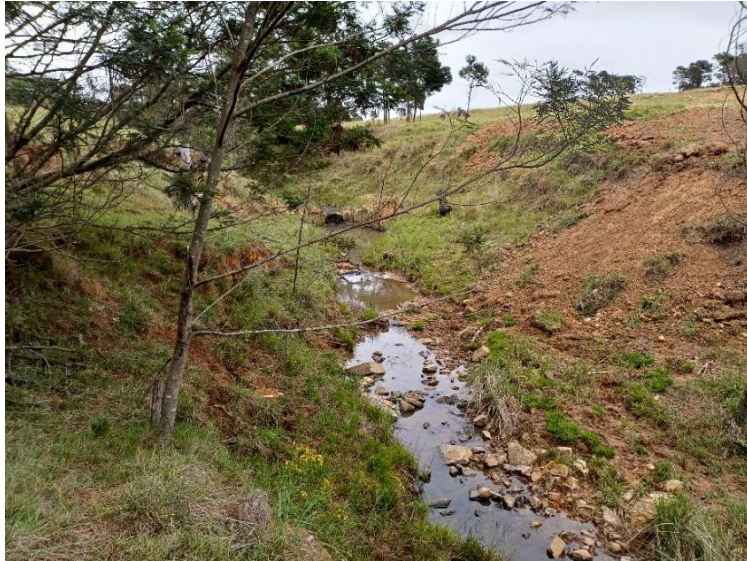
**Table 8-78 Transitional river 8 details (crossing S70D-9)**

Ngqamakhwe TR 8	Crossing No:	S70D-9	Quaternary Catchment	S70D	Map Reference	Figure 8-21
Habitat type	Transitional River		Latitude:	-32.204729	Longitude:	27.996063
Photograph

IHI/PES	Condition Score		Key current impacts			
	B/	C	Moderate bed and channel modification as well as a minor presence of invasive alien vegetation within the stream system. Minor bank erosion and channel modification in the riparian area.			
EIS Score	Moderate EIS. The score is derived from the ecological importance of the stream given it is a tributary of the Mtwaku River.					
Risks	Moderate to low risks associated with the proposed pipeline alignment given that the pipeline will pass directly through the river at only one point. Provided that careful construction measures are followed, the risk should be low.

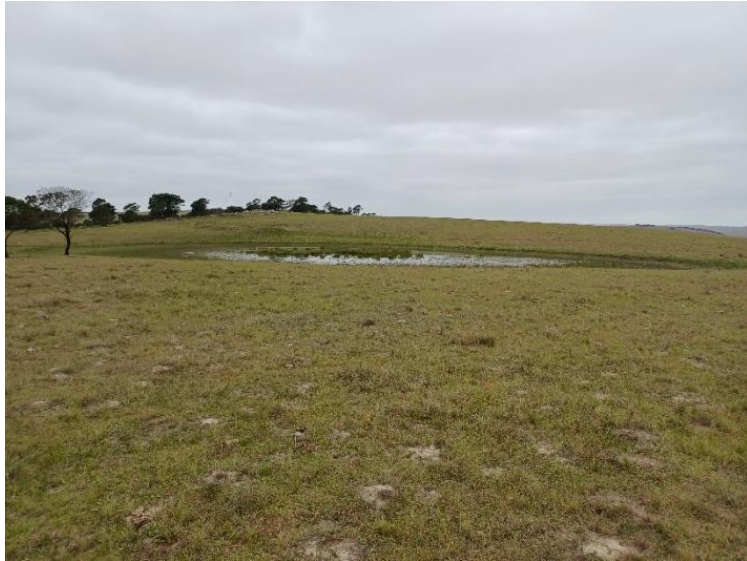
**Table 8-79 Depression 3 details (no direct crossing)**

Ngqamakhwe DEPR 3	Crossing No:	N/A	Quaternary Catchment	S70D	Map Reference	Figure 8-22
Habitat type	Depression Wetland		Latitude:	-32.2112372	Longitude:	27.9903885
Photograph

IHI/PES	Condition Score	Key current impacts				
	A	Minor grazing and trampling by livestock.				
EIS Score	High EIS. The score is derived from the biodiversity maintenance ecological importance of the wetland due to the good ecological condition of A and the fact that it supports a large amount of biodiversity.					
Risks	Minor risks are posed to this wetland given that there are no direct crossings that are proposed for this wetland. Minor risks include increased runoff from a burst pipe in the catchment of the wetland or from sedimentation during the construction phase.

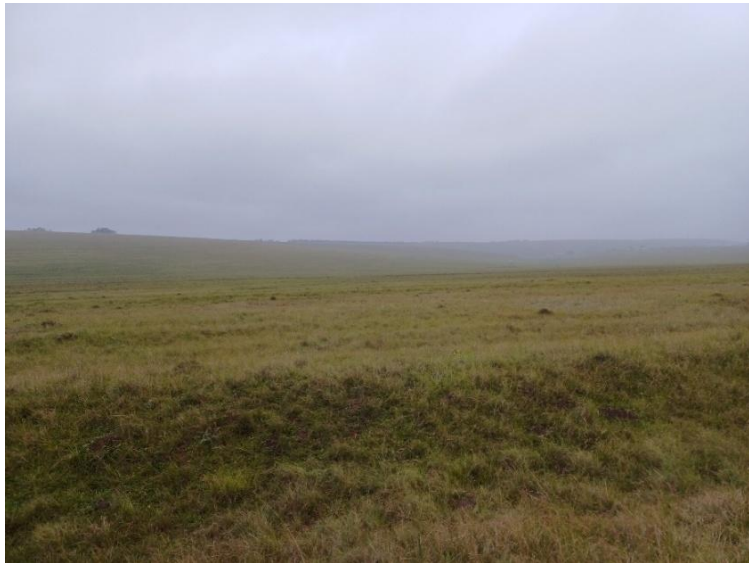
**Table 8-81 Seep 44 details (no direct crossing)**

Ngqamakhwe SEEP 44	Crossing No:	N/A	Quaternary Catchment	S70D	Map Reference	Figure 8-22
Habitat type	Hillslope Seep Wetland		Latitude:	-32.212104	Longitude:	28.003445
Photograph

IHI/PES	Condition Score	Key current impacts				
	C	Moderate grazing and trampling by livestock, erosion and a dam present in the wetland.				
EIS Score	Moderate EIS. The score is derived from the biodiversity maintenance ecological importance of the wetland due to the relatively good ecological condition of C and the fact that it is ecologically connected to other wetlands and freshwater ecosystems of importance.					
Risks	Minor risks are posed to this wetland given that there are no direct crossings that are proposed for this wetland. Minor risks include increased runoff from a burst pipe in the catchment of the wetland or from sedimentation during the construction phase.

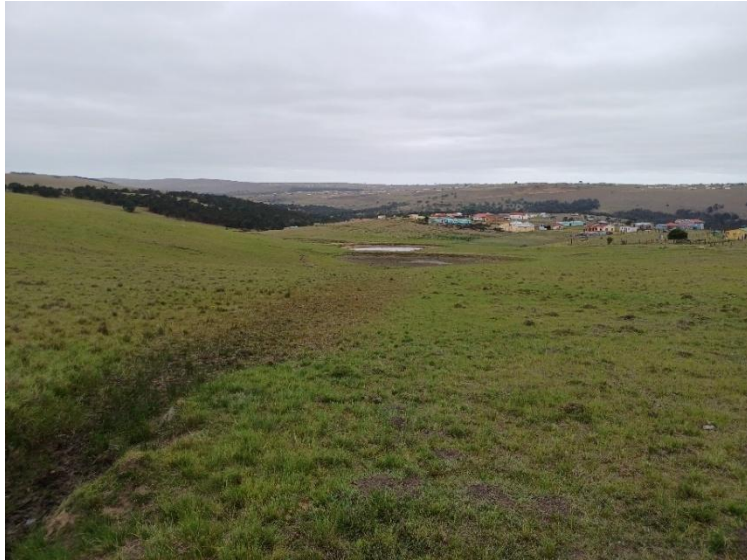
**Table 8-82 Seep 82 details (no direct crossing)**

Ngqamakhwe SEEP 82	Crossing No:	N/A	Quaternary Catchment	S70D	Map Reference	Figure 8-22
Habitat type	Hillslope Seep Wetland		Latitude:	-32.2142095	Longitude:	27.9902702
Photograph

IHI/PES	Condition Score	Key current impacts				
	C	Moderate to heavy grazing and trampling by livestock, erosion and a dam present in the wetland.				
EIS Score	Moderate EIS. The score is derived from the biodiversity maintenance ecological importance of the wetland due to the relatively good ecological condition of C and the fact that it is ecologically connected to other wetlands and freshwater ecosystems of importance.					
Risks	Minor risks are posed to this wetland given that there are no direct crossings that are proposed for this wetland. Minor risks include increased runoff from a burst pipe in the catchment of the wetland or from sedimentation during the construction phase.

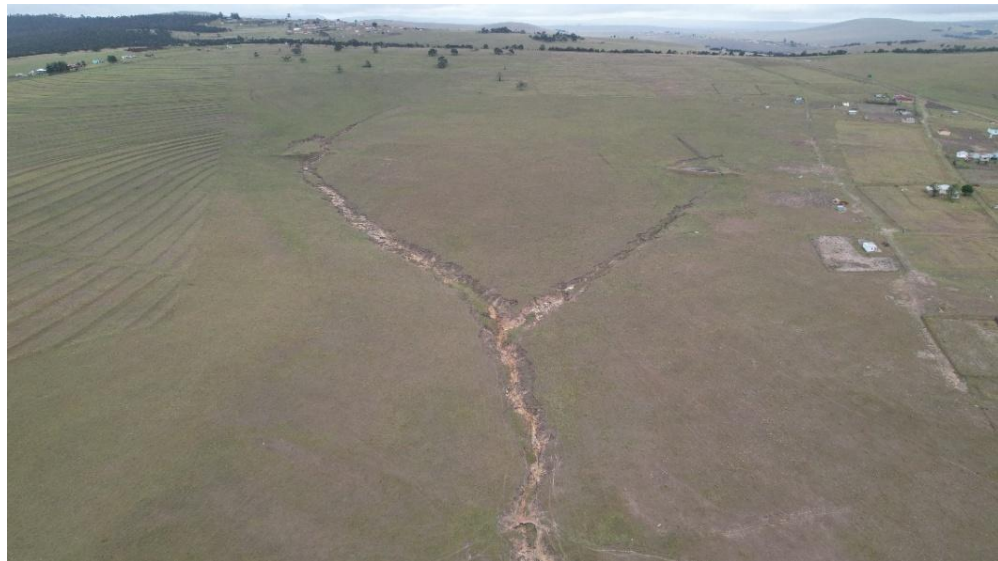
**Table 8-83 Seep 18 details (no direct crossing)**

Ngqamakhwe SEEP 18	Crossing No:	N/A	Quaternary Catchment	S70D	Map Reference	Figure 8-23
Habitat type	Hillslope Seep Wetland		Latitude:	-32.217520	Longitude:	27.983370
Photograph

IHI/PES	Condition Score	Key current impacts				
	C	Heavy grazing and trampling by livestock, erosion, a dam and historical agriculture present in the wetland.				
EIS Score	Moderate EIS. The score is derived from the biodiversity maintenance ecological importance of the wetland due to the relatively good ecological condition of C and the fact that it is ecologically connected to other wetlands and freshwater ecosystems of importance.					
Risks	Minor risks are posed to this wetland given that there are no direct crossings that are proposed for this wetland. Minor risks include increased runoff from a burst pipe in the catchment of the wetland or from sedimentation during the construction phase.

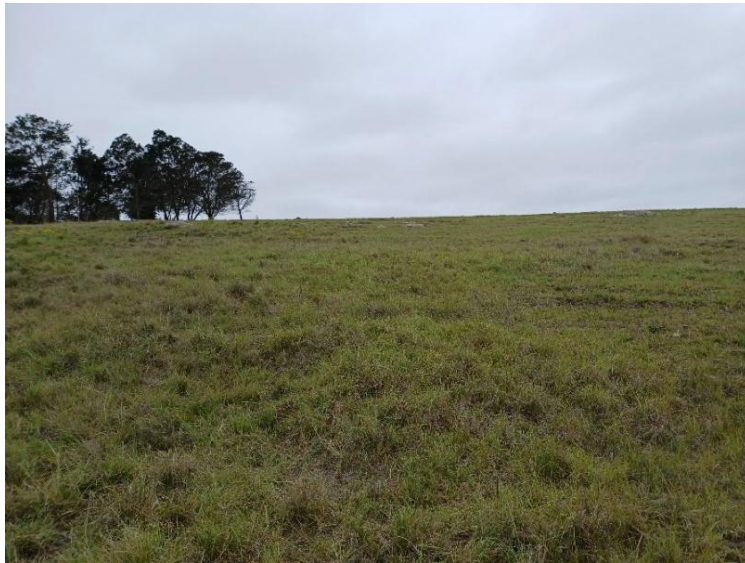
**Table 8-84 Seep 35 details (no direct crossing)**

Ngqamakhwe SEEP 35	Crossing No:	S70D-21	Quaternary Catchment	S70D	Map Reference	Figure 8-23
Habitat type	Hillslope Seep Wetland		Latitude:	-32.2127526	Longitude:	27.9759647
Photograph

IHI/PES	Condition Score	Key current impacts				
	C	Moderate grazing and trampling by livestock, minor erosion and invasive alien species present within the wetland.				
EIS Score	Moderate EIS. The score is derived from the biodiversity maintenance ecological importance of the wetland due to the relatively good ecological condition of C and the fact that it is ecologically connected to other wetlands and freshwater ecosystems of importance.					
Risks	Moderate to low risks associated with the proposed pipeline alignment given that the pipeline will pass directly through the northern edge of the wetland. Provided that careful construction measures are followed, the risk should be low.

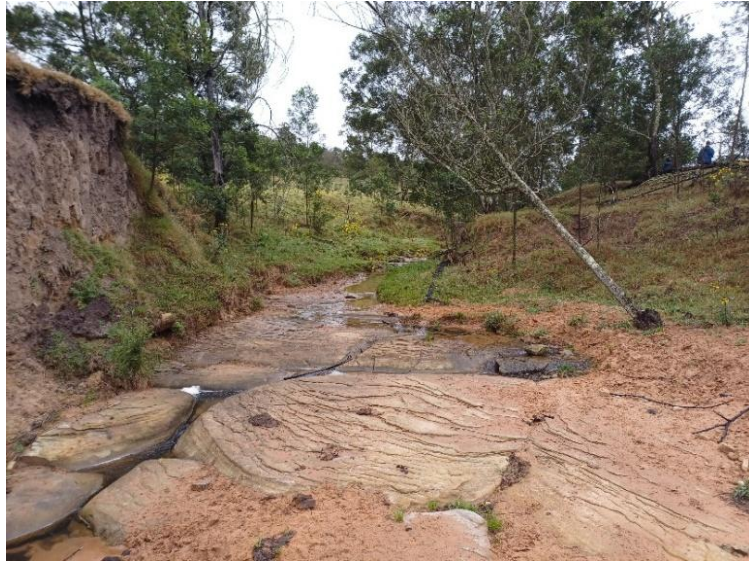
**Table 8-85 Transitional river 3 details (crossing S70D-10)**

Ngqamakhwe TR 3	Crossing No:	S70D-10	Quaternary Catchment	S70D	Map Reference	Figure 8-23
Habitat type	Transitional River		Latitude:	-32.220007	Longitude:	27.975044
Photograph

IHI/PES	Condition Score	Key current impacts				
	E	Moderate bed and major channel modification as well as a major presence of invasive alien vegetation within the stream system. Major invasive alien plants, bank erosion, channel modification and flow modification within the riparian area.				
EIS Score	Moderate EIS. The score is derived from the ecological importance of the stream given it is a tributary of the Ngqamakhwe River.					
Risks	Moderate to low risks associated with the proposed pipeline alignment given that the pipeline will pass directly through the river at a point of minimal disturbance. Provided that careful construction measures are followed, the risk should be low.

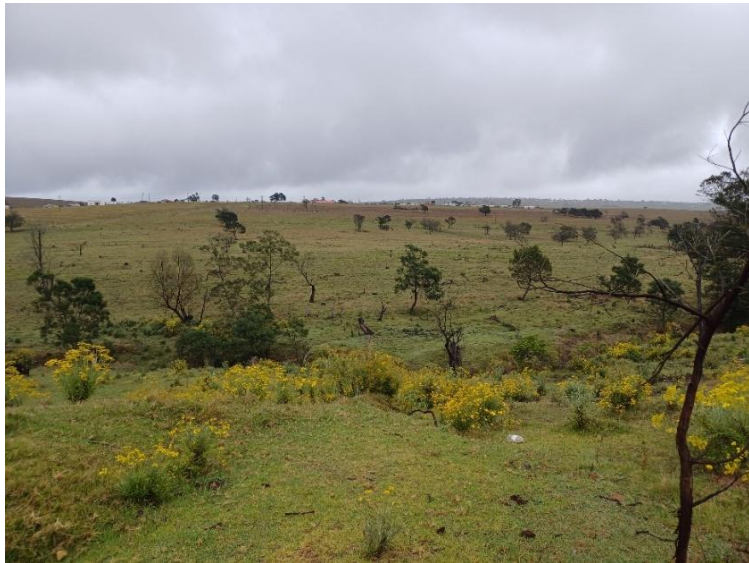
**Table 8-86 Seep 15 details (no direct crossing)**

Ngqamakhwe SEEP 15	Crossing No:	N/A	Quaternary Catchment	S70D	Map Reference	Figure 8-24
Habitat type	Hillslope Seep Wetland		Latitude:	-32.222871	Longitude:	27.971372
Photograph

IHI/PES	Condition Score	Key current impacts				
	C	Moderate grazing and trampling by livestock, invasive alien species present.				
EIS Score	Moderate EIS. The score is derived from the biodiversity maintenance ecological importance of the wetland due to the relatively good ecological condition of C and the fact that it is ecologically connected to other wetlands and freshwater ecosystems of importance.					
Risks	Minor risks are posed to this wetland given that there are no direct crossings that are proposed for this wetland. Minor risks include increased runoff from a burst pipe in the catchment of the wetland or from sedimentation during the construction phase.

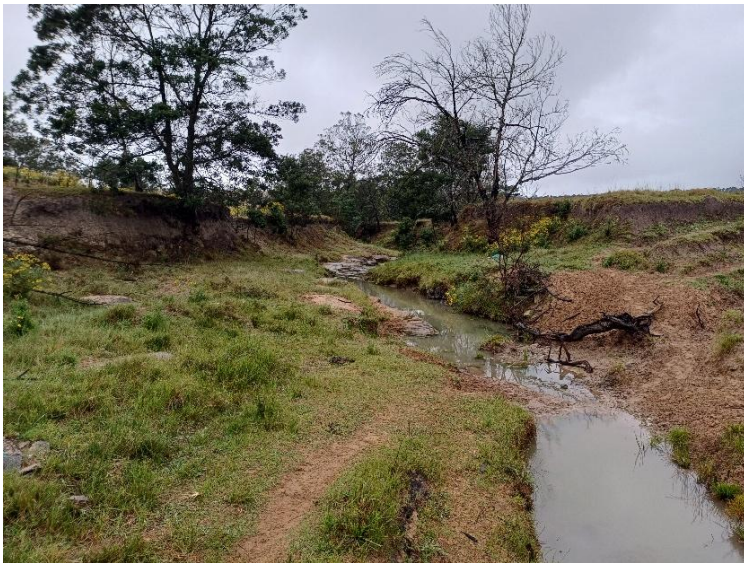
**Table 8-87 Transitional river 4 details (crossing S70D-11)**

Ngqamakhwe TR 4	Crossing No:	S70D-11	Quaternary Catchment	S70D	Map Reference	Figure 8-24
Habitat type	Transitional River		Latitude:	-32.2242040	Longitude:	27.9744782
Photograph

IHI/PES	Condition Score	Key current impacts				
	D	Moderate bed and channel modification as well as a major presence of invasive alien vegetation within the stream system. Major invasive alien plants, bank erosion and channel modification all present in the riparian area.				
EIS Score	Moderate EIS. The score is derived from the ecological importance of the stream given it is a tributary of the Ngqamakhe River.					
Risks	Moderate to low risks associated with the proposed pipeline alignment given that the pipeline will pass directly through the river at only one point, where disturbance already exists (i.e. informal river crossing). Provided that careful construction measures are followed, the risk should be low.

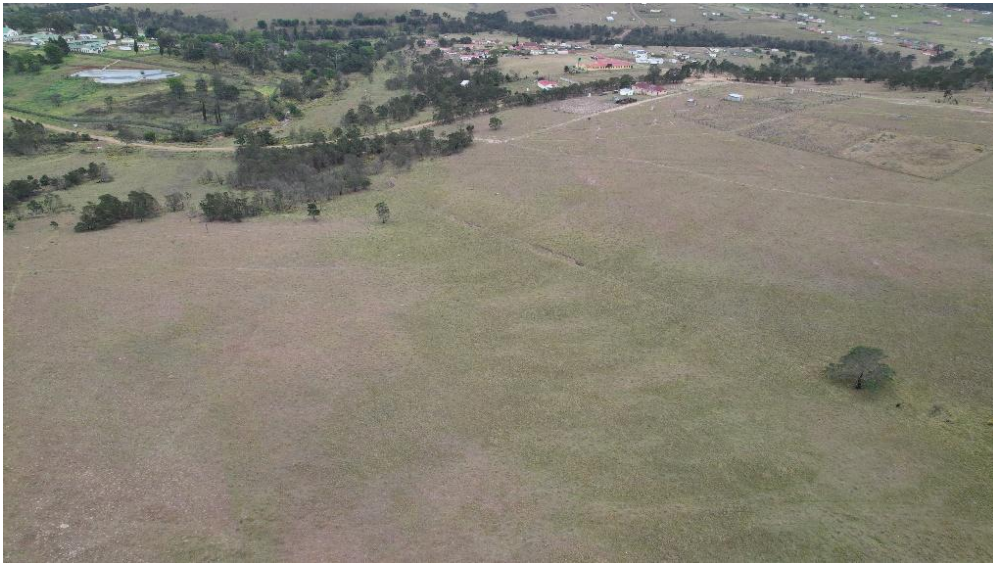
**Table 8-88 Seep 17 details (crossing S70D-13)**

Ngqamakhwe SEEP 17	Crossing No:	S70D-13	Quaternary Catchment	S70D	Map Reference	Figure 8-25
Habitat type	Hillslope Seep Wetland		Latitude:	-32.227946	Longitude:	27.980178
Photograph

IHI/PES	Condition Score	Key current impacts				
	C	Heavy grazing and trampling by livestock, minor erosion and invasive alien species present within the wetland.				
EIS Score	Moderate EIS. The score is derived from the biodiversity maintenance ecological importance of the wetland due to the relatively good ecological condition of C and the fact that it is ecologically connected to other wetlands and freshwater ecosystems of importance.					
Risks	Moderate to low risks associated with the proposed pipeline alignment given that the pipeline will pass directly through the northern edge of the wetland, on an existing road. Provided that careful construction measures are followed, the risk should be low.

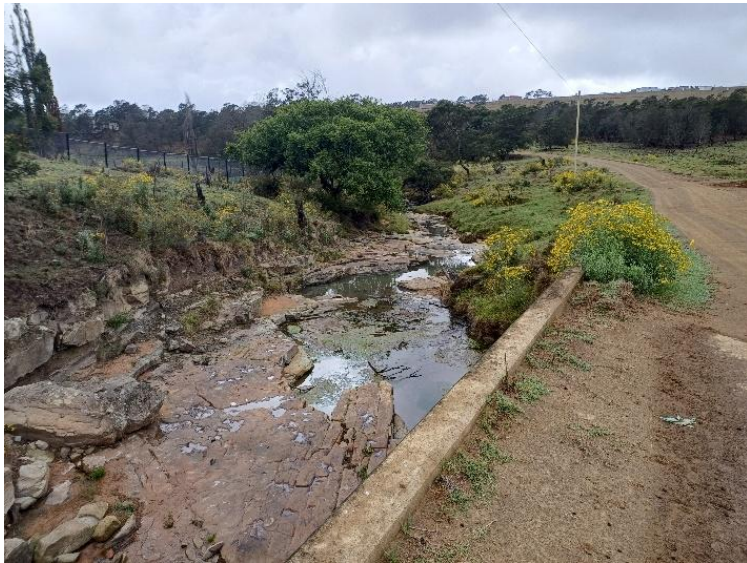
**Table 8-89 Transitional river 3 details (crossing S70D-12)**

Ngqamakhwe TR 3	Crossing No:	S70D-12	Quaternary Catchment	S70D	Map Reference	Figure 8-25
Habitat type	Transitional River		Latitude:	-32.2275191	Longitude:	27.9791546
Photograph

IHI/PES	Condition Score	Key current impacts				
	E	Moderate bed and major channel modification as well as a major presence of invasive alien vegetation within the stream system. Major invasive alien plants, bank erosion, channel modification and flow modification within the riparian area.				
EIS Score	Moderate EIS. The score is derived from the ecological importance of the stream given it is a tributary of the Ngqamakhe River.					
Risks	Moderate to low risks associated with the proposed pipeline alignment given that the pipeline will pass directly through the river at only one point where disturbance already exists (i.e. road crossing). Provided that careful construction measures are followed, the risk should be low.

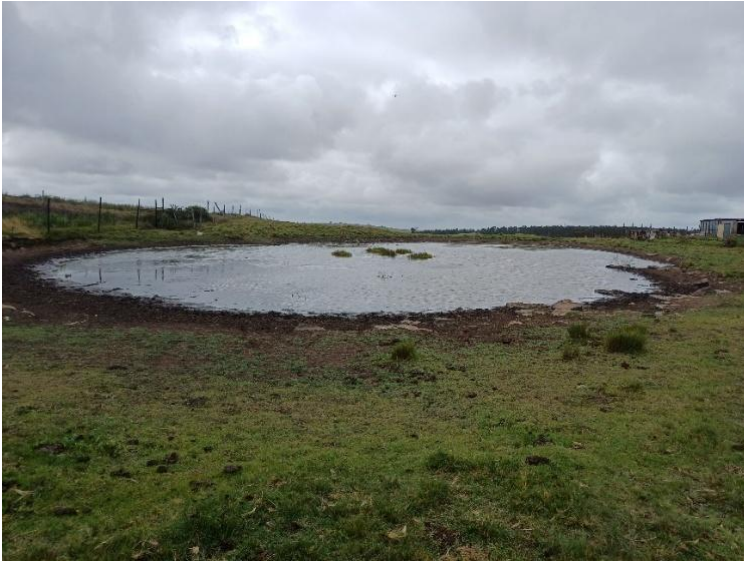
**Table 8-90 Depression 1 details (no direct crossing)**

Ngqamakhwe DEPR 1	Crossing No:	N/A	Quaternary Catchment	S70D	Map Reference	Figure 8-26
Habitat type	Depression Wetland		Latitude:	-32.2375382	Longitude:	27.9806389
Photograph

IHI/PES	Condition Score	Key current impacts				
	B	Minor grazing and trampling by livestock, infilling at the toe of the wetland.				
EIS Score	Low/Marginal EIS. The score is derived from the biodiversity maintenance ecological importance of the wetland due to the good ecological condition of B and the fact that it is considered endangered.					
Risks	Minor risks are posed to this wetland given that there are no direct crossings that are proposed for this wetland. Minor risks include increased runoff from a burst pipe in the catchment of the wetland or from sedimentation during the construction phase.

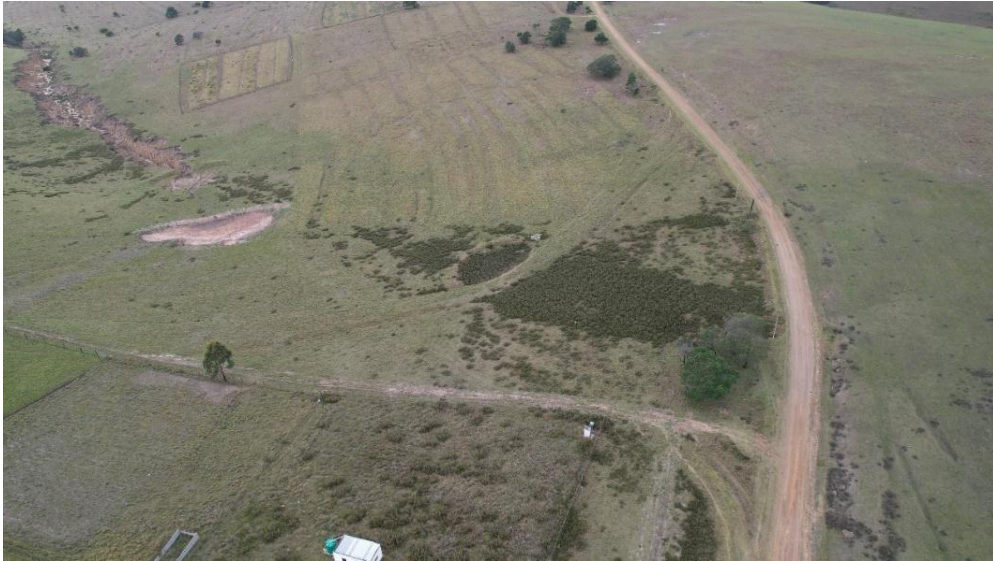
**Table 8-91 Seep 19 details (no direct crossing)**

Ngqamakhwe SEEP 19	Crossing No:	N/A	Quaternary Catchment	S70D	Map Reference	Figure 8-26
Habitat type	Hillslope Seep Wetland		Latitude:	-32.236309	Longitude:	27.990052
Photograph

IHI/PES	Condition Score	Key current impacts				
	C	Moderate grazing and trampling by livestock, erosion present at the toe of the wetland and invasive alien species present and a gravel road traversing the wetland.				
EIS Score	Moderate EIS. The score is derived from the biodiversity maintenance ecological importance of the wetland due to the relatively good ecological condition of C and the fact that it is ecologically connected to other wetlands and freshwater ecosystems of importance.					
Risks	Minor risks are posed to this wetland given that there are no direct crossings that are proposed for this wetland. Minor risks include increased runoff from a burst pipe in the catchment of the wetland or from sedimentation during the construction phase.

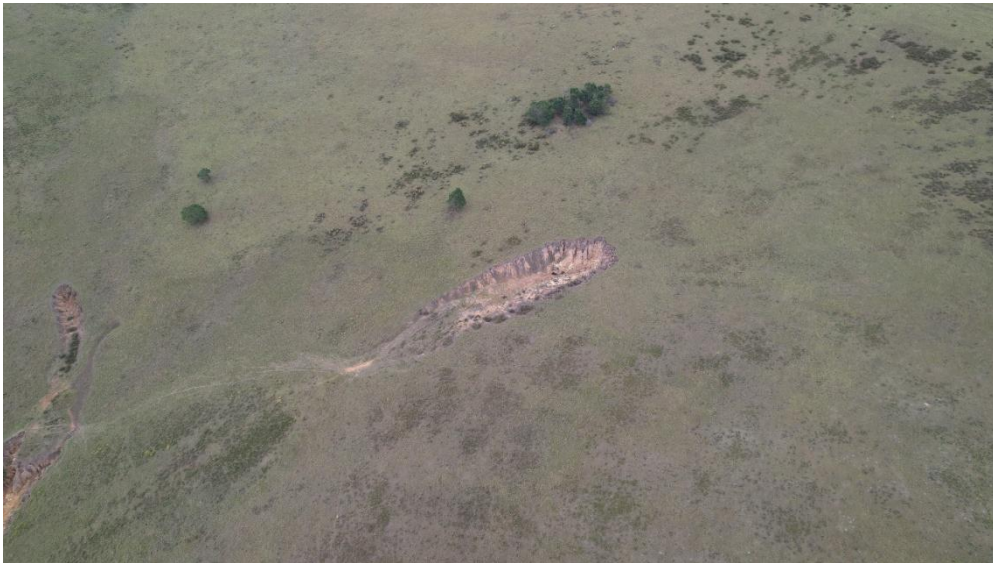
**Table 8-92 Seep 20 details (no direct crossing)**

Ngqamakhwe SEEP 20	Crossing No:	N/A	Quaternary Catchment	S70D	Map Reference	Figure 8-26
Habitat type	Hillslope Seep Wetland		Latitude:	-32.2410961	Longitude:	27.9827599
Photograph

IHI/PES	Condition Score	Key current impacts				
	C	Heavy grazing and trampling by livestock, erosion present within the wetland.				
EIS Score	Moderate EIS. The score is derived from the biodiversity maintenance ecological importance of the wetland due to the relatively good ecological condition of C and the fact that it is ecologically connected to other wetlands and freshwater ecosystems of importance.					
Risks	Minor risks are posed to this wetland given that there are no direct crossings that are proposed for this wetland. Minor risks include increased runoff from a burst pipe in the catchment of the wetland or from sedimentation during the construction phase.

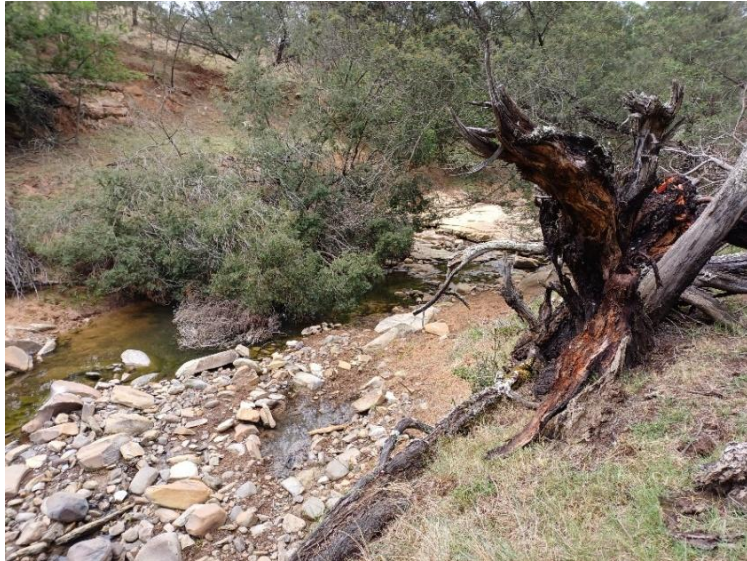
**Table 8-93 Upper foothills river 3 details (no direct crossing)**

Ngqamakhwe UFH 3	Crossing No:	N/A	Quaternary Catchment	S70D	Map Reference	Figure 8-27
Habitat type	Upper Foothills River		Latitude:	-32.238071	Longitude:	28.010717
Photograph

IHI/PES	Condition Score		Key current impacts			
	C/	D	Moderate bed and channel modification as well as invasive alien species within the stream system. Major invasive alien species, bank erosion and channel modification in the riparian area.			
EIS Score	Moderate EIS. The score is derived from the ecological importance of the Ngqamakhwe River					
Risks	Low risks associated with the proposed development given that the pipeline alignments will not cross this stream system at all. A low risk exists because the pipeline is located in the catchment of the stream system.

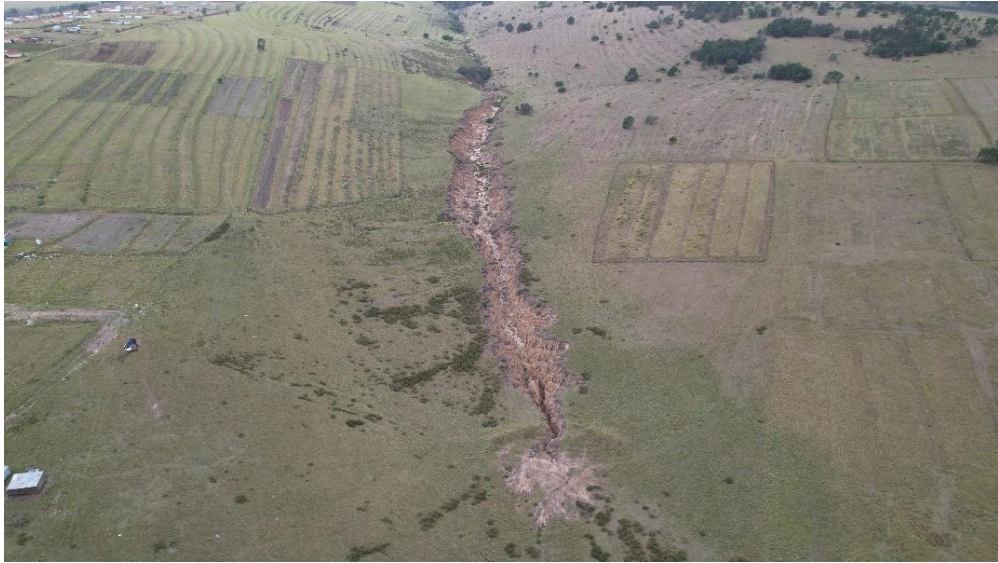
IHI/PES	Condition Score	Key current impacts				
	D	Moderate grazing and trampling by livestock, moderate erosion present and agriculture encroaching within the wetland.				
EIS Score	Moderate EIS. This score is derived from its ecological sensitivity and the fact that unchannelled valley-bottom wetlands are sensitive to changes in floods and extremely sensitive to the changes in low flows during the dry season.					
Risks	Minor risks are posed to this wetland given that there are no direct crossings that are proposed for this wetland. Minor risks include increased runoff from a burst pipe in the catchment of the wetland or from sedimentation during the construction phase.

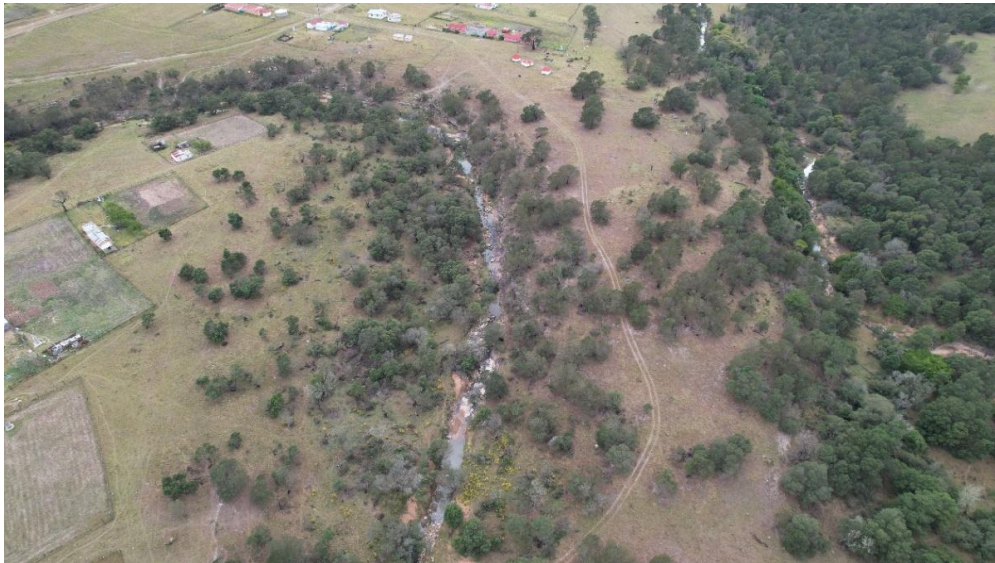
**Table 8-95 Upper foothills river 2 details (no direct crossing)**

Ngqamakhwe UFH 2	Crossing No:	N/A	Quaternary Catchment	S70D	Map Reference	Figure 8-28
Habitat type	Upper Foothills River		Latitude:	-32.2264899	Longitude:	27.9859325
Photograph

IHI/PES	Condition Score		Key current impacts			
	C/	D	Moderate bed and channel modification as well as invasive alien species within the stream system. Major invasive alien species, bank erosion and channel modification in the riparian area.			
EIS Score	Moderate EIS. The score is derived from the ecological importance of the stream as it is a tributary of the Ngqamakhwe River					
Risks	Low risks associated with the proposed development given that the pipeline alignments will not cross this stream system at all. A low risk exists because the pipeline is located in the catchment of the stream system.

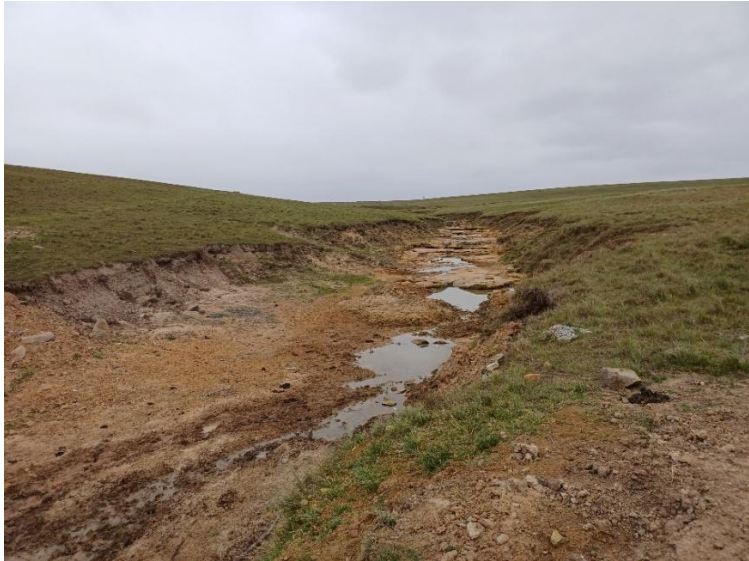
**Table 8-96 Mountain stream 13 details (no direct crossing)**

Ngqamakhwe MS 13	Crossing No:	N/A	Quaternary Catchment	S70D	Map Reference	Figure 8-29
Habitat type	Mountain Stream		Latitude:	-32.185211	Longitude:	28.010197
Photograph

IHI/PES	Condition Score	Key current impacts				
	E	Severe bed, channel and bed modification in the stream system.				
EIS Score	Moderate EIS. The score is derived from the ecological importance of the stream given it is a tributary of the Mtwaku River.					
Risks	Low risks associated with the proposed development given that the pipeline alignments will not cross this stream system at all. A low risk exists because the pipeline is located in the catchment of the stream system and within close proximity to the stream.

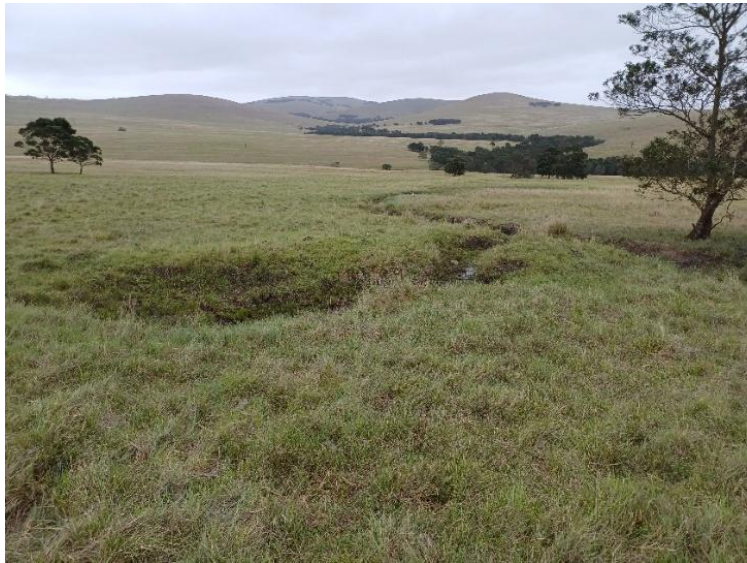
**Table 8-97 Seep 37 details (no direct crossing)**

Ngqamakhwe SEEP 37	Crossing No:	N/A	Quaternary Catchment	S70D	Map Reference	Figure 8-29
Habitat type	Hillslope Seep Wetland		Latitude:	-32.1968758	Longitude:	28.0044203
Photograph

IHI/PES	Condition Score	Key current impacts				
	C	Moderate grazing and trampling by livestock, erosion present at the toe of the wetland and invasive alien species present in the wetland.				
EIS Score	Moderate EIS. The score is derived from the biodiversity maintenance ecological importance of the wetland due to the relatively good ecological condition of C and the fact that it is ecologically connected to other wetlands and freshwater ecosystems of importance.					
Risks	Minor risks are posed to this wetland given that there are no direct crossings that are proposed for this wetland. Minor risks include increased runoff from a burst pipe in the catchment of the wetland or from sedimentation during the construction phase.

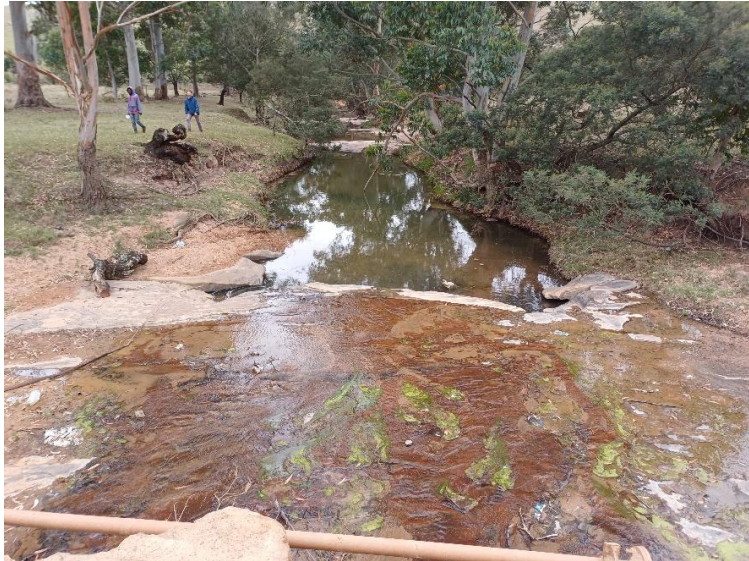
**Table 8-98 Upper foothills river 4 details (crossing S70D-14)**

Ngqamakhwe UFH 4	Crossing No:	S70D-14	Quaternary Catchment	S70D	Map Reference	Figure 8-29
Habitat type	Upper Foothills River		Latitude:	-32.1915493	Longitude:	28.0116338
Photograph

IHI/PES	Condition Score		Key current impacts			
	C/	D	Moderate bed and channel modification as well as invasive alien species within the stream system. Major invasive alien species, bank erosion and channel modification in the riparian area.			
EIS Score	Moderate EIS. The score is derived from the ecological importance of the Mtwaku River					
Risks	Moderate to low risks associated with the proposed pipeline alignment given that the pipeline will pass directly through the river at a point where disturbance already exists (i.e. road crossing). Provided that careful construction measures are followed, the risk should be low.

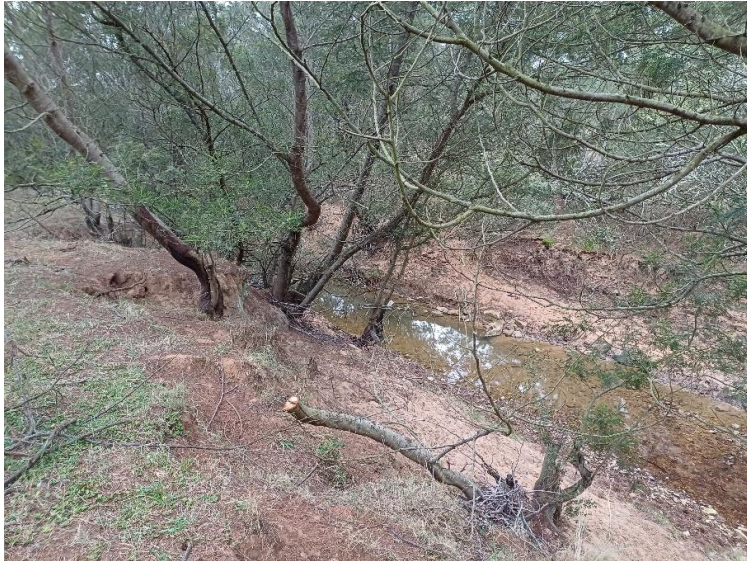
**Table 8-99 Upper foothills river 4 details (crossing S70D-15)**

Ngqamakhwe UFH 4	Crossing No:	S70D-15	Quaternary Catchment	S70D	Map Reference	Figure 8-29
Habitat type	Upper Foothills River		Latitude:	-32.193832	Longitude:	28.013165
Photograph

IHI/PES	Condition Score		Key current impacts			
	C/	D	Moderate bed and channel modification as well as invasive alien species within the stream system. Major invasive alien species, bank erosion and channel modification in the riparian area.			
EIS Score	Moderate EIS. The score is derived from the ecological importance of the Mtwaku River					
Risks	Moderate to low risks associated with the proposed pipeline alignment given that the pipeline will pass directly through the river at a point where conditions are already modified due to the presence of alien vegetation. Provided that careful construction measures are followed, the risk should be low.
