# NGQAMAKHWE WATER SUPPLY SCHEME - PHASE 3

## Aquatic Biodiversity Assessment

DRAFT REPORT

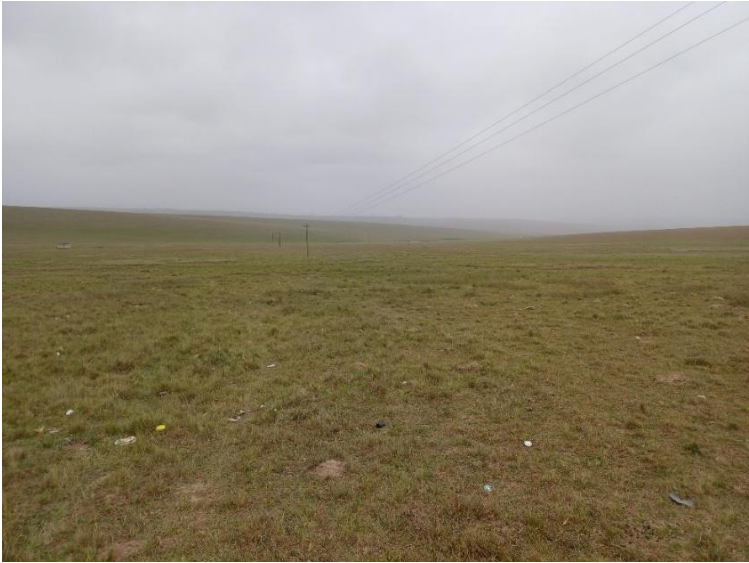
**Table 8-100 Seep 38 details (no direct crossing)**

Ngqamakhwe SEEP 38	Crossing No:	N/A	Quaternary Catchment	S70C	Map Reference	Figure 8-30
Habitat type	Hillslope Seep Wetland		Latitude:	-32.167892	Longitude:	28.010658
Photograph

IHI/PES	Condition Score	Key current impacts				
	C	Moderate grazing and trampling by livestock, minor erosion present.				
EIS Score	Moderate EIS. The score is derived from the biodiversity maintenance ecological importance of the wetland due to the relatively good ecological condition of C and the fact that it is ecologically connected to other wetlands and freshwater ecosystems of importance.					
Risks	Minor risks are posed to this wetland given that there are no direct crossings that are proposed for this wetland. Minor risks include increased runoff from a burst pipe in the catchment of the wetland or from sedimentation during the construction phase.

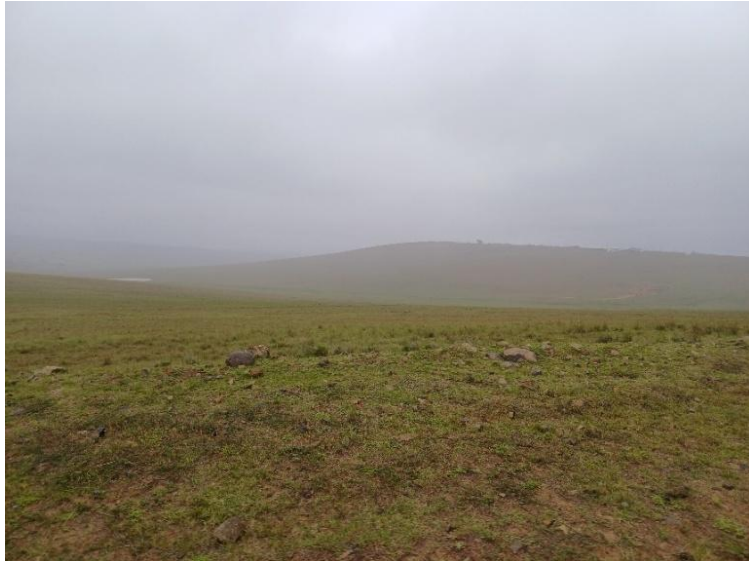
**Table 8-101 Hillslope Seep 39 details (no direct crossing)**

Ngqamakhwe SEEP 39	Crossing No:	N/A	Quaternary Catchment	S70C	Map Reference	Figure 8-30
Habitat type	Hillslope Seep Wetland		Latitude:	-32.168125	Longitude:	28.021482
Photograph

IHI/PES	Condition Score	Key current impacts				
	C	Moderate grazing and trampling by livestock, minor erosion present.				
EIS Score	Moderate EIS. The score is derived from the biodiversity maintenance ecological importance of the wetland due to the relatively good ecological condition of C and the fact that it is ecologically connected to other wetlands and freshwater ecosystems of importance.					
Risks	Minor risks are posed to this wetland given that there are no direct crossings that are proposed for this wetland. Minor risks include increased runoff from a burst pipe in the catchment of the wetland or from sedimentation during the construction phase.

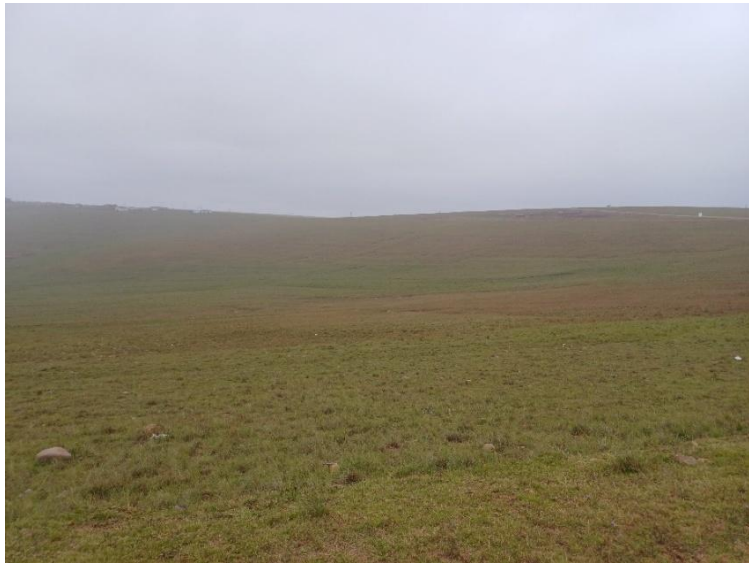
**Table 8-102 Seep 40 details (no direct crossing)**

Ngqamakhwe SEEP 40	Crossing No:	N/A	Quaternary Catchment	S70C	Map Reference	Figure 8-30
Habitat type	Hillslope Seep Wetland		Latitude:	-32.168412	Longitude:	28.030337
Photograph

IHI/PES	Condition Score	Key current impacts				
	C	Moderate grazing and trampling by livestock, minor erosion present.				
EIS Score	Moderate EIS. The score is derived from the biodiversity maintenance ecological importance of the wetland due to the relatively good ecological condition of C and the fact that it is ecologically connected to other wetlands and freshwater ecosystems of importance.					
Risks	Minor risks are posed to this wetland given that there are no direct crossings that are proposed for this wetland. Minor risks include increased runoff from a burst pipe in the catchment of the wetland or from sedimentation during the construction phase.

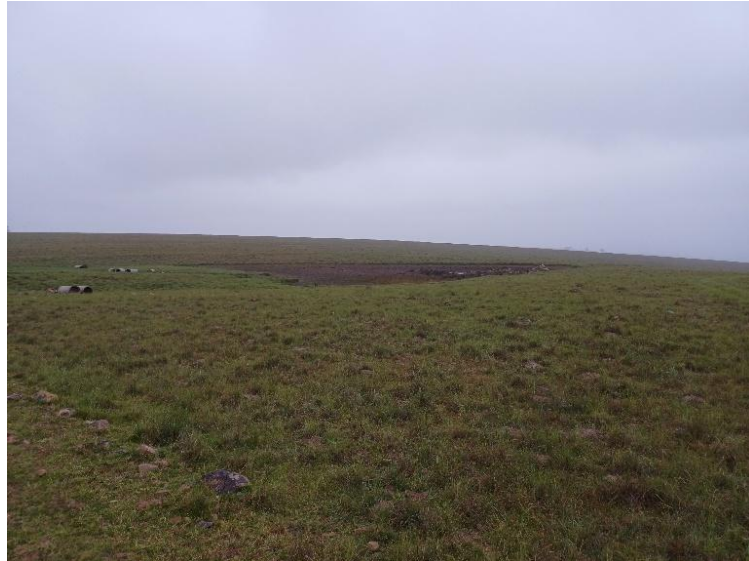
**Table 8-104 Depression 7 details (no direct crossing)**

Ngqamakhwe DEPR 7	Crossing No:	N/A	Quaternary Catchment	S70D	Map Reference	Figure 8-31
Habitat type	Depression Wetland		Latitude:	-32.175907	Longitude:	28.051955
Photograph

IHI/PES	Condition Score	Key current impacts				
	B	Minor grazing and trampling by livestock.				
EIS Score	High EIS. The score is derived from the biodiversity maintenance ecological importance of the wetland due to the good ecological condition of B and the fact that it is considered a high priority wetland.					
Risks	Minor risks are posed to this wetland given that there are no direct crossings that are proposed for this wetland. Minor risks include increased runoff from a burst pipe in the catchment of the wetland or from sedimentation during the construction phase.

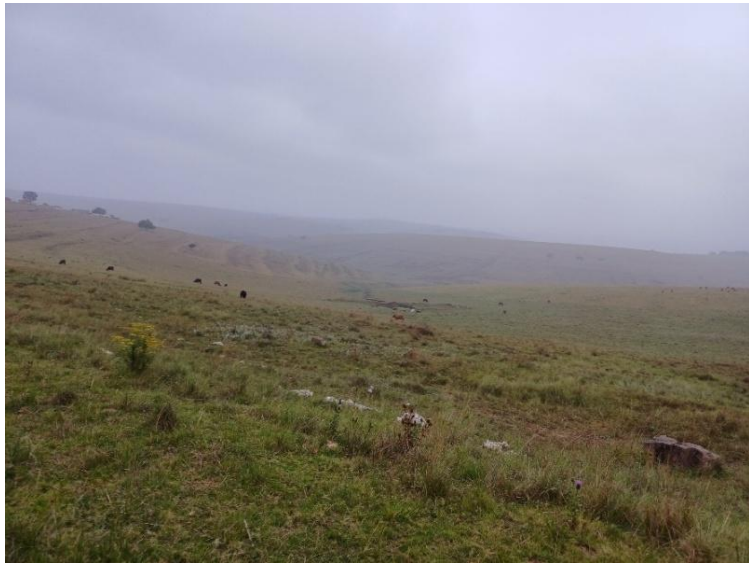
**Table 8-105 Seep 41 details (no direct crossing)**

Ngqamakhwe SEEP 41	Crossing No:	N/A	Quaternary Catchment	S70D	Map Reference	Figure 8-31
Habitat type	Hillslope Seep Wetland		Latitude:	-32.185913	Longitude:	28.036130
Photograph

IHI/PES	Condition Score	Key current impacts				
	C	Heavy grazing and trampling by livestock, minor erosion present.				
EIS Score	Moderate EIS. The score is derived from the biodiversity maintenance ecological importance of the wetland due to the relatively good ecological condition of C and the fact that it is ecologically connected to other wetlands and freshwater ecosystems of importance.					
Risks	Minor risks are posed to this wetland given that there are no direct crossings that are proposed for this wetland. Minor risks include increased runoff from a burst pipe in the catchment of the wetland or from sedimentation during the construction phase.

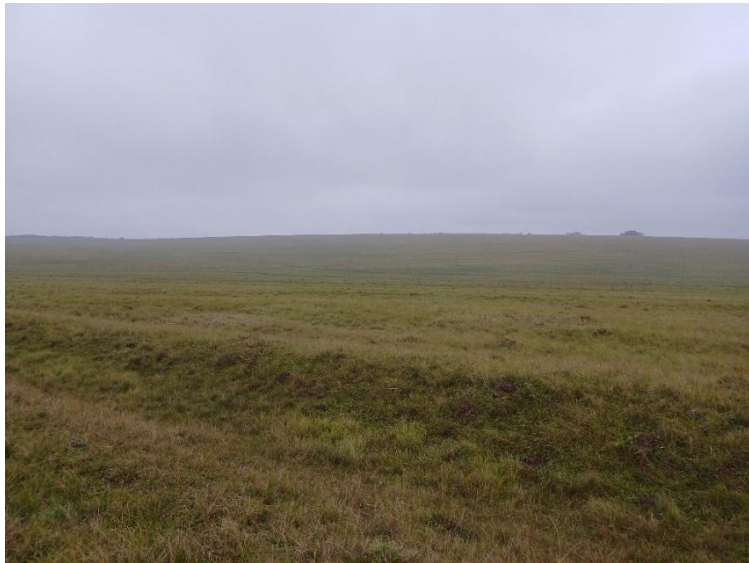
**Table 8-106 Seep 42 details (no direct crossing)**

Ngqamakhwe SEEP 42	Crossing No:	N/A	Quaternary Catchment	S70D	Map Reference	Figure 8-31
Habitat type	Hillslope Seep Wetland		Latitude:	-32.171055	Longitude:	28.047001
Photograph

IHI/PES	Condition Score	Key current impacts				
	C	Moderate grazing and trampling by livestock, minor erosion present.				
EIS Score	Moderate EIS. The score is derived from the biodiversity maintenance ecological importance of the wetland due to the relatively good ecological condition of C and the fact that it is ecologically connected to other wetlands and freshwater ecosystems of importance.					
Risks	Minor risks are posed to this wetland given that there are no direct crossings that are proposed for this wetland. Minor risks include increased runoff from a burst pipe in the catchment of the wetland or from sedimentation during the construction phase.

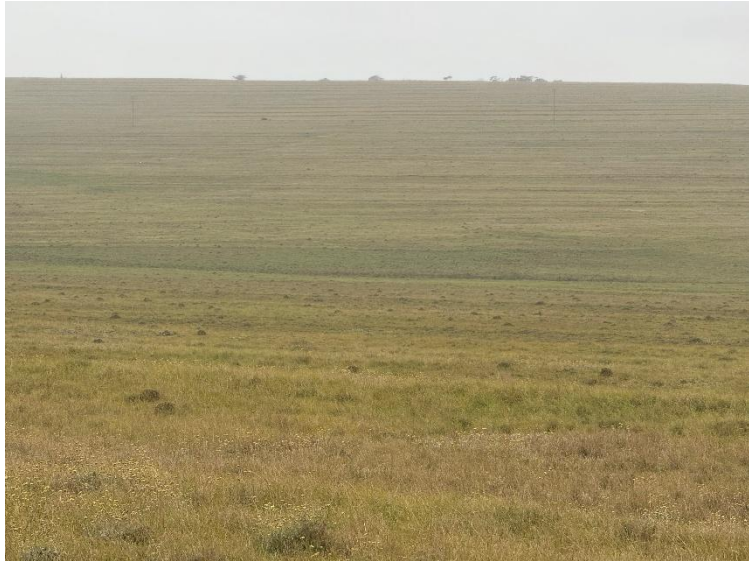
**Table 8-107 Seep 43 details (no direct crossing)**

Ngqamakhwe SEEP 43	Crossing No:	N/A	Quaternary Catchment	S70D	Map Reference	Figure 8-31
Habitat type	Hillslope Seep Wetland		Latitude:	-32.1763711	Longitude:	28.0431385
Photograph

IHI/PES	Condition Score	Key current impacts				
	C	Heavy grazing and trampling by livestock, minor erosion present.				
EIS Score	Moderate EIS. The score is derived from the biodiversity maintenance ecological importance of the wetland due to the relatively good ecological condition of C and the fact that it is ecologically connected to other wetlands and freshwater ecosystems of importance.					
Risks	Minor risks are posed to this wetland given that there are no direct crossings that are proposed for this wetland. Minor risks include increased runoff from a burst pipe in the catchment of the wetland or from sedimentation during the construction phase.

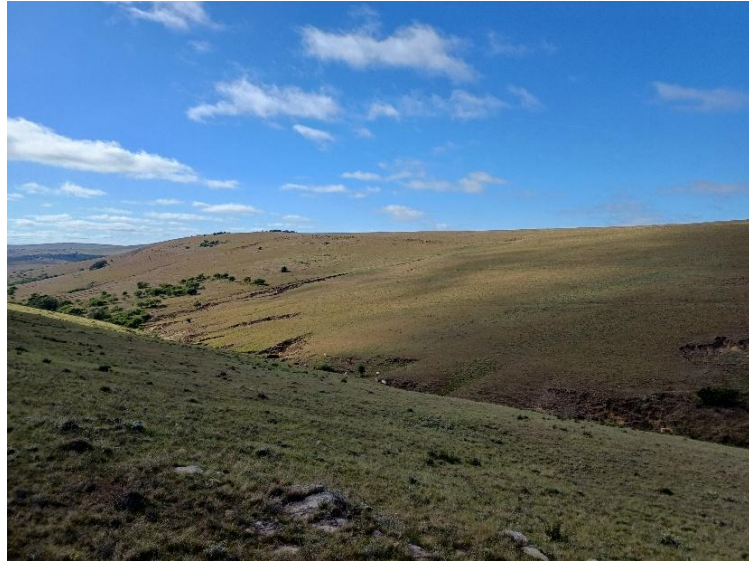
**Table 8-108 Mountain headwater stream 17 details (no direct crossing)**

Ngqamakhwe MHS 17	Crossing No:	N/A	Quaternary Catchment	S70D	Map Reference	Figure 8-32
Habitat type	Mountain Headwater Stream		Latitude:	-32.216902	Longitude:	28.019099
Photograph

IHI/PES	Condition Score	Key current impacts				
	F	Severe bank erosion, invasive alien plant infestation as well as channel modification within the riparian area of the stream.				
EIS Score	Moderate EIS. The score is derived from the ecological importance of the stream given it is a tributary of the Mtwaku River.					
Risks	Low risks associated with the proposed development given that the pipeline alignments will not cross this stream system at all. A low risk exists because the pipeline is located in the catchment of the stream system.

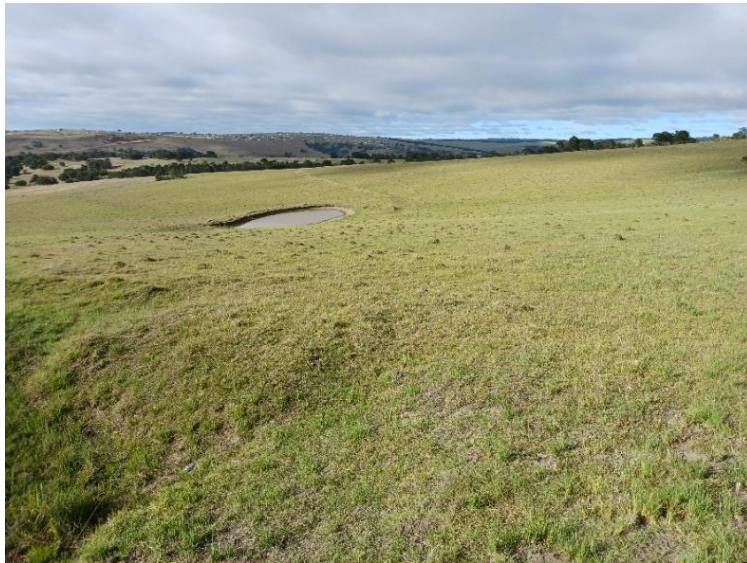
**Table 8-109 Seep 44 details (no direct crossing)**

Ngqamakhwe SEEP 44	Crossing No:	N/A	Quaternary Catchment	S70D	Map Reference	Figure 8-32
Habitat type	Hillslope Seep Wetland		Latitude:	-32.212555	Longitude:	28.003430
Photograph

IHI/PES	Condition Score	Key current impacts				
	C	Moderate grazing and trampling by livestock, minor erosion and invasive alien plants present. There is also a dam present in the wetland.				
EIS Score	Moderate EIS. The score is derived from the biodiversity maintenance ecological importance of the wetland due to the relatively good ecological condition of C and the fact that it is ecologically connected to other wetlands and freshwater ecosystems of importance.					
Risks	Minor risks are posed to this wetland given that there are no direct crossings that are proposed for this wetland. Minor risks include increased runoff from a burst pipe in the catchment of the wetland or from sedimentation during the construction phase.

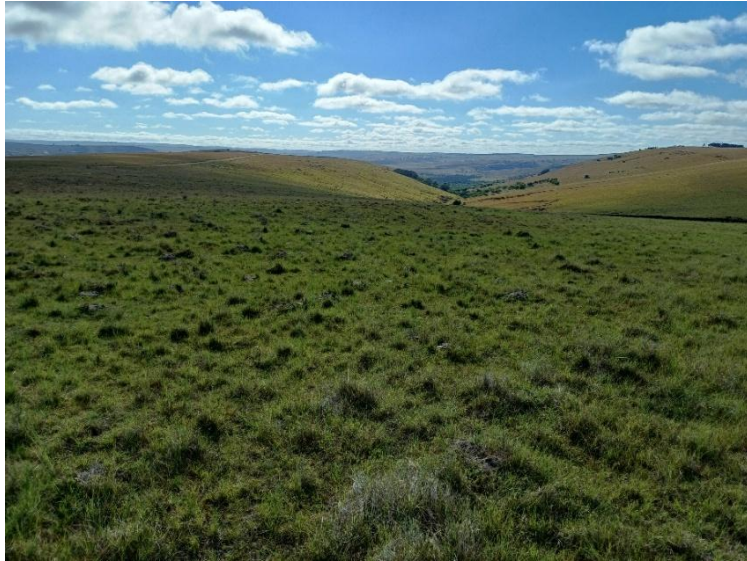
**Table 8-110 Seep 45 details (no direct crossing)**

Ngqamakhwe SEEP 45	Crossing No:	N/A	Quaternary Catchment	S70D	Map Reference	Figure 8-32
Habitat type	Hillslope Seep Wetland		Latitude:	-32.214942	Longitude:	28.013816
Photograph

IHI/PES	Condition Score	Key current impacts				
	C	Moderate grazing and trampling by livestock, major erosion a dam present at the toe of the wetland.				
EIS Score	Moderate EIS. The score is derived from the biodiversity maintenance ecological importance of the wetland due to the relatively good ecological condition of C and the fact that it is ecologically connected to other wetlands and freshwater ecosystems of importance.					
Risks	Minor risks are posed to this wetland given that there are no direct crossings that are proposed for this wetland. Minor risks include increased runoff from a burst pipe in the catchment of the wetland or from sedimentation during the construction phase.

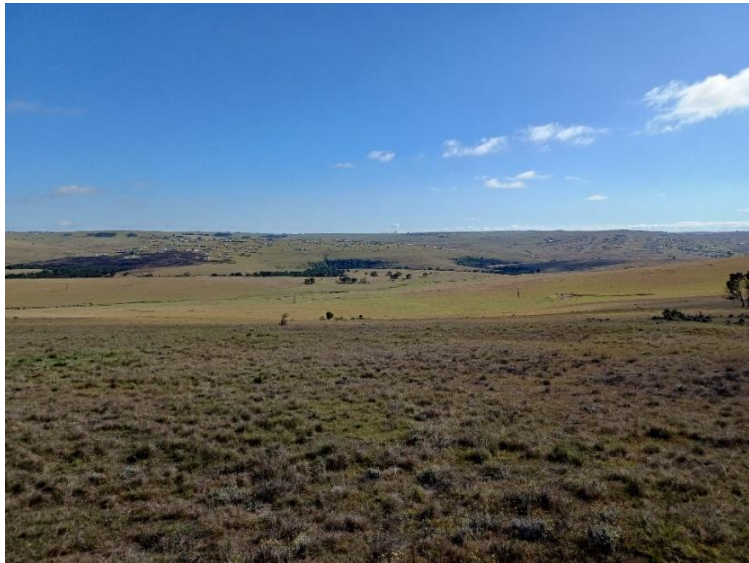
**Table 8-111 Seep 46 details (no direct crossing)**

Ngqamakhwe SEEP 46	Crossing No:	N/A	Quaternary Catchment	S70D	Map Reference	Figure 8-32
Habitat type	Hillslope Seep Wetland		Latitude:	-32.213323	Longitude:	28.028084
Photograph

IHI/PES	Condition Score	Key current impacts				
	C	Heavy grazing and trampling by livestock, dam present within the wetland.				
EIS Score	Moderate EIS. The score is derived from the biodiversity maintenance ecological importance of the wetland due to the relatively good ecological condition of C and the fact that it is ecologically connected to other wetlands and freshwater ecosystems of importance.					
Risks	Minor risks are posed to this wetland given that there are no direct crossings that are proposed for this wetland. Minor risks include increased runoff from a burst pipe in the catchment of the wetland or from sedimentation during the construction phase.

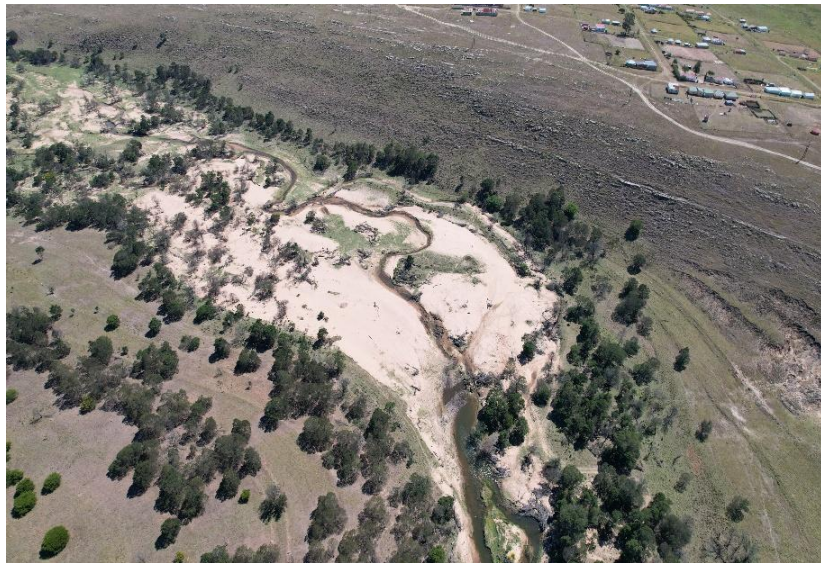
**Table 8-112 Floodplain 1 details (crossing S70D-16)**

Ngqamakhwe FLOOD 1	Crossing No:	S70D-16	Quaternary Catchment	S70D	Map Reference	Figure 8-33
Habitat type	Floodplain Wetland		Latitude:	-32.227650	Longitude:	28.041845
Photograph

IHI/PES	Condition Score	Key current impacts				
	D	Heavy grazing and trampling by livestock, invasive alien species present and a large amount of deposition present within the wetland.				
EIS Score	Moderate EIS. This score is derived from its ecological sensitivity and the fact that floodplain wetlands are extremely sensitive to changes in floods and the changes in low flows during the dry season.					
Risks	Moderate to low risks associated with the proposed pipeline alignment given that the pipeline will pass directly through the central portion of the wetland. The crossing point is located on an existing disturbance (i.e. a road crossing). Provided that careful construction measures are followed and the gentle gradient of the wetland, the risk should be low.

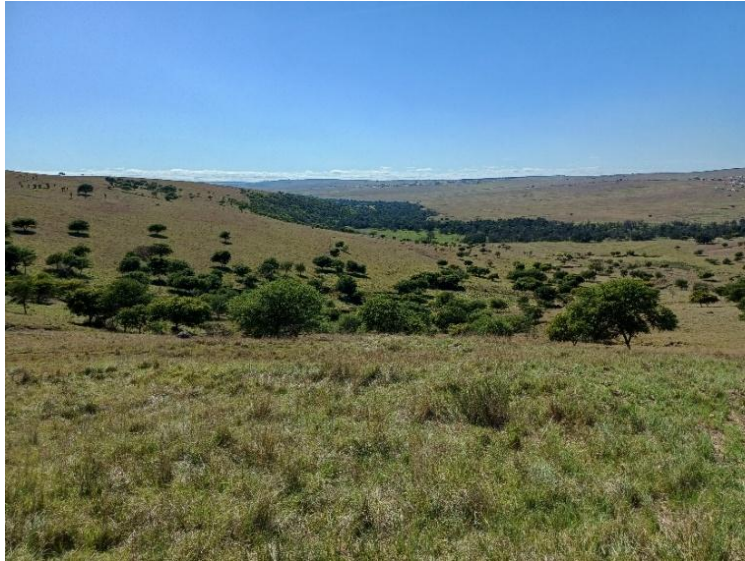
**Table 8-113 Seep 47 details (no direct crossing)**

Ngqamakhwe SEEP 47	Crossing No:	N/A	Quaternary Catchment	S70D	Map Reference	Figure 8-33
Habitat type	Hillslope Seep Wetland		Latitude:	-32.220867	Longitude:	28.041015
Photograph

IHI/PES	Condition Score	Key current impacts				
	C	Moderate grazing and trampling by livestock, erosion, invasive alien plant species and historical agriculture present within the wetland.				
EIS Score	Moderate EIS. The score is derived from the biodiversity maintenance ecological importance of the wetland due to the relatively good ecological condition of C and the fact that it is ecologically connected to other wetlands and freshwater ecosystems of importance.					
Risks	Minor risks are posed to this wetland given that there are no direct crossings that are proposed for this wetland. Minor risks include increased runoff from a burst pipe in the catchment of the wetland or from sedimentation during the construction phase.

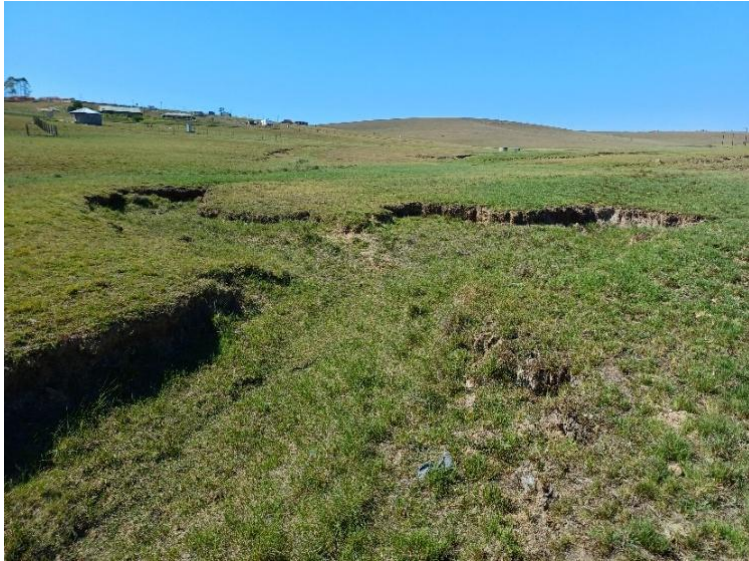
**Table 8-114 Channelled valley-bottom 4 details (crossing S70D-17)**

Ngqamakhwe CVB 4	Crossing No:	S70D-17	Quaternary Catchment	S70D	Map Reference	Figure 8-34
Habitat type	Channelled Valley-Bottom Wetland		Latitude:	-32.2333738	Longitude:	28.0466044
Photograph

IHI/PES	Condition Score	Key current impacts				
	C	Moderate grazing and trampling by livestock. Minor erosion present and infilling associated with a gravel road crossing through the centre of the wetland.				
EIS Score	High EIS. The score is derived from the biodiversity maintenance ecological importance of the wetland due to the relatively good ecological condition of C and the fact that it is ecologically connected to other wetlands and freshwater ecosystems of importance.					
Risks	Moderate to low risks associated with the proposed pipeline alignment given that the pipeline will pass directly through the central portion of the wetland. The crossing point is located on an existing disturbance (i.e. a road crossing). Provided that careful construction measures are followed and the gentle gradient of the wetland, the risk should be low.

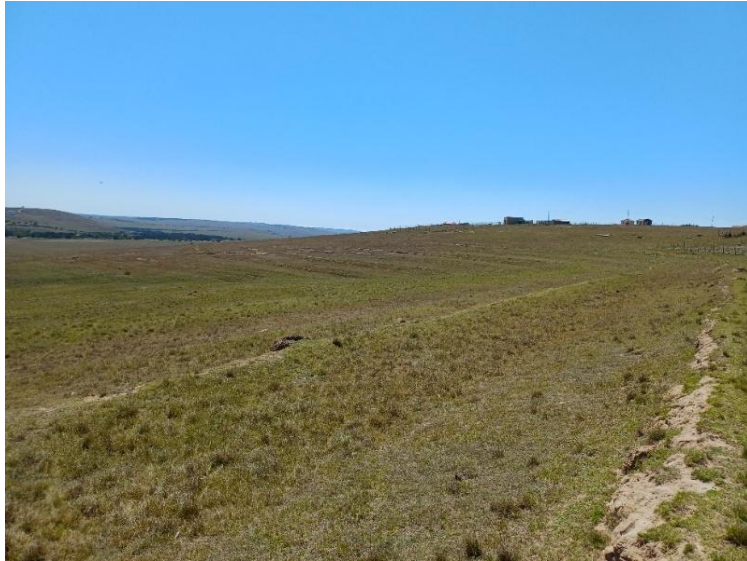
**Table 8-115 Seep 58 details (no direct crossing)**

Ngqamakhwe SEEP 58	Crossing No:	N/A	Quaternary Catchment	S70D	Map Reference	Figure 8-34
Habitat type	Hillslope Seep Wetland		Latitude:	-32.233382	Longitude:	28.053191
Photograph

IHI/PES	Condition Score	Key current impacts				
	C	Moderate grazing and trampling by livestock, erosion and historical agriculture present within the wetland.				
EIS Score	Moderate EIS. The score is derived from the biodiversity maintenance ecological importance of the wetland due to the relatively good ecological condition of C and the fact that it is ecologically connected to other wetlands and freshwater ecosystems of importance.					
Risks	Minor risks are posed to this wetland given that there are no direct crossings that are proposed for this wetland. Minor risks include increased runoff from a burst pipe in the catchment of the wetland or from sedimentation during the construction phase.

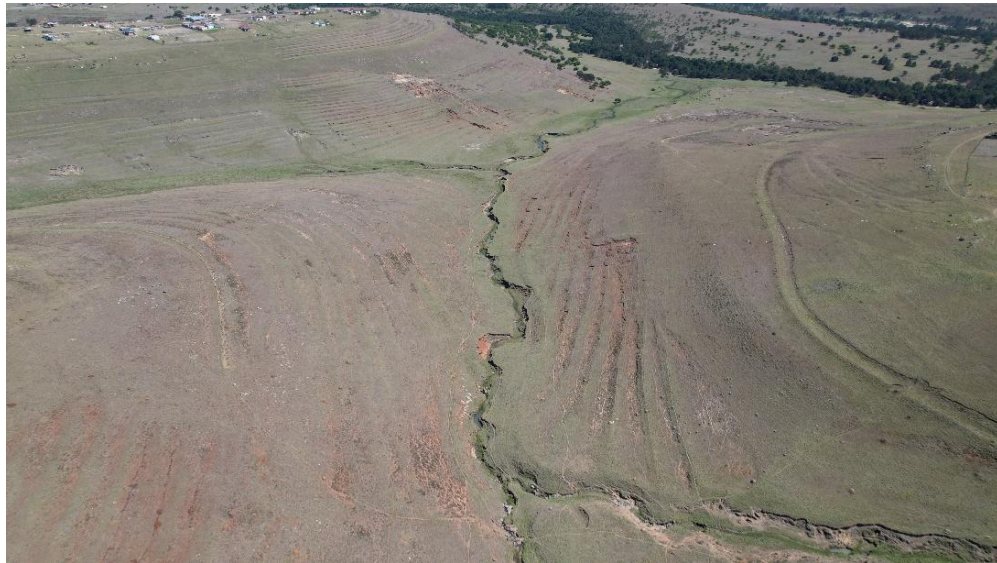
IHI/PES	Condition Score	Key current impacts				
	B	Moderate bed and channel modification within the stream system, as well as bank modification.				
EIS Score	Moderate EIS. The score is derived from the ecological importance of the stream given it is a tributary of the Ngqamakhwe River.					
Risks	Low risks associated with the proposed development given that the pipeline alignments will not cross this stream system at all. A low risk exists because the pipeline is located in the catchment of the stream system and within close proximity to the stream.

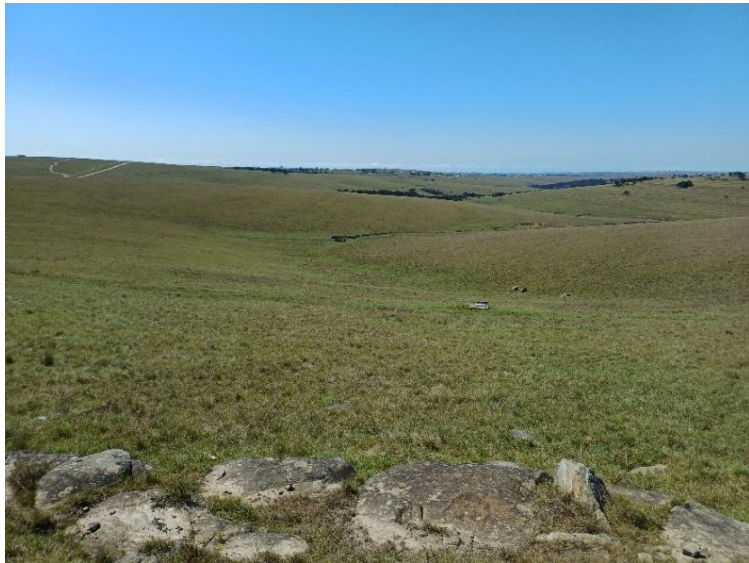
**Table 8-117 Seep 49 details (no direct crossing)**

Ngqamakhwe SEEP 49	Crossing No:	N/A	Quaternary Catchment	S70E	Map Reference	Figure 8-35
Habitat type	Hillslope Seep Wetland		Latitude:	-32.250253	Longitude:	28.047017
Photograph

IHI/PES	Condition Score	Key current impacts				
	C	Heavy grazing and trampling by livestock, minor erosion present within the wetland.				
EIS Score	Moderate EIS. The score is derived from the biodiversity maintenance ecological importance of the wetland due to the relatively good ecological condition of C and the fact that it is ecologically connected to other wetlands and freshwater ecosystems of importance.					
Risks	Minor risks are posed to this wetland given that there are no direct crossings that are proposed for this wetland. Minor risks include increased runoff from a burst pipe in the catchment of the wetland or from sedimentation during the construction phase.

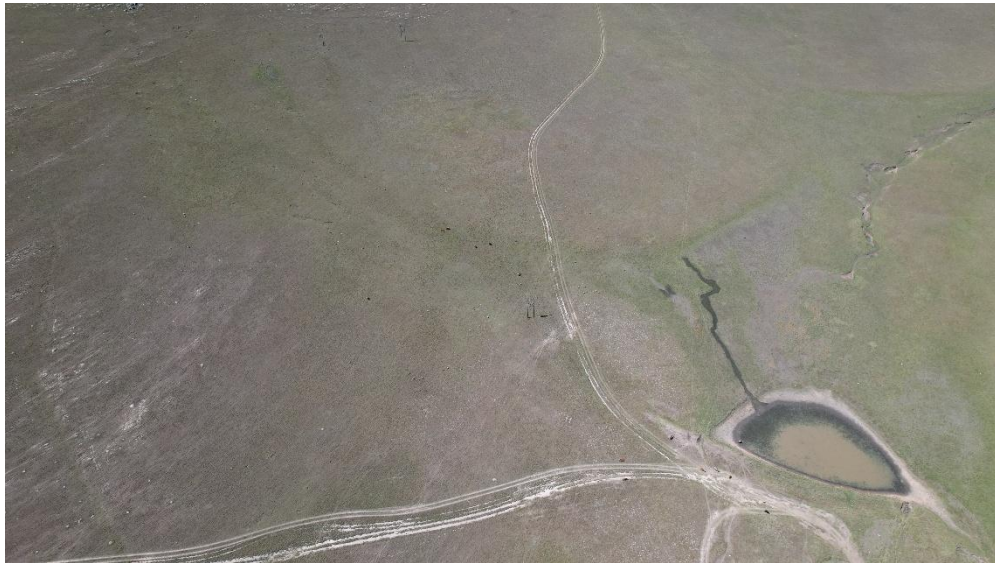
**Table 8-119 Seep 51 details (no direct crossing)**

Ngqamakhwe SEEP 51	Crossing No:	N/A	Quaternary Catchment	S70D	Map Reference	Figure 8-35
Habitat type	Hillslope Seep Wetland		Latitude:	-32.246282	Longitude:	28.043132
Photograph

IHI/PES	Condition Score	Key current impacts				
	C	Moderate grazing and trampling by livestock, minor erosion present.				
EIS Score	Moderate EIS. The score is derived from the biodiversity maintenance ecological importance of the wetland due to the relatively good ecological condition of C and the fact that it is ecologically connected to other wetlands and freshwater ecosystems of importance.					
Risks	Minor risks are posed to this wetland given that there are no direct crossings that are proposed for this wetland. Minor risks include increased runoff from a burst pipe in the catchment of the wetland or from sedimentation during the construction phase.

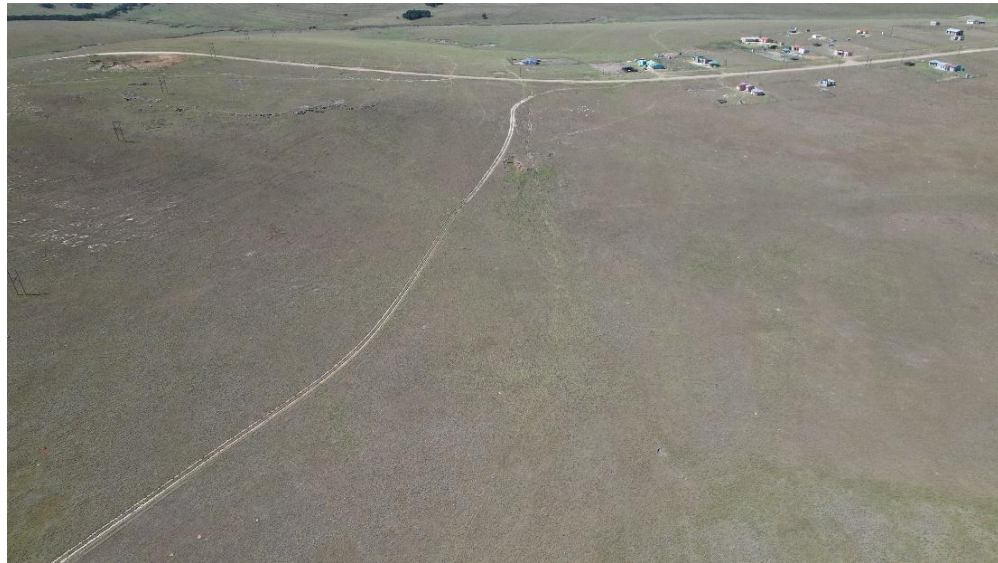
IHI/PES	Condition Score	Key current impacts					
	C	Moderate grazing and trampling by livestock, minor erosion present.					
EIS Score	Moderate EIS. The score is derived from the biodiversity maintenance ecological importance of the wetland due to the relatively good ecological condition of C and the fact that it is ecologically connected to other wetlands and freshwater ecosystems of importance.						
Risks	Minor risks are posed to this wetland given that there are no direct crossings that are proposed for this wetland. Minor risks include increased runoff from a burst pipe in the catchment of the wetland or from sedimentation during the construction phase.

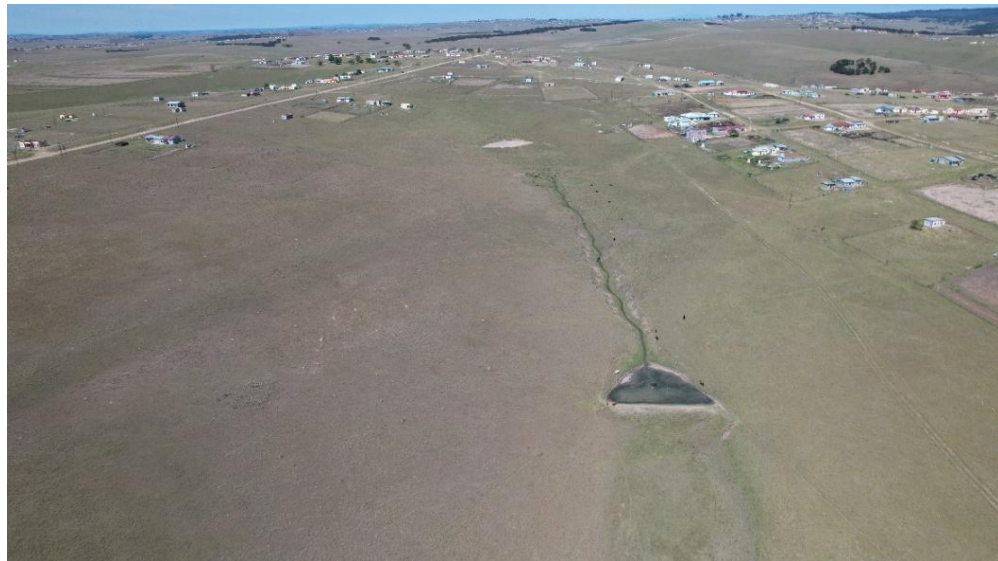
**Table 8-121 Seep 53 details (no direct crossing)**

Ngqamakhwe SEEP 53		Crossing No:	N/A	Quaternary Catchment	S70D	Map Reference	Figure 8-35
Habitat type	Hillslope Seep Wetland			Latitude:	-32.248237	Longitude:	28.035361
Photograph

IHI/PES	Condition Score	Key current impacts					
	C	Moderate grazing and trampling by livestock, minor erosion present and three dams located within the wetland.					
EIS Score	Moderate EIS. The score is derived from the biodiversity maintenance ecological importance of the wetland due to the relatively good ecological condition of C and the fact that it is ecologically connected to other wetlands and freshwater ecosystems of importance.						
Risks	Minor risks are posed to this wetland given that there are no direct crossings that are proposed for this wetland. Minor risks include increased runoff from a burst pipe in the catchment of the wetland or from sedimentation during the construction phase.

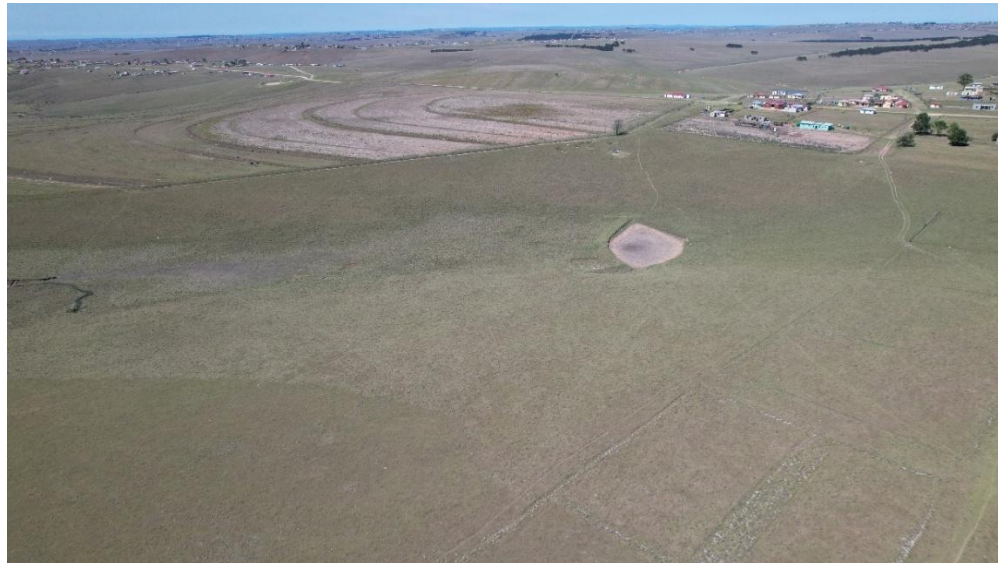
IHI/PES	Condition Score	Key current impacts					
	C	Moderate grazing and trampling by livestock, erosion and a dam present within the wetland.					
EIS Score	Moderate EIS. The score is derived from the biodiversity maintenance ecological importance of the wetland due to the relatively good ecological condition of C and the fact that it is ecologically connected to other wetlands and freshwater ecosystems of importance.						
Risks	Minor risks are posed to this wetland given that there are no direct crossings that are proposed for this wetland. Minor risks include increased runoff from a burst pipe in the catchment of the wetland or from sedimentation during the construction phase.

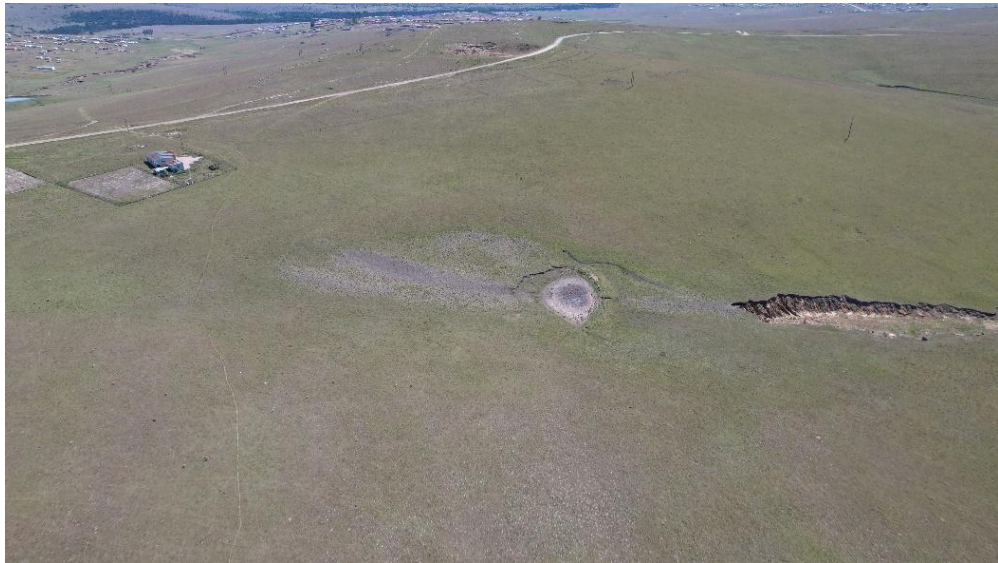
IHI/PES	Condition Score	Key current impacts				
	C	Moderate grazing and trampling by livestock, erosion and a dam present within the wetland.				
EIS Score	Moderate EIS. The score is derived from the biodiversity maintenance ecological importance of the wetland due to the relatively good ecological condition of C and the fact that it is ecologically connected to other wetlands and freshwater ecosystems of importance.					
Risks	Minor risks are posed to this wetland given that there are no direct crossings that are proposed for this wetland. Minor risks include increased runoff from a burst pipe in the catchment of the wetland or from sedimentation during the construction phase.

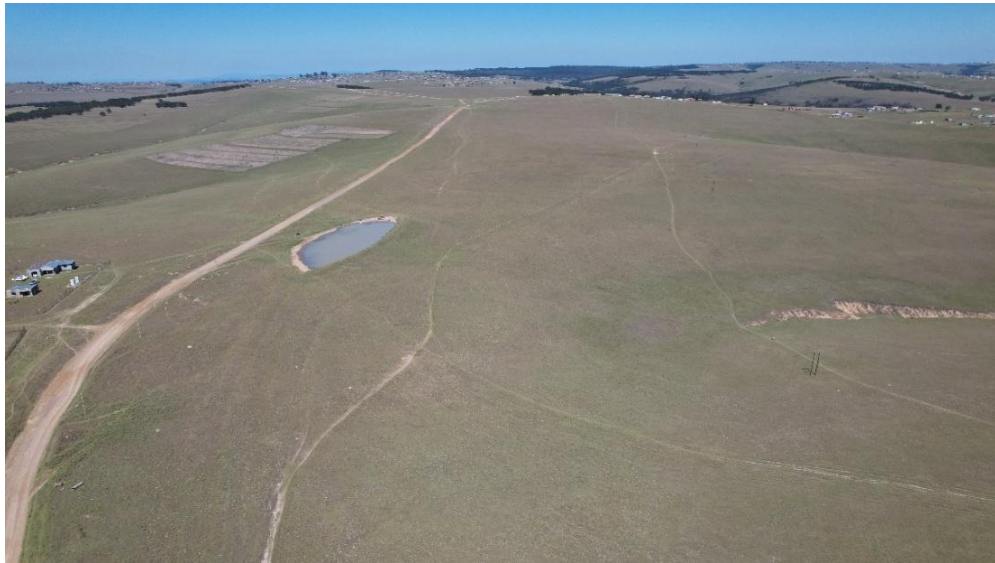
**Table 8-124 Seep 56 details (no direct crossing)**

Ngqamakhwe SEEP 56	Crossing No:	N/A	Quaternary Catchment	S70D	Map Reference	Figure 8-35
Habitat type	Hillslope Seep Wetland	Latitude:		-32.252466	Longitude:	28.025217
Photograph

IHI/PES	Condition Score	Key current impacts				
	C	Moderate grazing and trampling by livestock, erosion present within the wetland.				
EIS Score	Moderate EIS. The score is derived from the biodiversity maintenance ecological importance of the wetland due to the relatively good ecological condition of C and the fact that it is ecologically connected to other wetlands and freshwater ecosystems of importance.					
Risks	Minor risks are posed to this wetland given that there are no direct crossings that are proposed for this wetland. Minor risks include increased runoff from a burst pipe in the catchment of the wetland or from sedimentation during the construction phase.

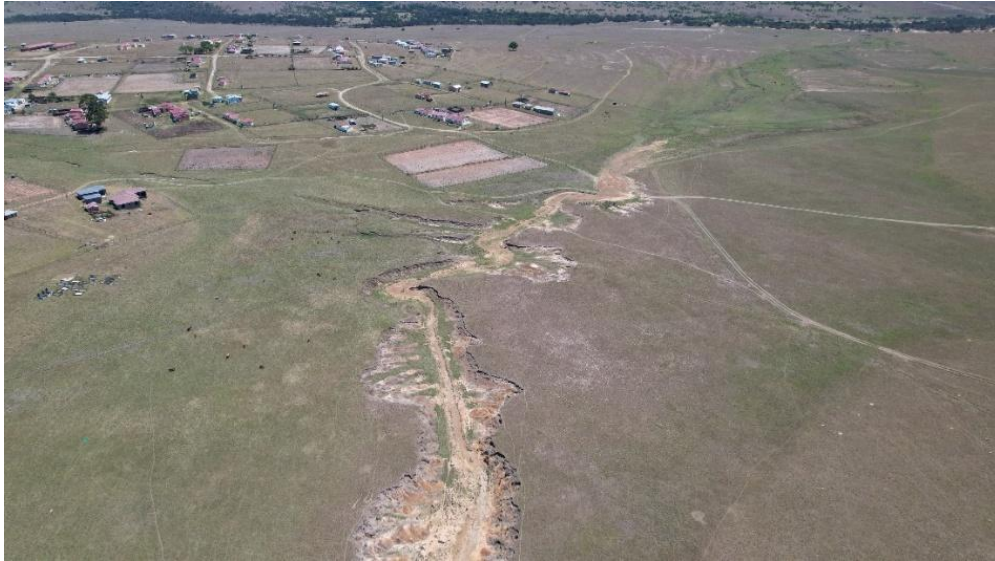
**Table 8-125 Channelled valley-bottom 2 details (no direct crossing)**

Ngqamakhwe CVB 2	Crossing No:	N/A	Quaternary Catchment	S70D	Map Reference	Figure 8-36
Habitat type	Channelled Valley-Bottom Wetland		Latitude:	-32.239333	Longitude:	28.061026
Photograph

IHI/PES	Condition Score	Key current impacts				
	C	Heavy grazing and trampling by livestock. Major erosion present within the wetland and the banks surrounding it.				
EIS Score	High EIS. The score is derived from the biodiversity maintenance ecological importance of the wetland due to the relatively good ecological condition of C and the fact that it is ecologically connected to other wetlands and freshwater ecosystems of importance.					
Risks	Minor risks are posed to this wetland given that there are no direct crossings that are proposed for this wetland. Minor risks include increased runoff from a burst pipe in the catchment of the wetland or from sedimentation during the construction phase.

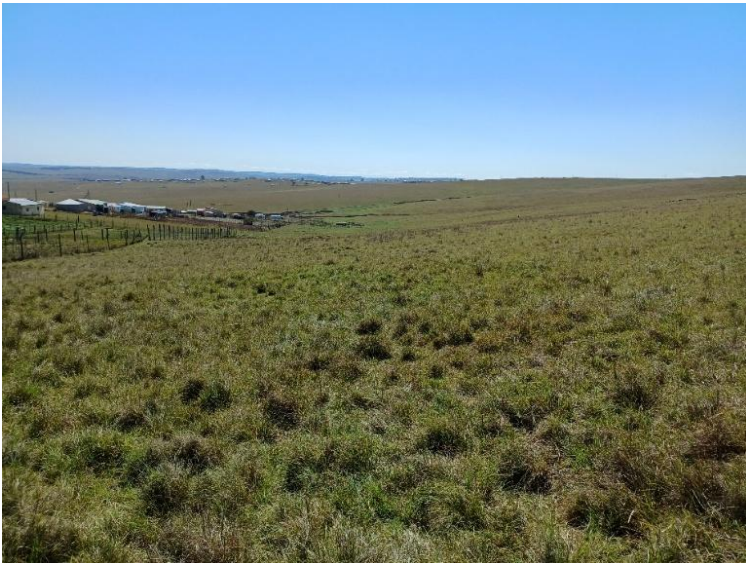
**Table 8-126 Seep 48 details (no direct crossing)**

Ngqamakhwe SEEP 48	Crossing No:	N/A	Quaternary Catchment	S70D	Map Reference	Figure 8-36
Habitat type	Hillslope Seep Wetland		Latitude:	-32.246630	Longitude:	28.051358
Photograph

IHI/PES	Condition Score	Key current impacts				
	C	Moderate grazing and trampling by livestock, major erosion present within the wetland. Surrounding dwellings have also encroached within the wetland.				
EIS Score	Moderate EIS. The score is derived from the biodiversity maintenance ecological importance of the wetland due to the relatively good ecological condition of C and the fact that it is ecologically connected to other wetlands and freshwater ecosystems of importance.					
Risks	Minor risks are posed to this wetland given that there are no direct crossings that are proposed for this wetland. Minor risks include increased runoff from a burst pipe in the catchment of the wetland or from sedimentation during the construction phase.

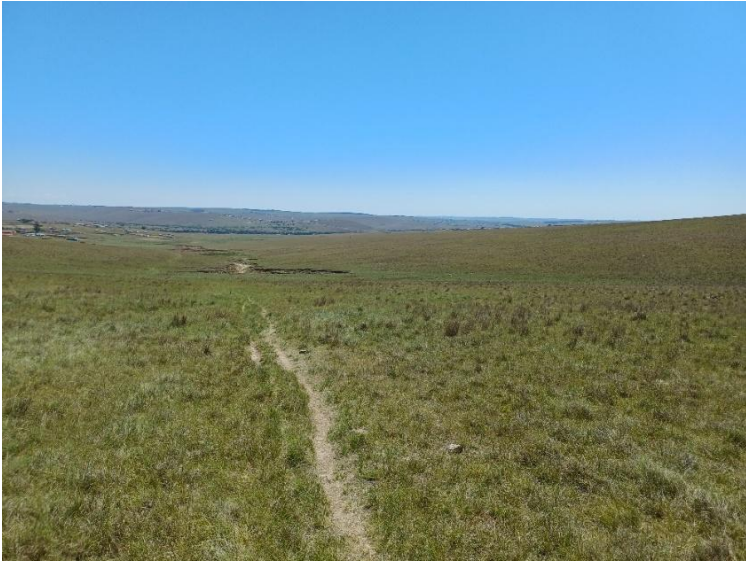
**Table 8-128 Seep 59 details (no direct crossing)**

Ngqamakhwe SEEP 59	Crossing No:	N/A	Quaternary Catchment	S70D	Map Reference	Figure 8-36
Habitat type	Hillslope Seep Wetland		Latitude:	-32.251652	Longitude:	28.057269
Photograph

IHI/PES	Condition Score	Key current impacts				
	C	Moderate grazing and trampling by livestock, major erosion and a dam present within the wetland.				
EIS Score	Moderate EIS. The score is derived from the biodiversity maintenance ecological importance of the wetland due to the relatively good ecological condition of C and the fact that it is ecologically connected to other wetlands and freshwater ecosystems of importance.					
Risks	Minor risks are posed to this wetland given that there are no direct crossings that are proposed for this wetland. Minor risks include increased runoff from a burst pipe in the catchment of the wetland or from sedimentation during the construction phase.

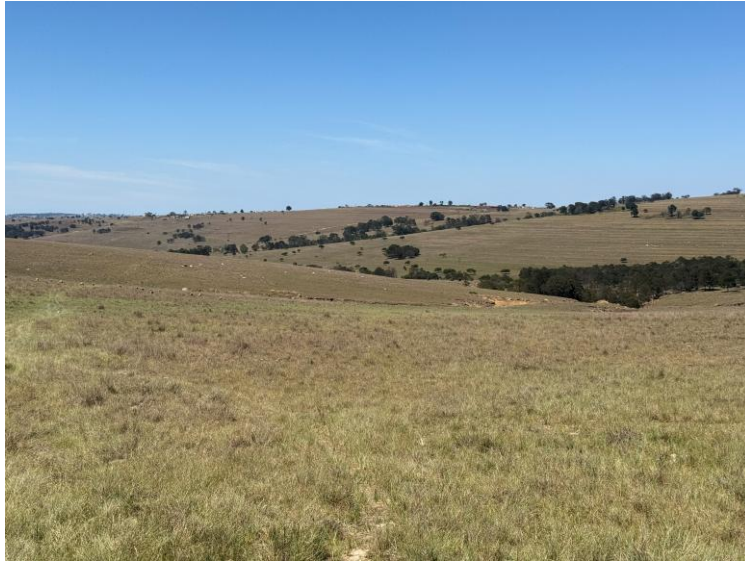
**Table 8-129 Seep 60 details (no direct crossing)**

Ngqamakhwe SEEP 60	Crossing No:	N/A	Quaternary Catchment	S70E	Map Reference	Figure 8-36
Habitat type	Hillslope Seep Wetland		Latitude:	-32.255124	Longitude:	28.055396
Photograph

IHI/PES	Condition Score	Key current impacts				
	C	Moderate grazing and trampling by livestock, major erosion and a dam present within the wetland.				
EIS Score	Moderate EIS. The score is derived from the biodiversity maintenance ecological importance of the wetland due to the relatively good ecological condition of C and the fact that it is ecologically connected to other wetlands and freshwater ecosystems of importance.					
Risks	Minor risks are posed to this wetland given that there are no direct crossings that are proposed for this wetland. Minor risks include increased runoff from a burst pipe in the catchment of the wetland or from sedimentation during the construction phase.

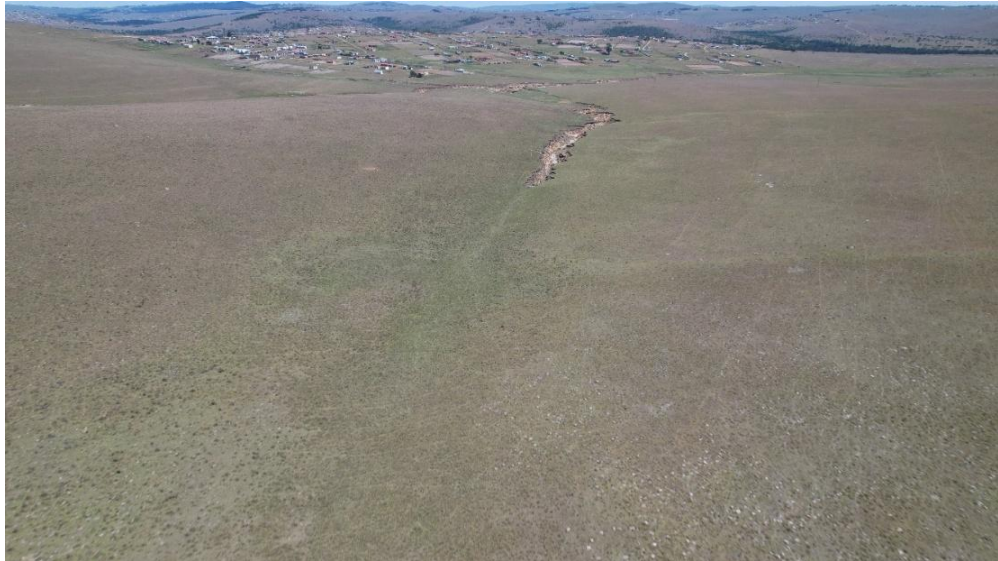
**Table 8-130 Seep 61 details (no direct crossing)**

Ngqamakhwe SEEP 61	Crossing No:	N/A	Quaternary Catchment	S70D	Map Reference	Figure 8-36
Habitat type	Hillslope Seep Wetland	Latitude:		-32.248309	Longitude:	28.062370
Photograph

IHI/PES	Condition Score	Key current impacts				
	C	Moderate grazing and trampling by livestock, major erosion present within the wetland.				
EIS Score	Moderate EIS. The score is derived from the biodiversity maintenance ecological importance of the wetland due to the relatively good ecological condition of C and the fact that it is ecologically connected to other wetlands and freshwater ecosystems of importance.					
Risks	Minor risks are posed to this wetland given that there are no direct crossings that are proposed for this wetland. Minor risks include increased runoff from a burst pipe in the catchment of the wetland or from sedimentation during the construction phase.

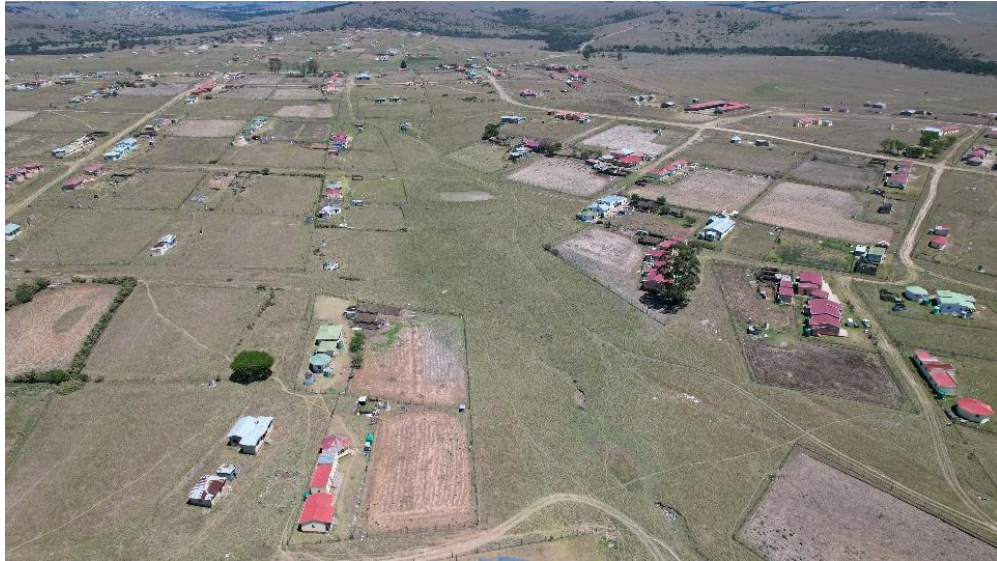
**Table 8-131 Seep 62 details (no direct crossing)**

Ngqamakhwe SEEP 62	Crossing No:	N/A	Quaternary Catchment	S70D	Map Reference	Figure 8-36
Habitat type	Hillslope Seep Wetland	Latitude:		-32.239253	Longitude:	28.056263
Photograph

IHI/PES	Condition Score	Key current impacts				
	C	Moderate grazing and trampling by livestock, minor erosion and a dam present within the wetland. Surrounding dwellings have also encroached within the wetland.				
EIS Score	Moderate EIS. The score is derived from the biodiversity maintenance ecological importance of the wetland due to the relatively good ecological condition of C and the fact that it is ecologically connected to other wetlands and freshwater ecosystems of importance.					
Risks	Minor risks are posed to this wetland given that there are no direct crossings that are proposed for this wetland. Minor risks include increased runoff from a burst pipe in the catchment of the wetland or from sedimentation during the construction phase.

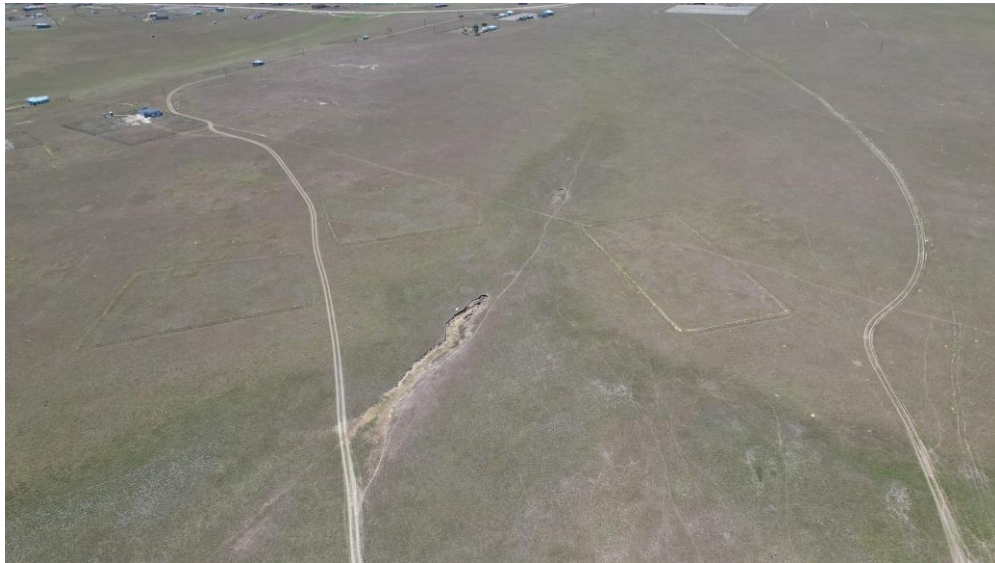
**Table 8-132 Seep 63 details (no direct crossing)**

Ngqamakhwe SEEP 63	Crossing No:	N/A	Quaternary Catchment	S70D	Map Reference	Figure 8-36
Habitat type	Hillslope Seep Wetland		Latitude:	-32.243459	Longitude:	28.064364
Photograph

IHI/PES	Condition Score	Key current impacts				
	C	Moderate grazing and trampling by livestock, minor erosion present at the toe of the wetland.				
EIS Score	Moderate EIS. The score is derived from the biodiversity maintenance ecological importance of the wetland due to the relatively good ecological condition of C and the fact that it is ecologically connected to other wetlands and freshwater ecosystems of importance.					
Risks	Minor risks are posed to this wetland given that there are no direct crossings that are proposed for this wetland. Minor risks include increased runoff from a burst pipe in the catchment of the wetland or from sedimentation during the construction phase.

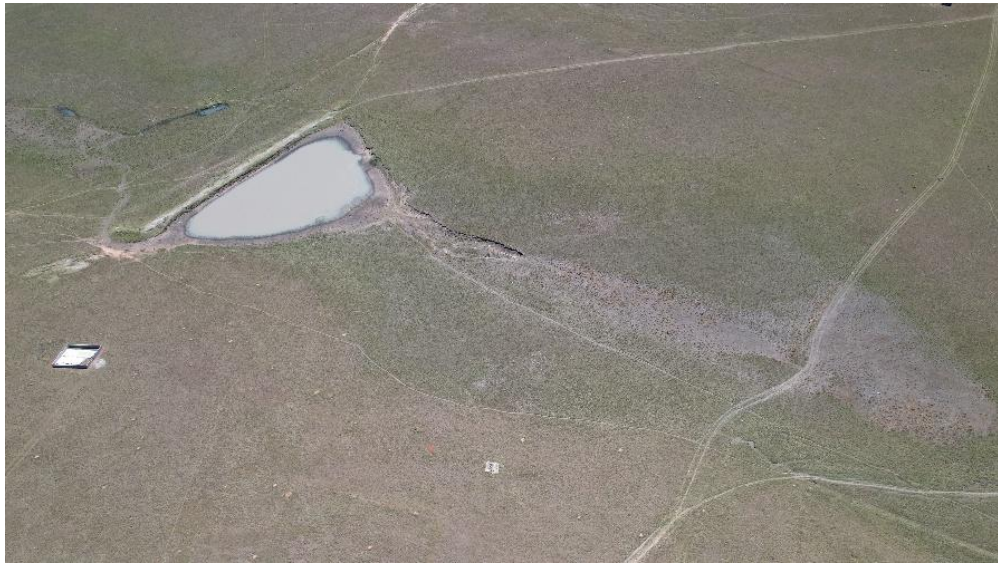
IHI/PES	Condition Score	Key current impacts				
	C	Moderate grazing and trampling by livestock, minor erosion and a dam present at the toe of the wetland.				
EIS Score	Moderate EIS. The score is derived from the biodiversity maintenance ecological importance of the wetland due to the relatively good ecological condition of C and the fact that it is ecologically connected to other wetlands and freshwater ecosystems of importance.					
Risks	Minor risks are posed to this wetland given that there are no direct crossings that are proposed for this wetland. Minor risks include increased runoff from a burst pipe in the catchment of the wetland or from sedimentation during the construction phase.
