# NGQAMAKHWE WATER SUPPLY SCHEME - PHASE 3

## Aquatic Biodiversity Assessment

DRAFT REPORT

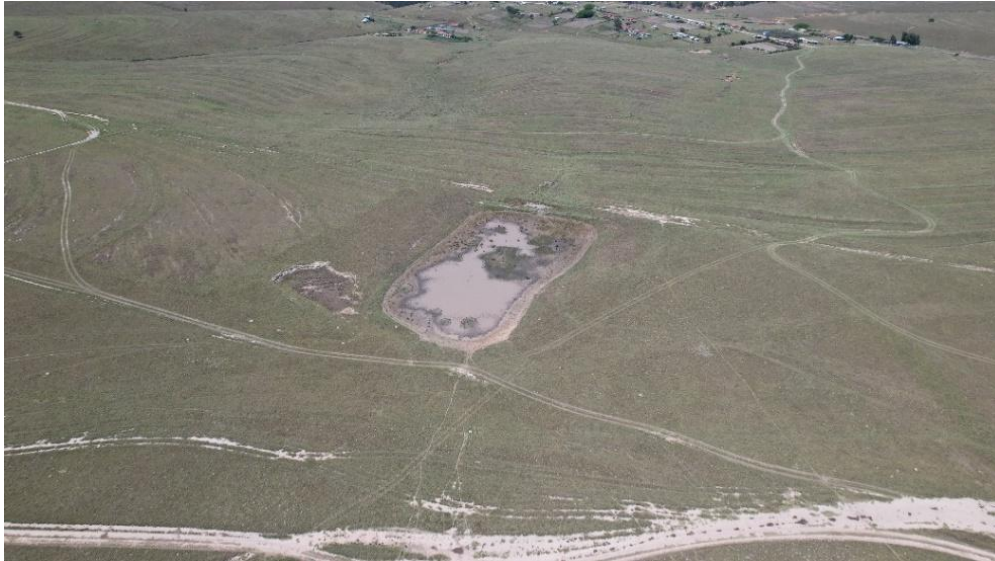
**Table 8-134 Depression 5 details (no direct crossing)**

Ngqamakhwe DEPR 5	Crossing No:	N/A	Quaternary Catchment	S70D	Map Reference	Figure 8-37
Habitat type	Depression Wetland		Latitude:	-32.2573742	Longitude:	28.0797106
Photograph

IHI/PES	Condition Score	Key current impacts				
	B	Minor grazing and trampling by livestock.				
EIS Score	High EIS. The score is derived from the biodiversity maintenance ecological importance of the wetland due to the good ecological condition of B and the fact that it is considered a high priority wetland.					
Risks	Minor risks are posed to this wetland given that there are no direct crossings that are proposed for this wetland. Minor risks include increased runoff from a burst pipe in the catchment of the wetland or from sedimentation during the construction phase.

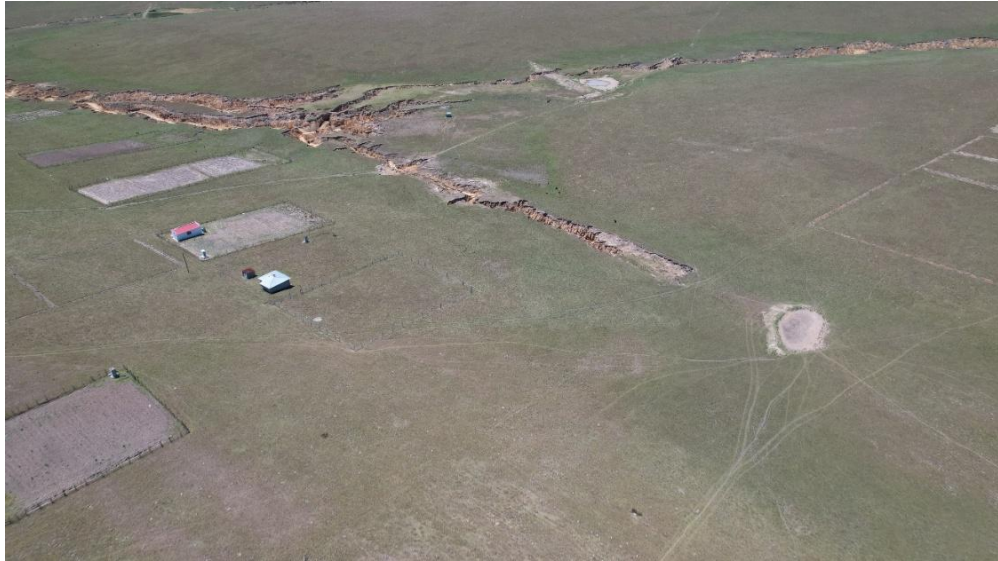
**Table 8-135 Seep 65 details (no direct crossing)**

Ngqamakhwe SEEP 65	Crossing No:	N/A	Quaternary Catchment	S70D	Map Reference	Figure 8-37
Habitat type	Hillslope Seep Wetland		Latitude:	-32.246185	Longitude:	28.071064
Photograph

IHI/PES	Condition Score	Key current impacts				
	C	Moderate grazing and trampling by livestock, major erosion and a dam present within the wetland.				
EIS Score	Moderate EIS. The score is derived from the biodiversity maintenance ecological importance of the wetland due to the relatively good ecological condition of C and the fact that it is ecologically connected to other wetlands and freshwater ecosystems of importance.					
Risks	Minor risks are posed to this wetland given that there are no direct crossings that are proposed for this wetland. Minor risks include increased runoff from a burst pipe in the catchment of the wetland or from sedimentation during the construction phase.

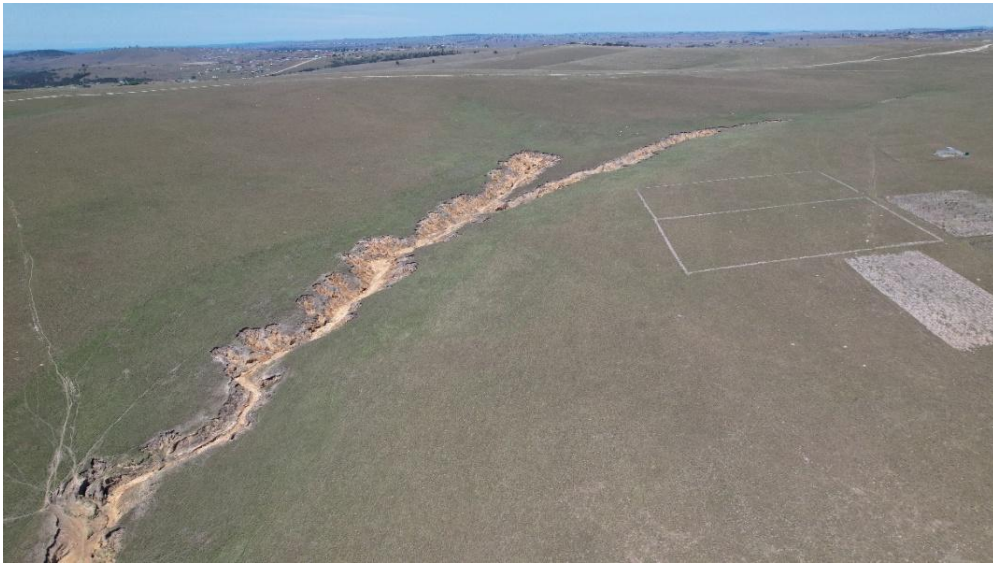
**Table 8-136 Seep 66 details (no direct crossing)**

Ngqamakhwe SEEP 66	Crossing No:	N/A	Quaternary Catchment	S70D	Map Reference	Figure 8-37
Habitat type	Hillslope Seep Wetland		Latitude:	-32.249471	Longitude:	28.075383
Photograph

IHI/PES	Condition Score	Key current impacts				
	C	Moderate grazing and trampling by livestock, major erosion and a dam present within the wetland. This dam wall has been eroded so that it no longer serves as a dam.				
EIS Score	Moderate EIS. The score is derived from the biodiversity maintenance ecological importance of the wetland due to the relatively good ecological condition of C and the fact that it is ecologically connected to other wetlands and freshwater ecosystems of importance.					
Risks	Minor risks are posed to this wetland given that there are no direct crossings that are proposed for this wetland. Minor risks include increased runoff from a burst pipe in the catchment of the wetland or from sedimentation during the construction phase.

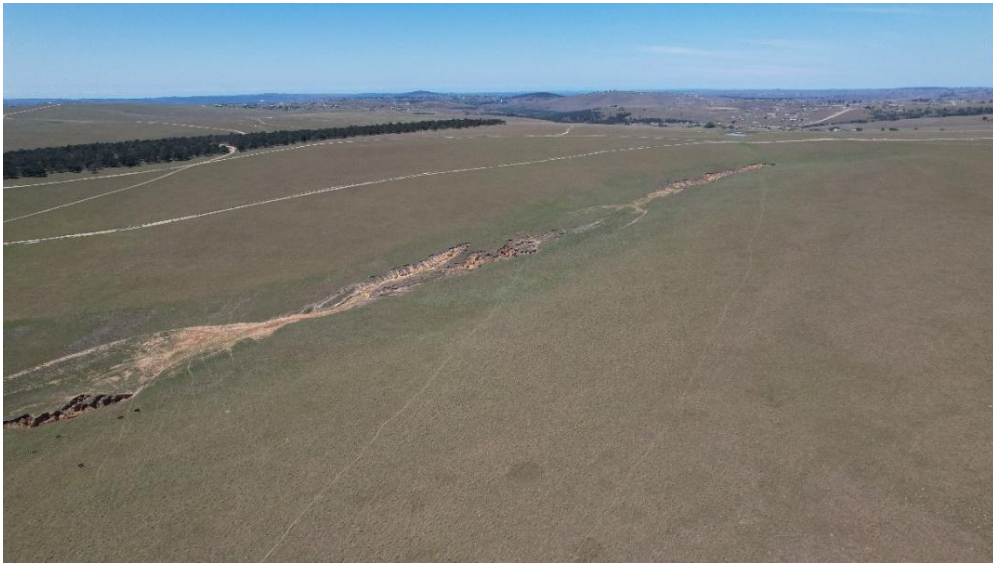
**Table 8-137 Seep 67 details (no direct crossing)**

Ngqamakhwe SEEP 67	Crossing No:	N/A	Quaternary Catchment	S70D	Map Reference	Figure 8-37
Habitat type	Hillslope Seep Wetland		Latitude:	-32.251881	Longitude:	28.081409
Photograph

IHI/PES	Condition Score	Key current impacts				
	C	Moderate grazing and trampling by livestock, major erosion and a dam present within the wetland. This dam wall has been eroded so that it no longer serves as a dam.				
EIS Score	Moderate EIS. The score is derived from the biodiversity maintenance ecological importance of the wetland due to the relatively good ecological condition of C and the fact that it is ecologically connected to other wetlands and freshwater ecosystems of importance.					
Risks	Minor risks are posed to this wetland given that there are no direct crossings that are proposed for this wetland. Minor risks include increased runoff from a burst pipe in the catchment of the wetland or from sedimentation during the construction phase.

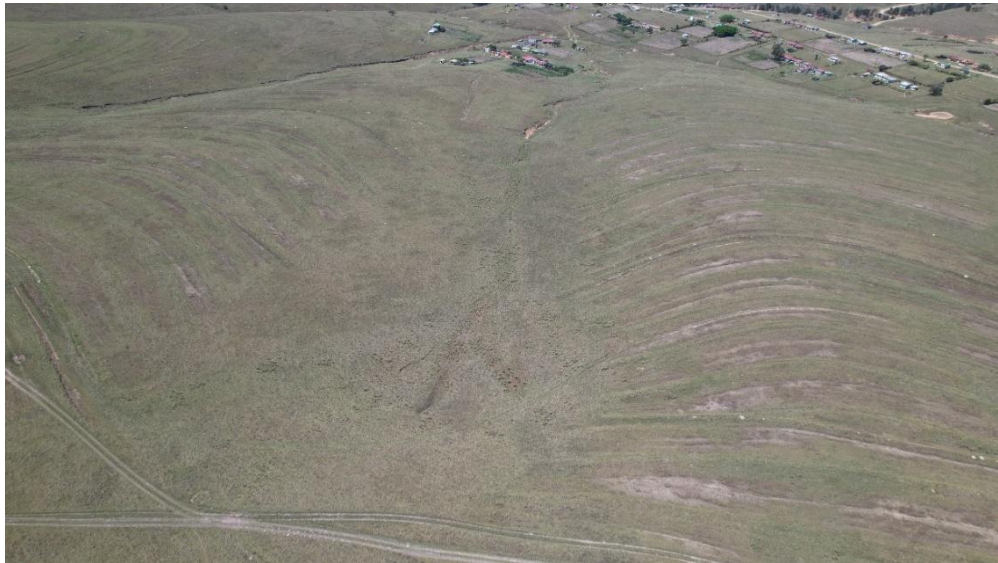
IHI/PES	Condition Score	Key current impacts				
	C	Moderate grazing and trampling by livestock, minor erosion present within the wetland.				
EIS Score	Moderate EIS. The score is derived from the biodiversity maintenance ecological importance of the wetland due to the relatively good ecological condition of C and the fact that it is ecologically connected to other wetlands and freshwater ecosystems of importance.					
Risks	Minor risks are posed to this wetland given that there are no direct crossings that are proposed for this wetland. Minor risks include increased runoff from a burst pipe in the catchment of the wetland or from sedimentation during the construction phase.

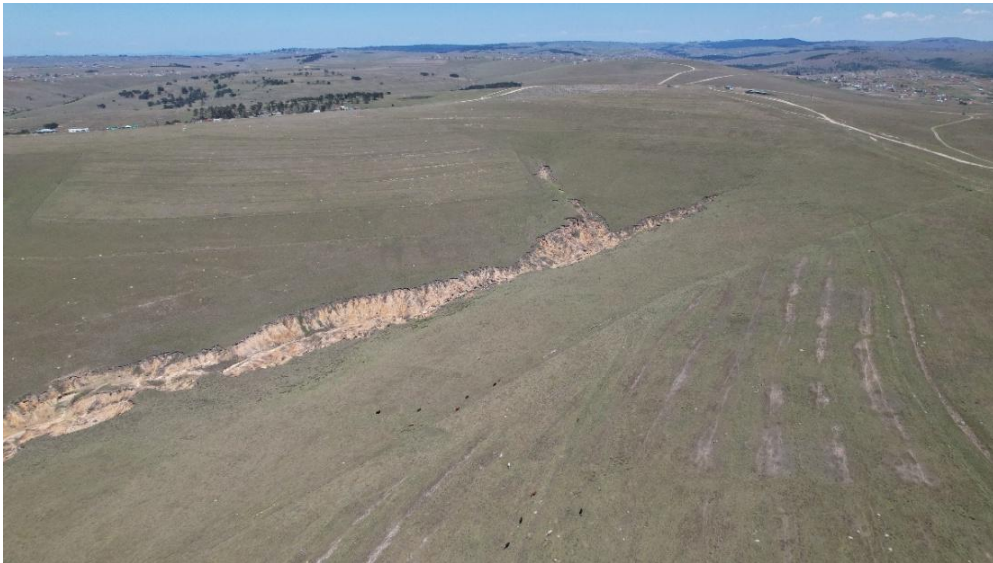
**Table 8-139 Seep 69 details (no direct crossing)**

Ngqamakhwe SEEP 69	Crossing No:	N/A	Quaternary Catchment	S70D	Map Reference	Figure 8-37
Habitat type	Hillslope Seep Wetland	Latitude:		-32.257789	Longitude:	28.068281
Photograph

IHI/PES	Condition Score	Key current impacts				
	C	Moderate grazing and trampling by livestock, major erosion present within the wetland.				
EIS Score	Moderate EIS. The score is derived from the biodiversity maintenance ecological importance of the wetland due to the relatively good ecological condition of C and the fact that it is ecologically connected to other wetlands and freshwater ecosystems of importance.					
Risks	Minor risks are posed to this wetland given that there are no direct crossings that are proposed for this wetland. Minor risks include increased runoff from a burst pipe in the catchment of the wetland or from sedimentation during the construction phase.

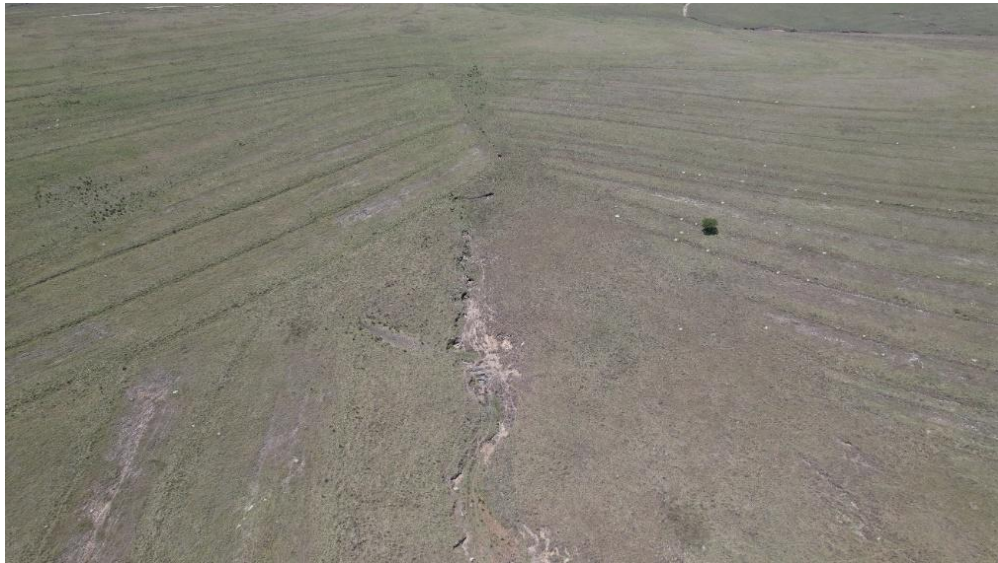
IHI/PES	Condition Score	Key current impacts				
	C	Moderate grazing and trampling by livestock, minor erosion present within the wetland as well as evidence of historical agriculture.				
EIS Score	Moderate EIS. The score is derived from the biodiversity maintenance ecological importance of the wetland due to the relatively good ecological condition of C and the fact that it is ecologically connected to other wetlands and freshwater ecosystems of importance.					
Risks	Minor risks are posed to this wetland given that there are no direct crossings that are proposed for this wetland. Minor risks include increased runoff from a burst pipe in the catchment of the wetland or from sedimentation during the construction phase.

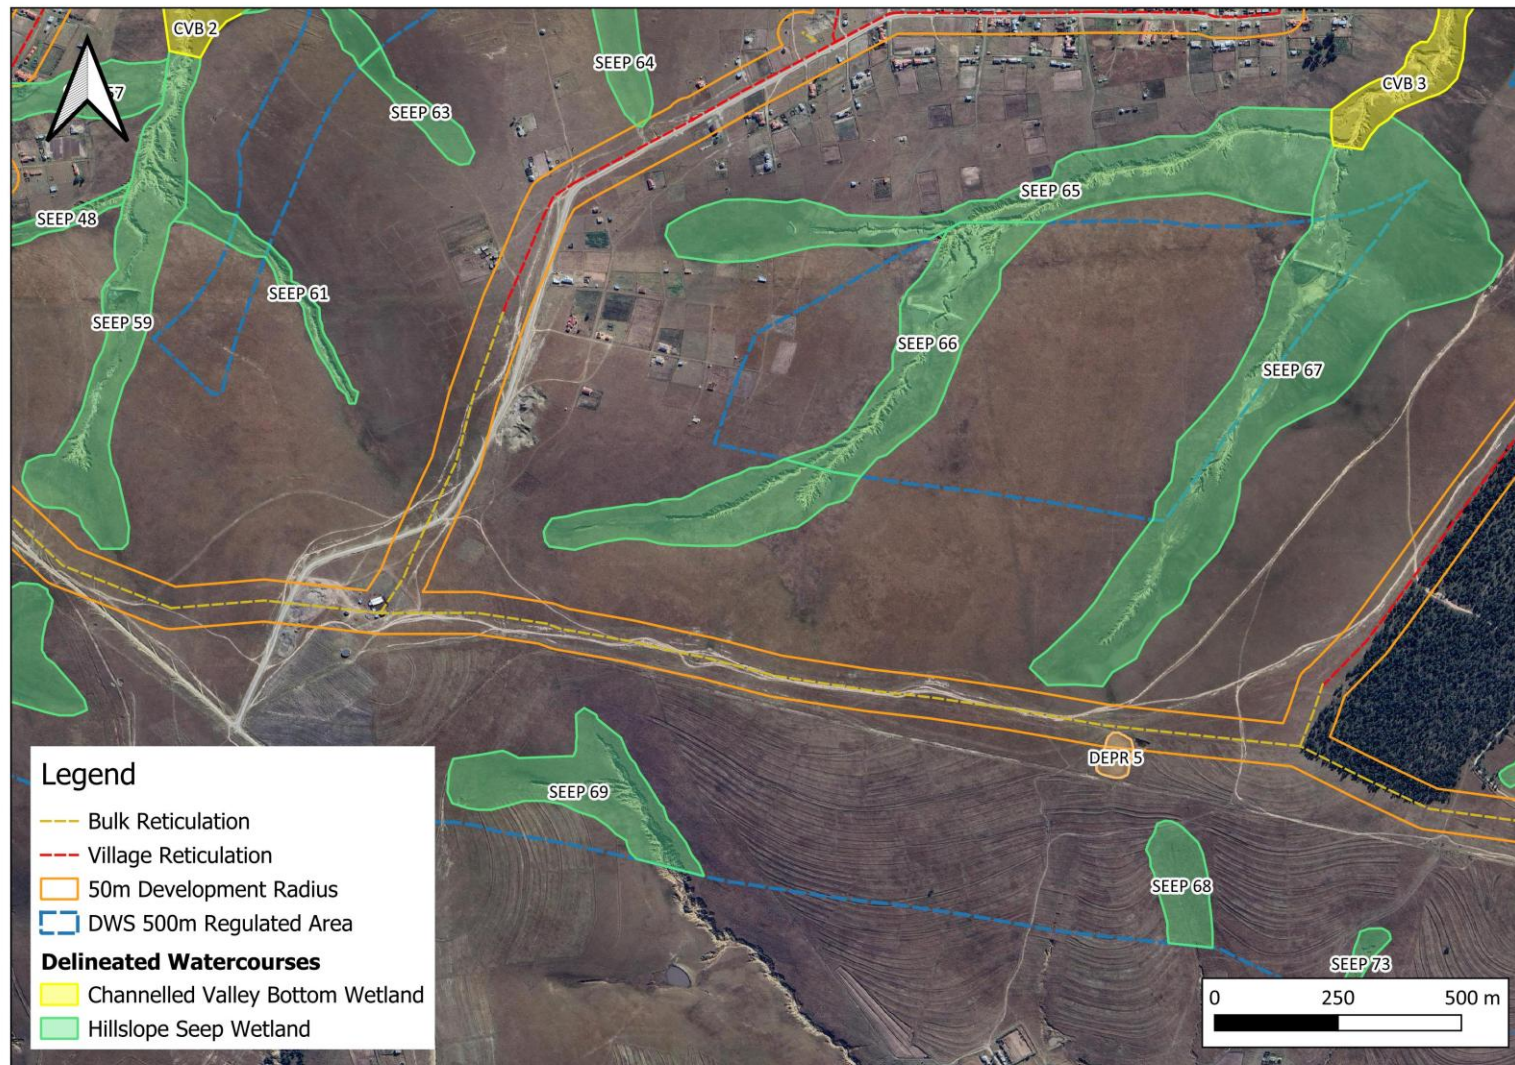
Figure 8-37 The proposed pipeline alignments in relation to the delineated freshwater ecosystems, specifically DEPR 5, SEEP 65, SEEP 66, SEEP 67, SEEP 68, SEEP 69 and SEEP 73.

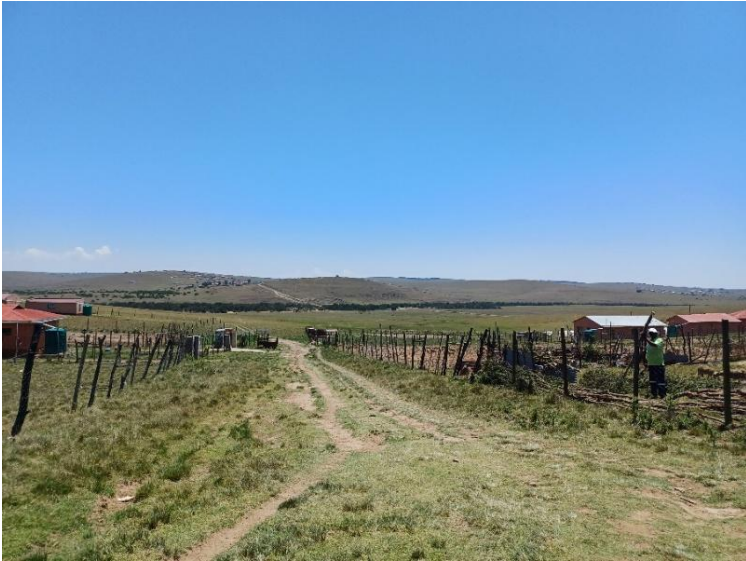
**Table 8-142 Seep 70 details (no direct crossing)**

Ngqamakhwe SEEP 70	Crossing No:	N/A	Quaternary Catchment	S70D	Map Reference	Figure 8-38
Habitat type	Hillslope Seep Wetland		Latitude:	-32.234369	Longitude:	28.077831
Photograph

IHI/PES	Condition Score	Key current impacts				
	C	Moderate grazing and trampling by livestock, major erosion and a dam present within the wetland.				
EIS Score	Moderate EIS. The score is derived from the biodiversity maintenance ecological importance of the wetland due to the relatively good ecological condition of C and the fact that it is ecologically connected to other wetlands and freshwater ecosystems of importance.					
Risks	Minor risks are posed to this wetland given that there are no direct crossings that are proposed for this wetland. Minor risks include increased runoff from a burst pipe in the catchment of the wetland or from sedimentation during the construction phase.

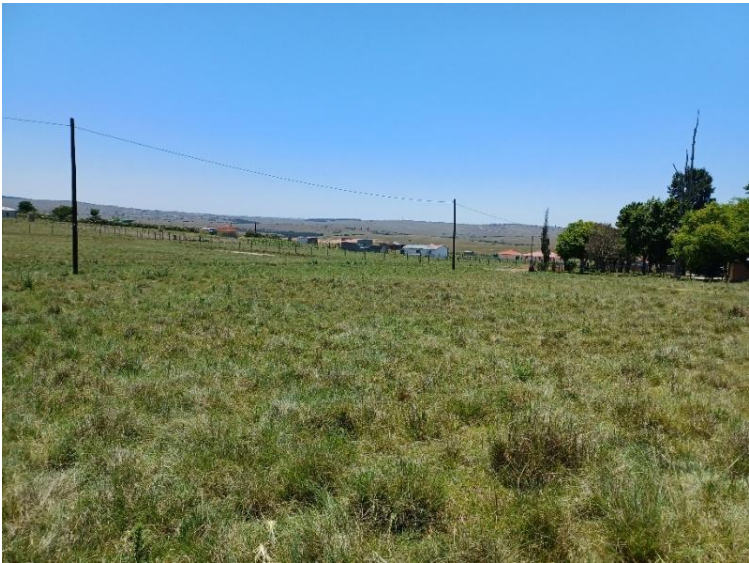
**Table 8-143 Seep 71 details (crossing S70D-18)**

Ngqamakhwe SEEP 71	Crossing No:	S70D-18	Quaternary Catchment	S70D	Map Reference	Figure 8-38
Habitat type	Hillslope Seep Wetland		Latitude:	-32.238885	Longitude:	28.083135
Photograph

IHI/PES	Condition Score	Key current impacts				
	C	Moderate grazing and trampling by livestock, minor erosion and invasive alien species present within the wetland. Dwellings have also encroached within the wetland.				
EIS Score	Moderate EIS. The score is derived from the biodiversity maintenance ecological importance of the wetland due to the relatively good ecological condition of C and the fact that it is ecologically connected to other wetlands and freshwater ecosystems of importance.					
Risks	Moderate to low risks associated with the proposed pipeline alignment given that the pipeline will pass directly through the northern edge of the wetland, on an existing road. Provided that careful construction measures are followed, the risk should be low.

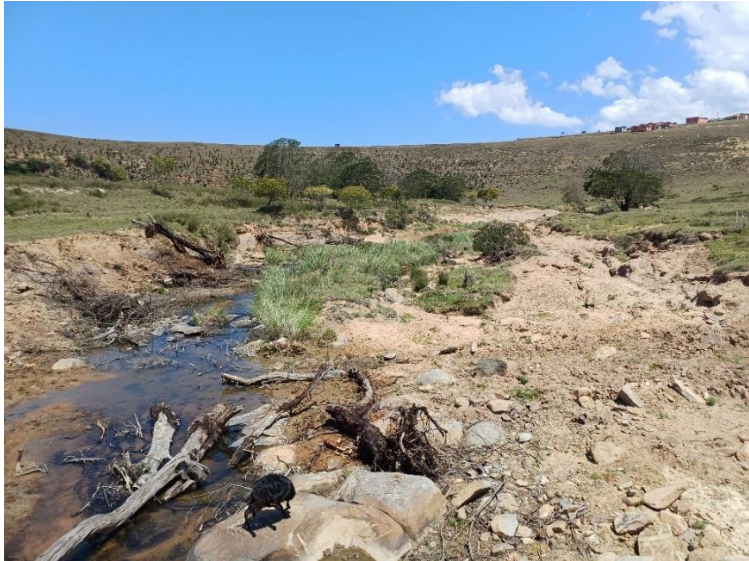
**Table 8-145 Lower foothills river 1 details (no direct crossing)**

Ngqamakhwe LFH 1	Crossing No:	N/A	Quaternary Catchment	S70D	Map Reference	Figure 8-39
Habitat type	Lower Foothills River		Latitude:	-32.242220	Longitude:	28.115990
Photograph

IHI/PES	Condition Score	Key current impacts				
	D	Major bed and channel modification in the river system as well as major bank erosion and channel modification in the riparian area.				
EIS Score	Moderate EIS. The score is derived from the ecological importance of the Mtwaku River					
Risks	Low risks associated with the proposed development given that the pipeline alignments will not cross this stream system at all. A low risk exists because the pipeline is located in the catchment of the stream system.

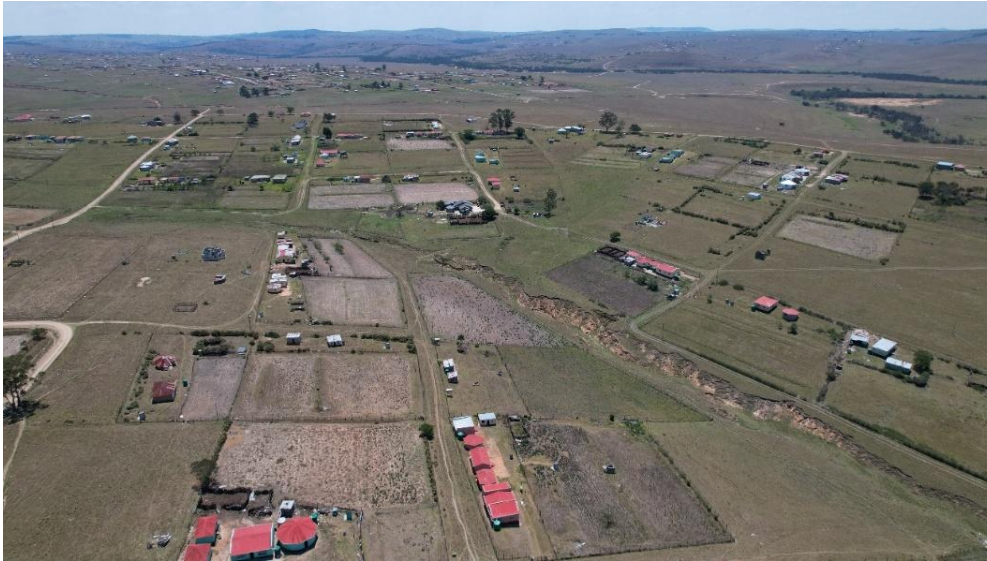
Table 8-146 Seep 78 details (no direct crossing)

Ngqamakhwe SEEP 78	Crossing No:	N/A	Quaternary Catchment	S70D	Map Reference	Figure 8-39
Habitat type	Hillslope Seep Wetland	Latitude:		-32.2443481	Longitude:	28.0977101
Photograph

IHI/PES	Condition Score	Key current impacts				
	C	Moderate grazing and trampling by livestock, minor erosion and dwellings present within the wetland.				
EIS Score	Moderate EIS. The score is derived from the biodiversity maintenance ecological importance of the wetland due to the relatively good ecological condition of C and the fact that it is ecologically connected to other wetlands and freshwater ecosystems of importance.					
Risks	Minor risks are posed to this wetland given that there are no direct crossings that are proposed for this wetland. Minor risks include increased runoff from a burst pipe in the catchment of the wetland or from sedimentation during the construction phase.

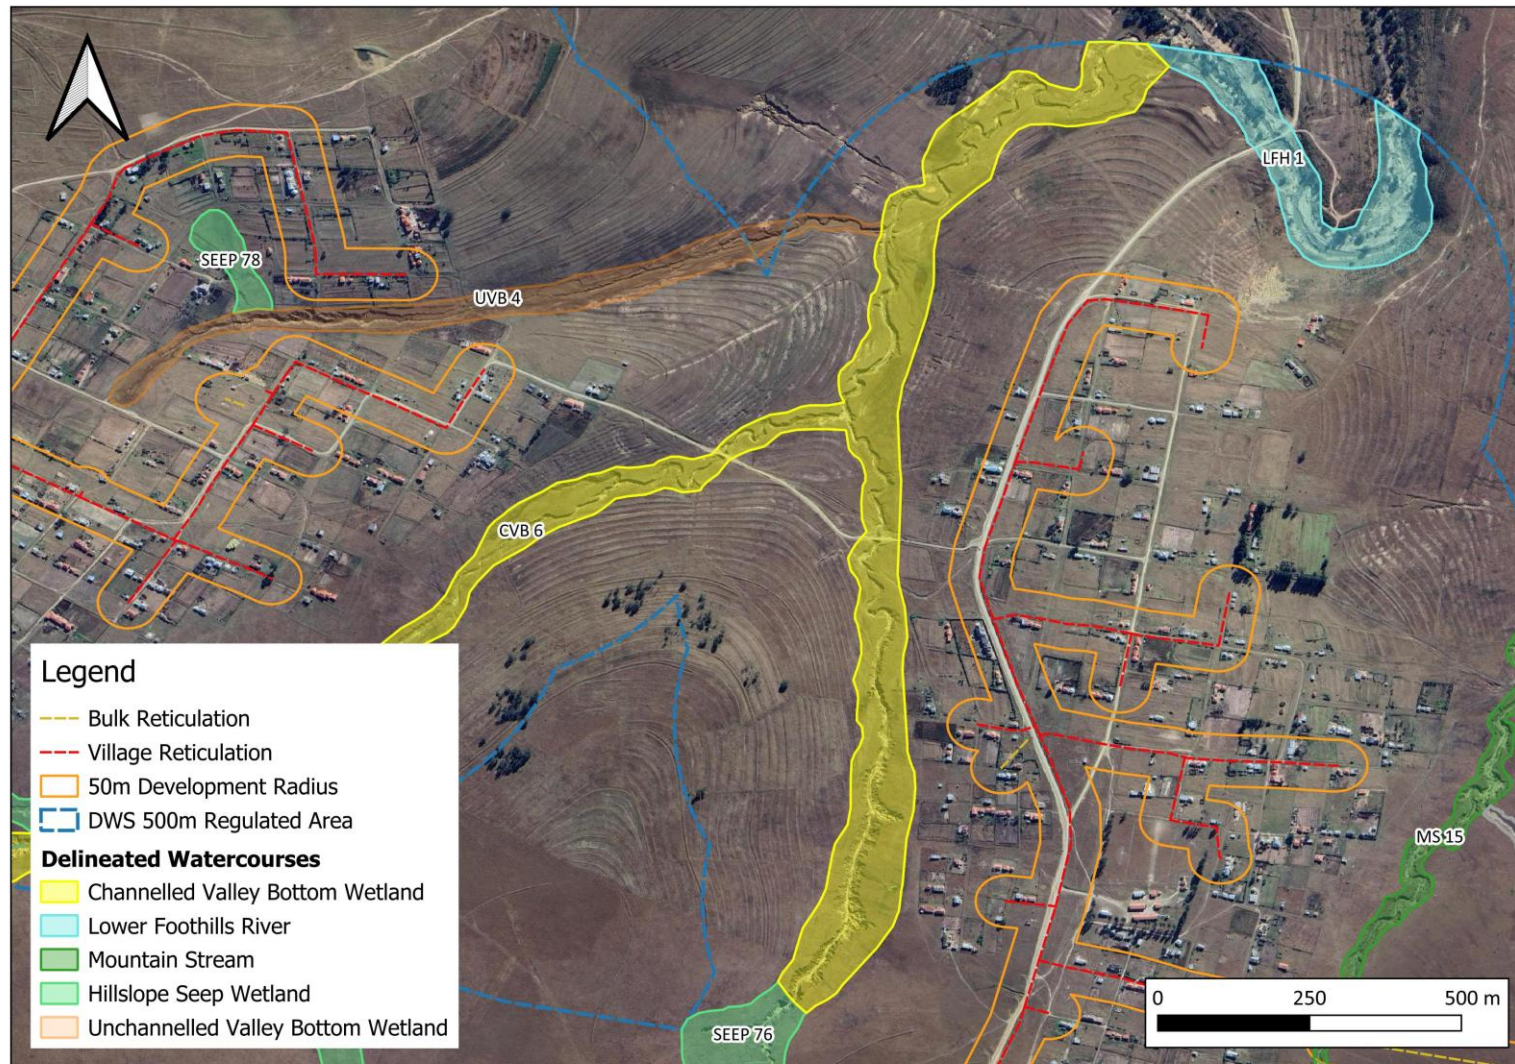
Figure 8-39 The proposed pipeline alignments in relation to the delineated freshwater ecosystems, specifically CVB 6, LFH 1, SEEP 78 and UVB 4.

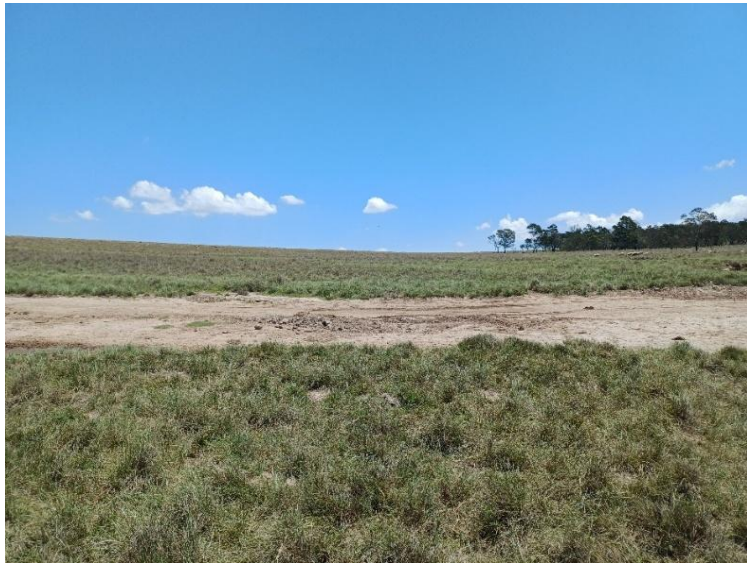
**Table 8-148 Seep 72 details (no direct crossing)**

Ngqamakhwe SEEP 72	Crossing No:	N/A	Quaternary Catchment	S70D	Map Reference	Figure 8-40
Habitat type	Hillslope Seep Wetland		Latitude:	-32.257806	Longitude:	28.089038
Photograph

IHI/PES	Condition Score	Key current impacts				
	C	Heavy grazing and trampling by livestock, major erosion present at the toe of the wetland. A gravel road traverses the wetland.				
EIS Score	Moderate EIS. The score is derived from the biodiversity maintenance ecological importance of the wetland due to the relatively good ecological condition of C and the fact that it is ecologically connected to other wetlands and freshwater ecosystems of importance.					
Risks	Minor risks are posed to this wetland given that there are no direct crossings that are proposed for this wetland. Minor risks include increased runoff from a burst pipe in the catchment of the wetland or from sedimentation during the construction phase.

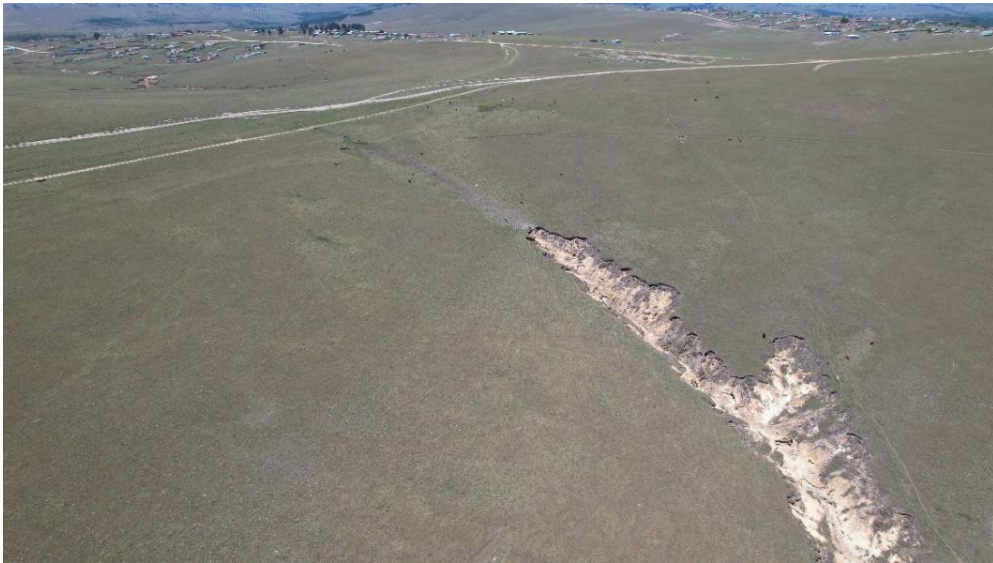
**Table 8-149 Seep 74 details (no direct crossing)**

Ngqamakhwe SEEP 74	Crossing No:	N/A	Quaternary Catchment	S70D	Map Reference	Figure 8-40
Habitat type	Hillslope Seep Wetland		Latitude:	-32.263775	Longitude:	28.103751
Photograph

IHI/PES	Condition Score	Key current impacts				
	C	Heavy grazing and trampling by livestock, major erosion present throughout a large portion of the wetland.				
EIS Score	Moderate EIS. The score is derived from the biodiversity maintenance ecological importance of the wetland due to the relatively good ecological condition of C and the fact that it is ecologically connected to other wetlands and freshwater ecosystems of importance.					
Risks	Minor risks are posed to this wetland given that there are no direct crossings that are proposed for this wetland. Minor risks include increased runoff from a burst pipe in the catchment of the wetland or from sedimentation during the construction phase.

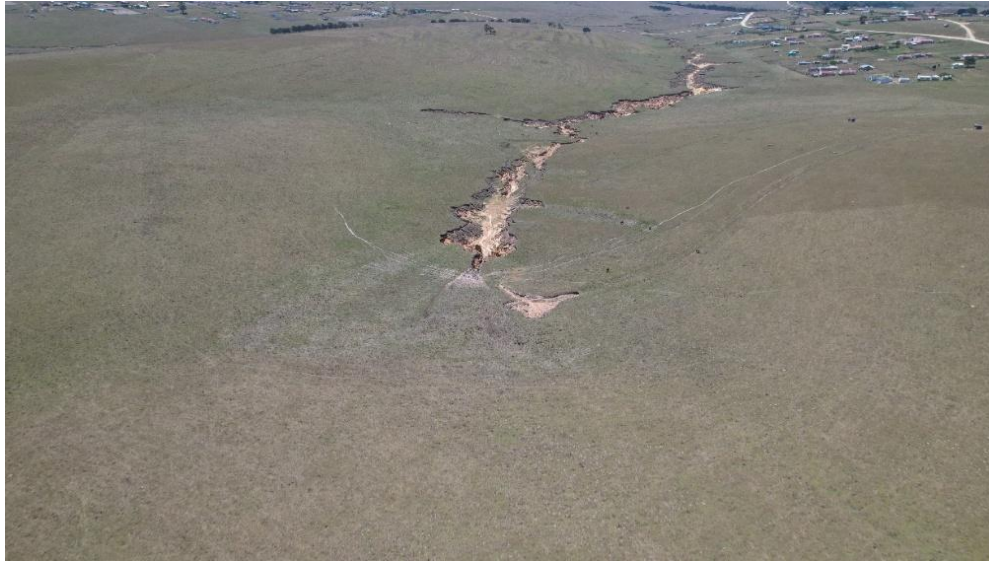
**Table 8-150 Seep 76 details (no direct crossing)**

Ngqamakhwe SEEP 76	Crossing No:	N/A	Quaternary Catchment	S70D	Map Reference	Figure 8-40
Habitat type	Hillslope Seep Wetland		Latitude:	-32.260607	Longitude:	28.106631
Photograph

IHI/PES	Condition Score	Key current impacts				
	C	Heavy grazing and trampling by livestock, major erosion present throughout a large portion of the wetland.				
EIS Score	Moderate EIS. The score is derived from the biodiversity maintenance ecological importance of the wetland due to the relatively good ecological condition of C and the fact that it is ecologically connected to other wetlands and freshwater ecosystems of importance.					
Risks	Minor risks are posed to this wetland given that there are no direct crossings that are proposed for this wetland. Minor risks include increased runoff from a burst pipe in the catchment of the wetland or from sedimentation during the construction phase.

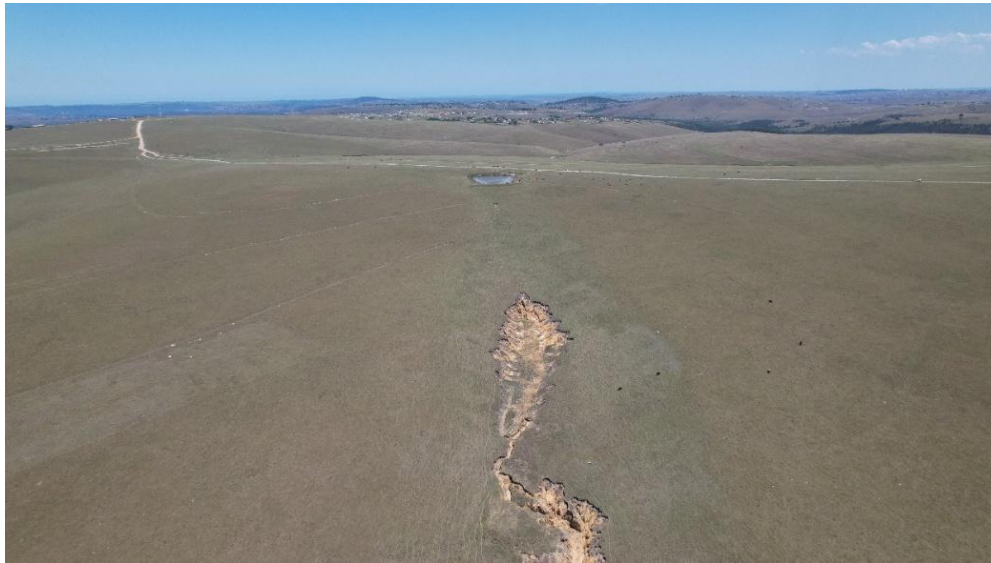
**Table 8-151 Seep 77 details (no direct crossing)**

Ngqamakhwe SEEP 77	Crossing No:	N/A	Quaternary Catchment	S70D	Map Reference	Figure 8-40
Habitat type	Hillslope Seep Wetland		Latitude:	-32.260109	Longitude:	28.100060
Photograph

IHI/PES	Condition Score	Key current impacts				
	C	Heavy grazing and trampling by livestock, major erosion present throughout a large portion of the wetland. A dam is present at the head of the wetland.				
EIS Score	Moderate EIS. The score is derived from the biodiversity maintenance ecological importance of the wetland due to the relatively good ecological condition of C and the fact that it is ecologically connected to other wetlands and freshwater ecosystems of importance.					
Risks	Minor risks are posed to this wetland given that there are no direct crossings that are proposed for this wetland. Minor risks include increased runoff from a burst pipe in the catchment of the wetland or from sedimentation during the construction phase.

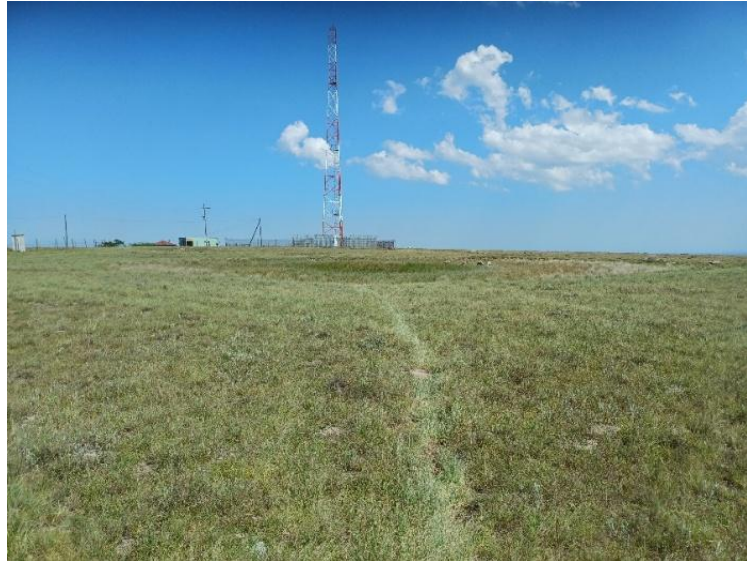
**Table 8-153 Depression 6 details (no direct crossing)**

Ngqamakhwe DEPR 6	Crossing No:	N/A	Quaternary Catchment	S70D	Map Reference	Figure 8-41
Habitat type	Depression Wetland		Latitude:	-32.2688660	Longitude:	28.1110205
Photograph

IHI/PES	Condition Score	Key current impacts				
	B	Minor grazing and trampling by livestock.				
EIS Score	High EIS. The score is derived from the biodiversity maintenance ecological importance of the wetland due to the good ecological condition of B and the fact that it is considered a high priority wetland.					
Risks	Minor risks are posed to this wetland given that there are no direct crossings that are proposed for this wetland. Minor risks include increased runoff from a burst pipe in the catchment of the wetland or from sedimentation during the construction phase.

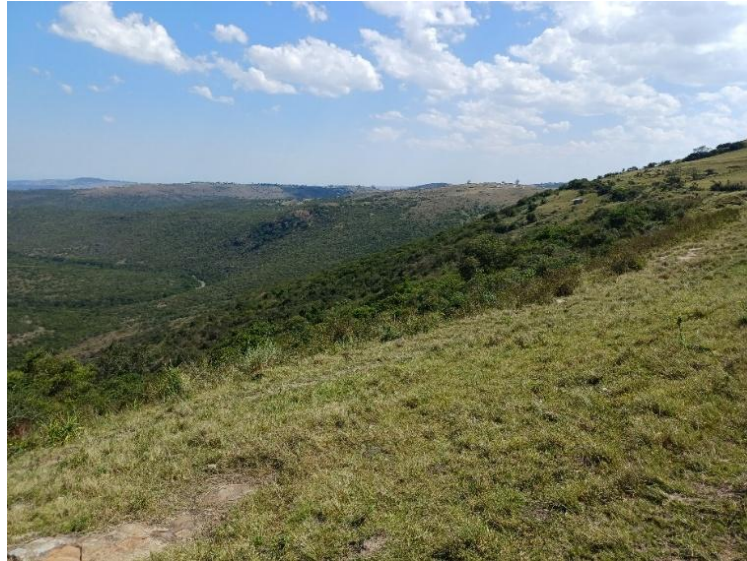
**Table 8-154 Mountain headwater stream 19 details (no direct crossing)**

Ngqamakhwe MHS 19	Crossing No:	N/A	Quaternary Catchment	S70D	Map Reference	Figure 8-41
Habitat type	Mountain Headwater Stream		Latitude:	-32.2682782	Longitude:	28.1168175
Photograph

IHI/PES	Condition Score	Key current impacts				
	A	Minor impacts associated with the stream. Some litter present at the head of the stream.				
EIS Score	Moderate EIS. The score is derived from the ecological importance of the stream given it is a tributary of the Gcuwa River.					
Risks	Low risks associated with the proposed development given that the pipeline alignments will not cross this stream system at all. A low risk exists because the pipeline is located in the catchment of the stream system.

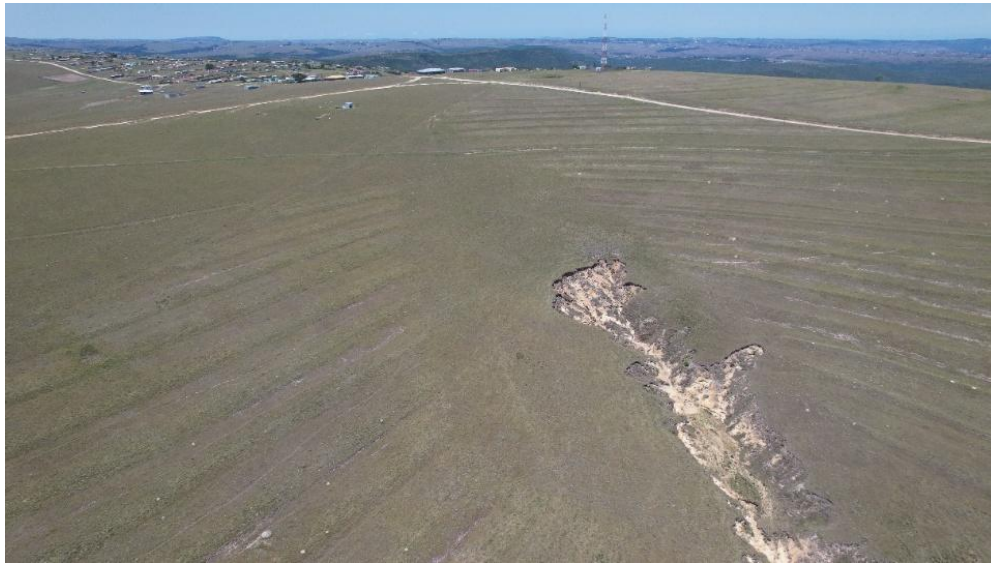
**Table 8-155 Seep 75 details (no direct crossing)**

Ngqamakhwe SEEP 75	Crossing No:	N/A	Quaternary Catchment	S70D	Map Reference	Figure 8-41
Habitat type	Hillslope Seep Wetland		Latitude:	-32.2681794	Longitude:	28.1069756
Photograph

IHI/PES	Condition Score	Key current impacts				
	C	Heavy grazing and trampling by livestock, major erosion present throughout a large portion of the wetland.				
EIS Score	Moderate EIS. The score is derived from the biodiversity maintenance ecological importance of the wetland due to the relatively good ecological condition of C and the fact that it is ecologically connected to other wetlands and freshwater ecosystems of importance.					
Risks	Minor risks are posed to this wetland given that there are no direct crossings that are proposed for this wetland. Minor risks include increased runoff from a burst pipe in the catchment of the wetland or from sedimentation during the construction phase.

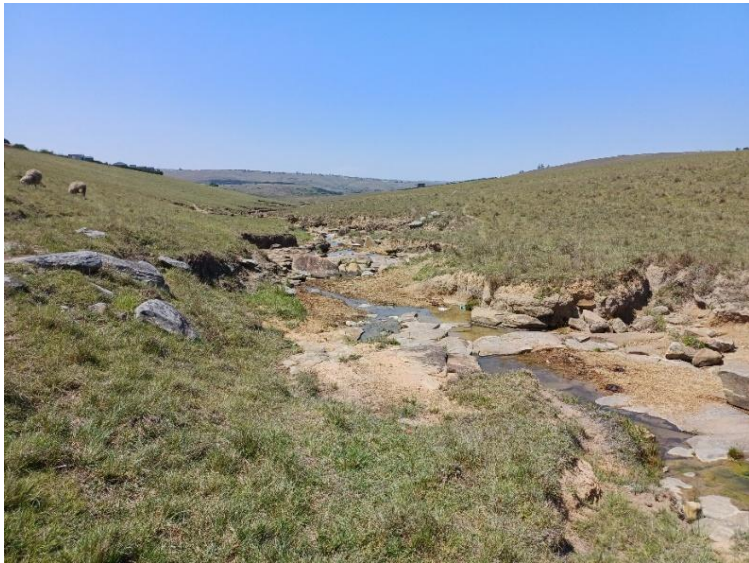
**Table 8-156 Mountain stream 15 details (no direct crossing)**

Ngqamakhwe MS 15	Crossing No:	N/A	Quaternary Catchment	S70D	Map Reference	Figure 8-42
Habitat type	Mountain Stream		Latitude:	-32.2578259	Longitude:	28.1167919
Photograph

IHI/PES	Condition Score	Key current impacts				
	B	Moderate grazing and trampling by livestock. Moderate bed and channel modification within the stream system, as well as bank modification.				
EIS Score	Moderate EIS. The score is derived from the ecological importance of the stream given it is a tributary of the Mtwaku River.					
Risks	Low risks associated with the proposed development given that the pipeline alignments will not cross this stream system at all. A low risk exists because the pipeline is located in the catchment of the stream system and within close proximity to the stream.

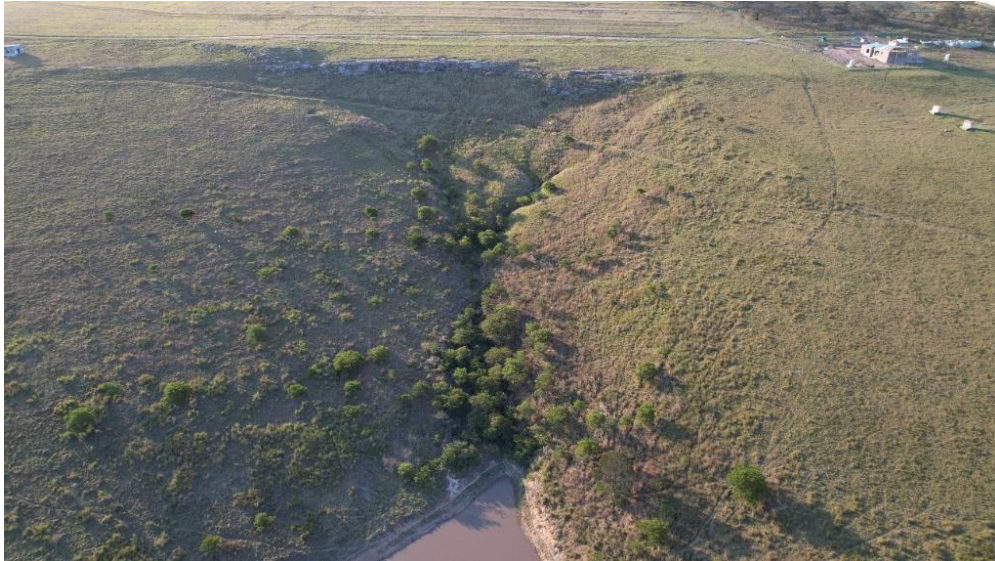
**Table 8-157 Mountain headwater stream 20 details (no direct crossing)**

Ngqamakhwe MHS 20	Crossing No:	N/A	Quaternary Catchment	S70D	Map Reference	Figure 8-43
Habitat type	Mountain Headwater Stream		Latitude:	-32.2551739	Longitude:	28.1341280
Photograph

IHI/PES	Condition Score		Key current impacts			
	C/	D	A large infestation of invasive alien vegetation in the stream system of the stream, as well as infilling in the form of a dam.			
EIS Score	Moderate EIS. The score is derived from the ecological importance of the stream given it is a tributary of the Gcuwa River.					
Risks	Low risks associated with the proposed development given that the pipeline alignments will not cross this stream system at all. A low risk exists because the pipeline is located in the catchment of the stream system.

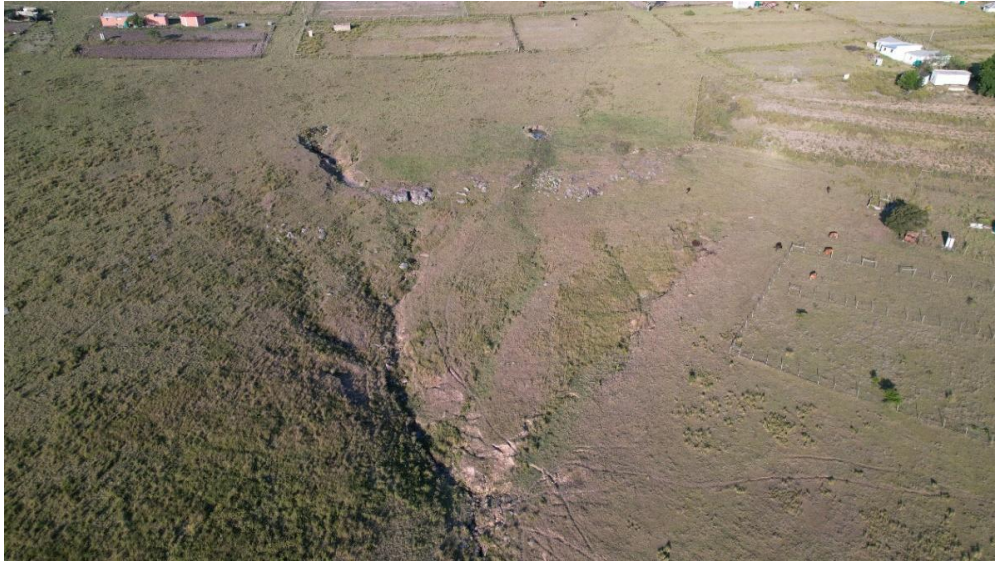
**Table 8-158 Mountain headwater stream 21 details (no direct crossing)**

Ngqamakhwe MHS 21	Crossing No:	N/A	Quaternary Catchment	S70D	Map Reference	Figure 8-43
Habitat type	Mountain Headwater Stream		Latitude:	-32.251996	Longitude:	28.140000
Photograph

IHI/PES	Condition Score	Key current impacts				
	A	Minor erosion present at the head of the wetland.				
EIS Score	Moderate EIS. The score is derived from the ecological importance of the stream given it is a tributary of the Gcuwa River.					
Risks	Low risks associated with the proposed development given that the pipeline alignments will not cross this stream system at all. A low risk exists because the pipeline is located in the catchment of the stream system.

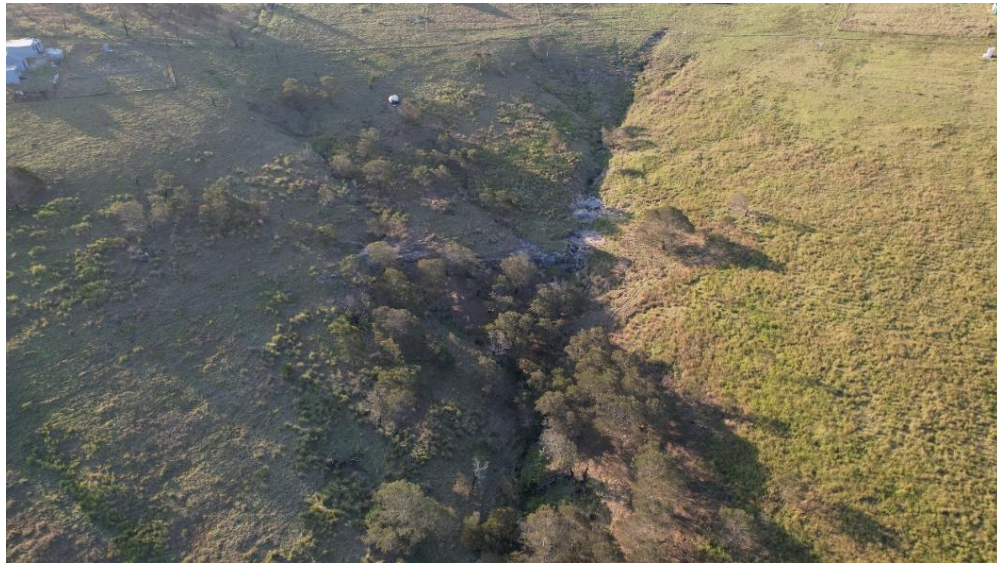
IHI/PES	Condition Score		Key current impacts			
	B/	C	Invasive alien infestation present in a portion the stream system as well as within the riparian areas of the stream.			
EIS Score	Moderate EIS. The score is derived from the ecological importance of the stream given it is a tributary of the Gcuwa River.					
Risks	Low risks associated with the proposed development given that the pipeline alignments will not cross this stream system at all. A low risk exists because the pipeline is located in the catchment of the stream system and within close proximity to the stream.

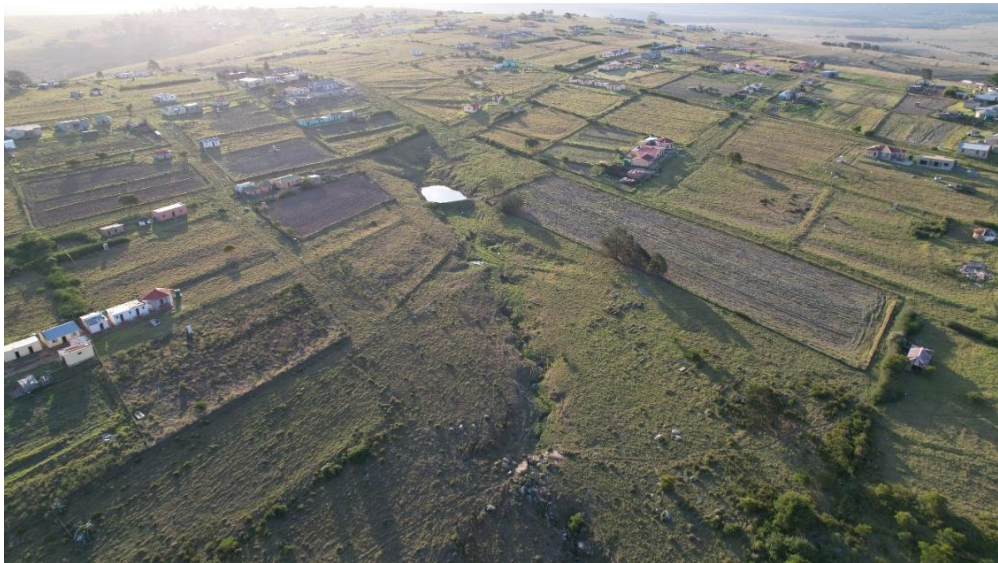
**Table 8-160 Mountain stream 17 details (no direct crossing)**

Ngqamakhwe MS 17	Crossing No:	N/A	Quaternary Catchment	S70D	Map Reference	Figure 8-44
Habitat type	Mountain Stream		Latitude:	-32.247668	Longitude:	28.145015
Photograph

IHI/PES	Condition Score		Key current impacts			
	B/	C	Minor bed and bank modification as well as infilling in the form of a dam at the head of the stream.			
EIS Score	Moderate EIS. The score is derived from the ecological importance of the stream given it is a tributary of the Gcuwa River.					
Risks	Low risks associated with the proposed development given that the pipeline alignments will not cross this stream system at all. A low risk exists because the pipeline is located in the catchment of the stream system and within close proximity to the stream.

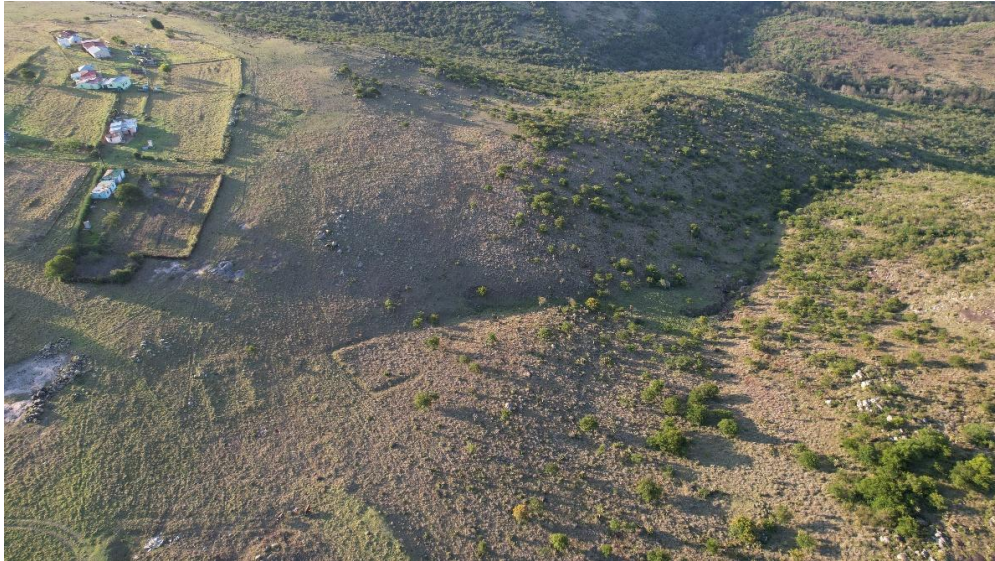
**Table 8-161 Mountain headwater stream 18 details (no direct crossing)**

Ngqamakhwe MHS 18	Crossing No:	N/A	Quaternary Catchment	S70D	Map Reference	Figure 8-45
Habitat type	Mountain Headwater Stream	Latitude:		-32.242639	Longitude:	28.147842
Photograph

IHI/PES	Condition Score	Key current impacts				
	A	Minor impacts associated with the stream.				
EIS Score	Moderate EIS. The score is derived from the ecological importance of the stream given it is a tributary of the Mtwaku River.					
Risks	Low risks associated with the proposed development given that the pipeline alignments will not cross this stream system at all. A low risk exists because the pipeline is located in the catchment of the stream system.

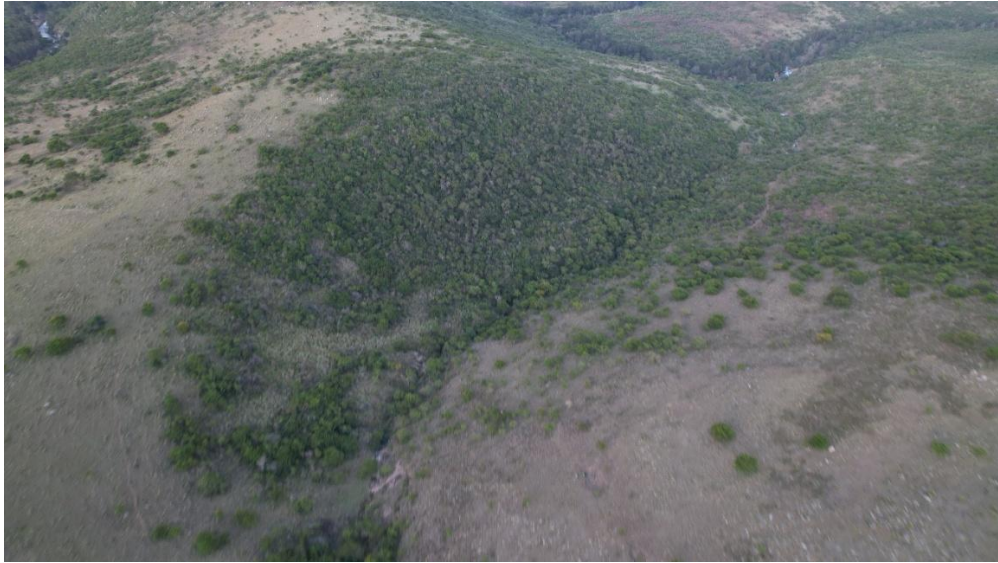
**Table 8-162 Mountain stream 18 details (no direct crossing)**

Ngqamakhwe MS 18	Crossing No:	N/A	Quaternary Catchment	S70D	Map Reference	Figure 8-45
Habitat type	Mountain Stream		Latitude:	-32.2397561	Longitude:	28.1425342
Photograph

IHI/PES	Condition Score		Key current impacts			
	B/	C	Minor bed modification and sedimentation due to erosion upstream.			
EIS Score	Moderate EIS. The score is derived from the ecological importance of the stream given it is a tributary of the Mtwaku River.					
Risks	Low risks associated with the proposed development given that the pipeline alignments will not cross this stream system at all. A low risk exists because the pipeline is located in the catchment of the stream system and within close proximity to the stream.
