# NGQAMAKHWE WATER SUPPLY SCHEME - PHASE 3

## Aquatic Biodiversity Assessment

DRAFT REPORT

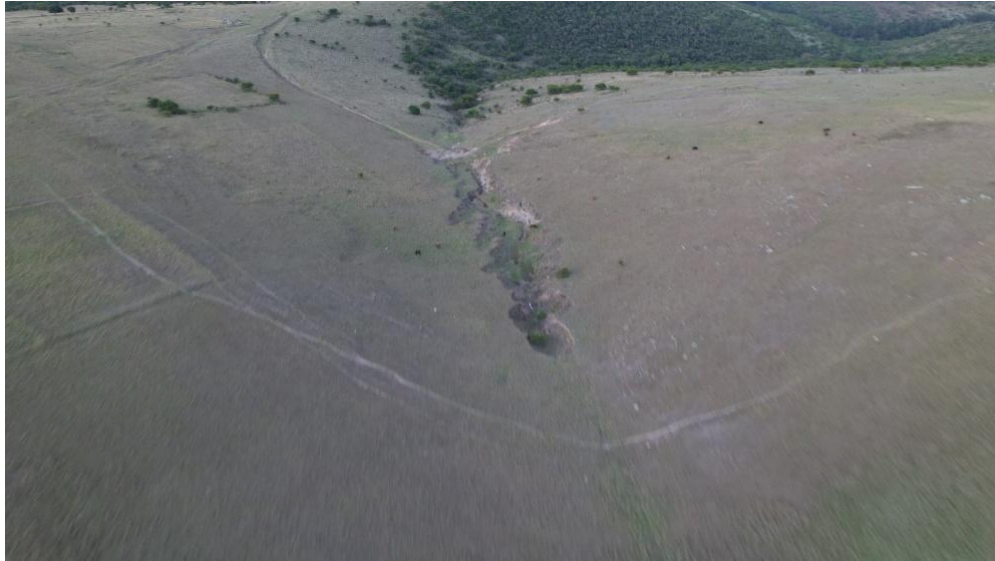
**Table 8-163 Seep 80 details (no direct crossing)**

Ngqamakhwe SEEP 80	Crossing No:	N/A	Quaternary Catchment	S70D	Map Reference	Figure 8-45
Habitat type	Hillslope Seep Wetland		Latitude:	-32.243413	Longitude:	28.139681
Photograph

IHI/PES	Condition Score	Key current impacts				
	C	Heavy grazing and trampling by livestock, major erosion present throughout a large portion of the wetland.				
EIS Score	Moderate EIS. The score is derived from the biodiversity maintenance ecological importance of the wetland due to the relatively good ecological condition of C and the fact that it is ecologically connected to other wetlands and freshwater ecosystems of importance.					
Risks	Minor risks are posed to this wetland given that there are no direct crossings that are proposed for this wetland. Minor risks include increased runoff from a burst pipe in the catchment of the wetland or from sedimentation during the construction phase.

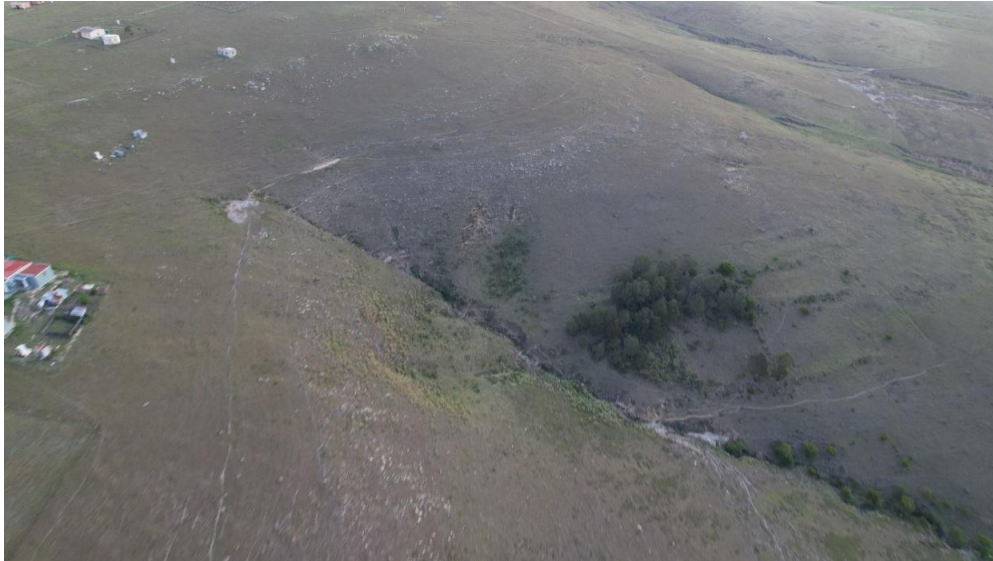
**Table 8-164 Mountain headwater stream 9 details (no direct crossing)**

Ngqamakhwe MHS 9	Crossing No:	N/A	Quaternary Catchment	S70D	Map Reference	Figure 8-46
Habitat type	Mountain Headwater Stream	Latitude:	-32.245573	Longitude:	28.133579	
Photograph

IHI/PES	Condition Score	Key current impacts				
	A	Minor impacts associated with the stream.				
EIS Score	Moderate EIS. The score is derived from the ecological importance of the stream given it is a tributary of the Gcuwa River.					
Risks	Low risks associated with the proposed development given that the pipeline alignments will not cross this stream system at all. A low risk exists because the pipeline is located in the catchment of the stream system.
